Re: Recon Inspection Report – MESD Harding Ditch stormwater outfalls

Purpose: Metro East Sanitary District (MESD) – Recon Inspection Report

Facility: MESD’s Harding Ditch Stormwater Outfalls, Centreville, Illinois

Date of Inspection: April 1, 2021

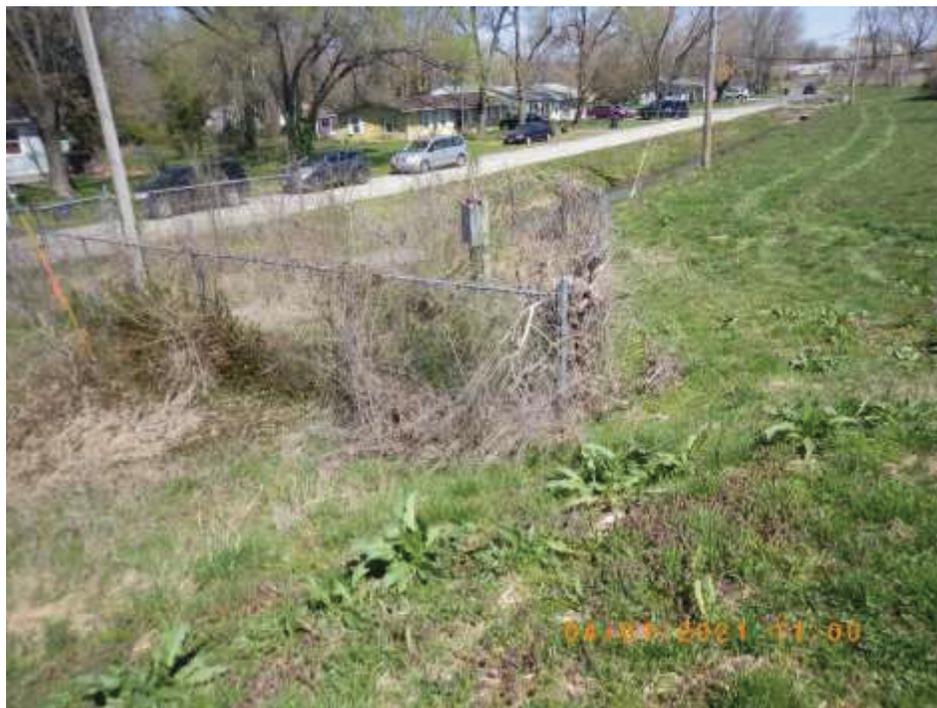
1: MESD0001

We walked to the berm along the north side of Harding Ditch and began the inspection at the stormwater outfall at Inspection Station 1 (see Attachment A for a map of the outfall inspection stations). First we observed the stormwater pump station at the end of Delano Drive. (Photograph 1; MESD0001.jpg). The pump station sends stormwater flow to an outfall to Harding Ditch (Photograph 2; MESD0002.jpg). The outfall appeared to be partially blocked by rocks and debris. The outfall was not visibly discharging but it appears that once stormwater discharges from the outfall it flows through a short gully to Harding Ditch (Photograph 3; MESD0003.jpg). At this point in the inspection, Joan Rogers and Ted Flatebo departed to attend another meeting. Mr. Hillman and I walked back to our vehicles on Delano Drive and drove along the berm on the north side of Harding Ditch to Inspection Station #2.

Description: stormwater pump station.

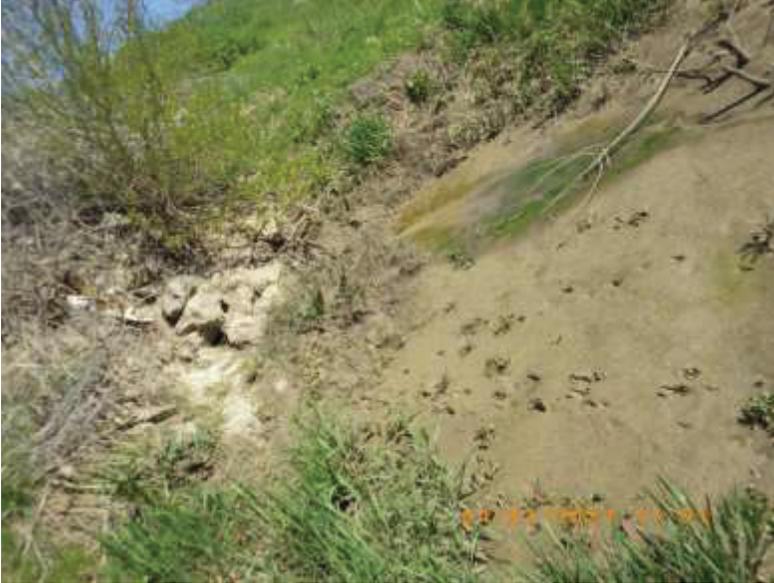
2: MESD0002

Description: outfall to Harding Ditch. The outfall appeared to be partially blocked by rocks and debris.

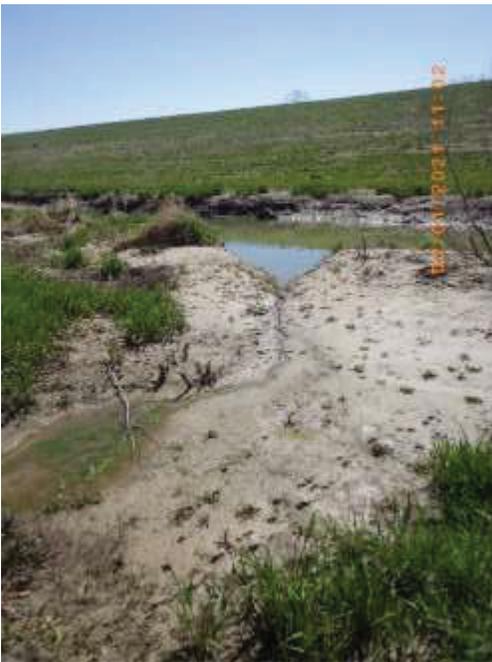
3: MESD0003

Description: short gully from outfall to Harding Creek.

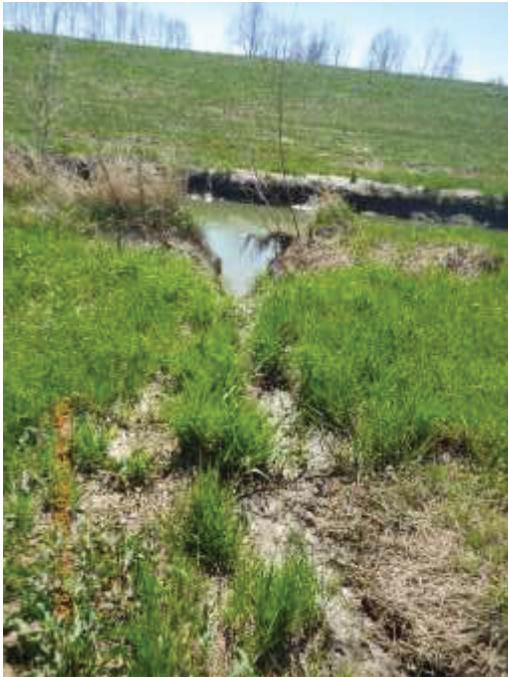
4: MESD0004

Description: outfall discharges to a short gully to Harding Ditch.

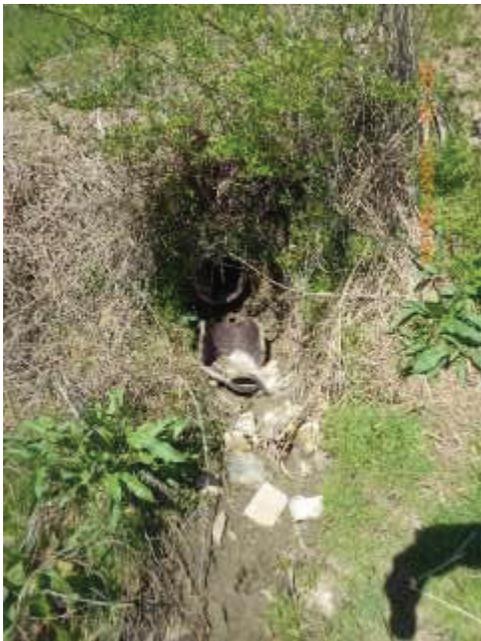
5: MESD0005

The outfall at this location discharges to a short gully to Harding Ditch (Photograph 4; MESD0004.jpg). The outfall itself appeared to be damaged and was not discharging (Photograph 5; MESD0005.jpg). The outfall pipe runs under the berm (Photograph 6; MESD0006.jpg) and conveys stormwater from a ditch and field north of the berm.

Description: outfall appeared to be damaged and was not flowing.

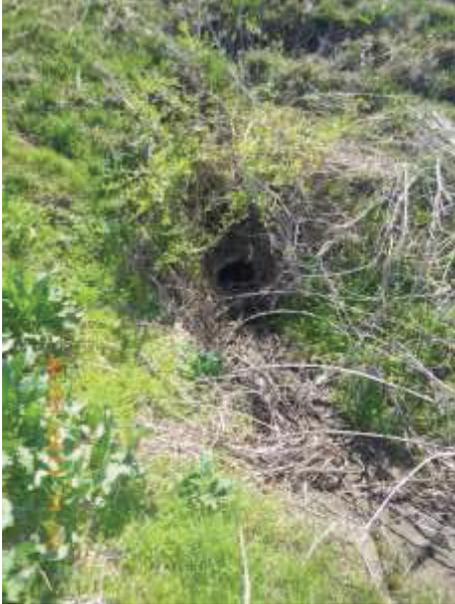
6: MESD0006

Description: outfall pipe inlet under the berm. Conveys stormwater from a ditch and field north of the berm to Harding Ditch.

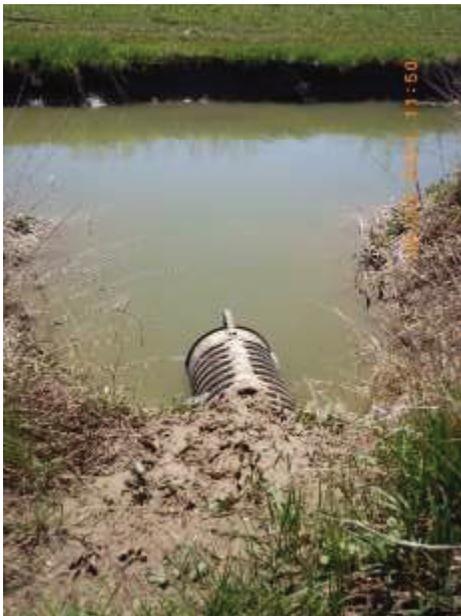
7: MESD0007

Description: The outfall at this station discharges directly to Harding Ditch and was partially submerged.

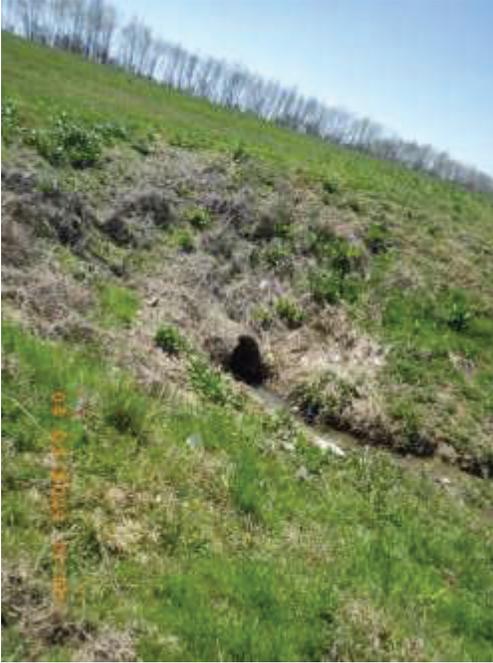
8: MESD0008

We continued along the berm to Inspection Station #3. The outfall at this station discharges directly to Harding Ditch and was partially submerged. The outfall pipe runs under the berm (Photograph 7; MESD0007.jpg) and conveys stormwater from a ditch north of the berm (Photograph 8; MESD0008.jpg). I observed flowing water in the ditch.

Description: outfall pipe inlet under the berm. Conveys stormwater from a ditch north of the berm to Harding Ditch.

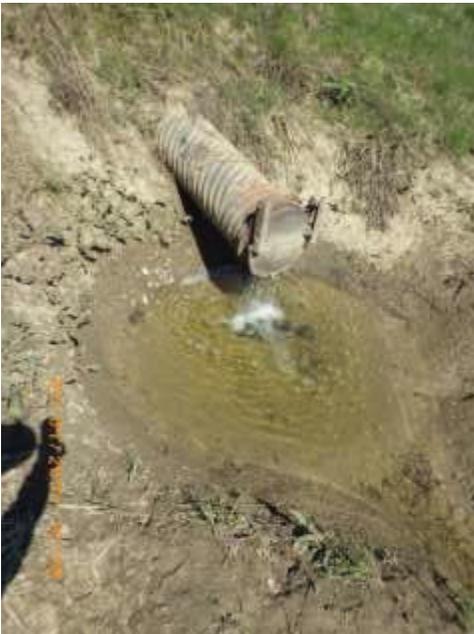
9: MESD0009

Description: corrugated metal outfall. Discharging to a short ditch to Harding Ditch.

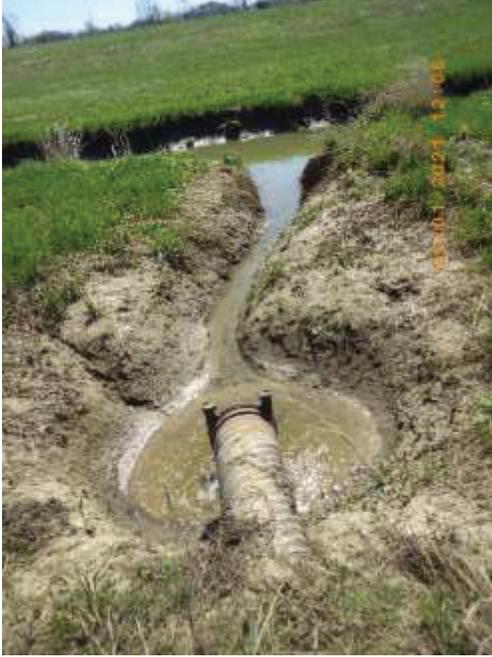
10: MESD0010

Description: Outfall discharging to a short ditch to Harding Ditch.

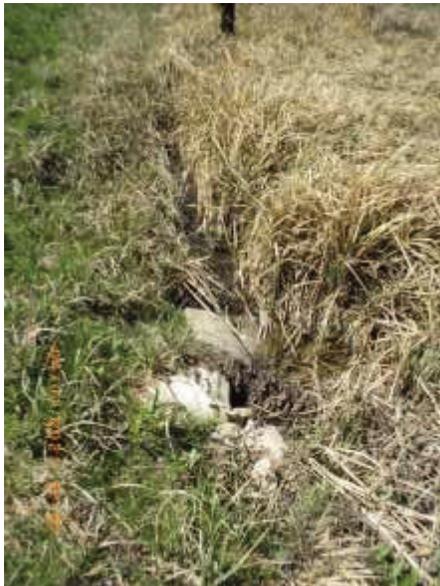
11: MESD0011

At Inspection Station #4, a corrugated metal outfall was discharging (Photograph 9; MESD0009.jpg) to a short gully to Harding Ditch (Photograph 10; MESD0010.jpg). The outfall pipe runs under the berm and conveys stormwater from a ditch north of the berm (Photograph 11; MESD0011.jpg). The corrugated pipe inlet appeared damaged and partially buried in sediment.

Description: inlet to outfall pipe running under the berm, conveying stormwater from a ditch north of the berm. The inlet appeared damaged and partially buried in sediment.

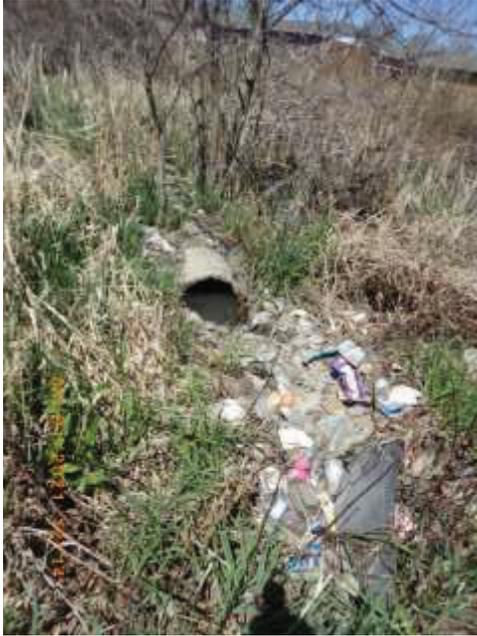
12: MESD0012

We continued to Inspection Station #5. An outfall was observed in a ditch along the base of the north side of berm and appeared to be coming from the upland area towards Camp Jackson Road (Photograph 12; MESD0012.jpg). The outfall was not discharging and I noted heavy litter and debris in the ditch. No outfall was observed on the south side of the berm along Harding Ditch at this inspection station.

Description: outfall observed in a ditch along the base of the north side of berm and appeared to be coming from the upland area towards Camp Jackson Road. Note heavy litter and debris.

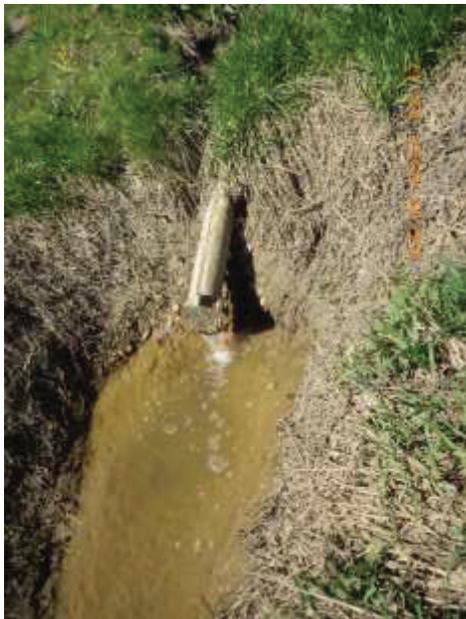
13: MESD0013

We continued along the berm to Inspection Station #6. An outfall was observed at this station and was discharging to a short ditch to Harding Ditch (Photograph 13; MESD0013.jpg). Mr. Hillman noted a sewage smell near the area of the discharge. I also noted the odor. The last section of the outfall pipe was separated from the pipe heading under the berm (Photograph 14; MESD0014.jpg). The outfall pipe runs under the berm and neither the other end of the pipe or an inlet was visible on the north side of the berm.

Description: outfall observed discharging at this station to a short ditch to Harding Ditch.

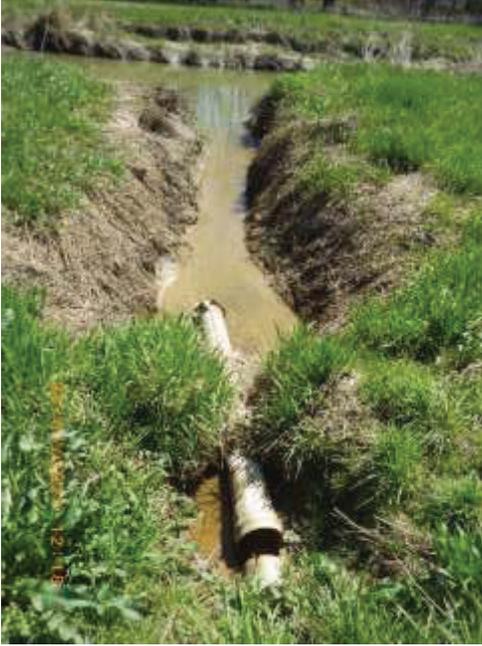
14: MESD0014

Description: outfall pipe was separated from the pipe heading under the berm.

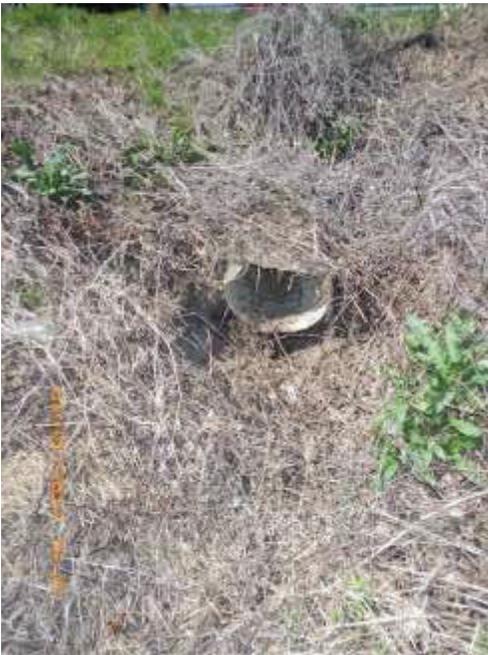
15: MESD0015

We continued along the berm to Inspection Station #7. In this area there is no drop off in elevation on the north side of the berm. I observed an outfall along the south side (Harding Ditch side) of the berm and it was not discharging (Photograph 15; MESD0015.jpg). The outfall pipe runs under the berm and neither the other end of the pipe or an inlet was visible on the north side of the berm.

Description: outfall along the south side (Harding Ditch side) of the berm.

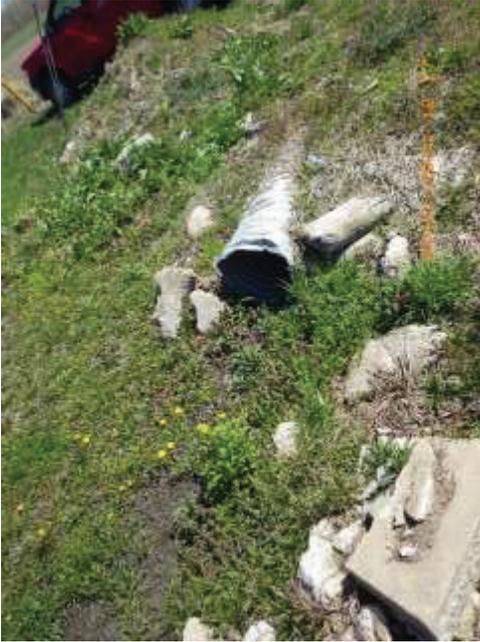
16: MESD0016

Description: inlet of metal pipe heading under the berm and to the outfall on Harding Ditch.

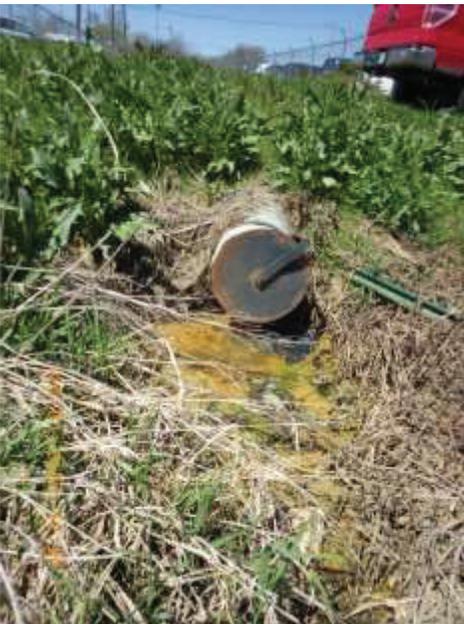
17: MESD0017

We continued to along the berm to the last station, Inspection Station #8. Similar to Inspection Station #7, there is only a small drop off in elevation on the north side of the berm. I observed a ditch between the two facilities and Camp Jackson Road to the north, and the inlet of a metal pipe (Photograph 16; MESD0016.jpg) that leads under the berm to the outfall on the south side (Harding Ditch side) of the berm. The outfall was not visibly discharging but a small pool of rust-colored water was observed under the outfall (Photograph 17; MESD0017.jpg). The outfall discharges to a short ditch that flows into Harding Ditch.

Description: outfall to Harding Ditch not visibly discharging but a small pool of rust-colored water was observed under the outfall.
