Re: April 1, 2021 Inspection Report

**Purpose:** City of Centreville – SSO Reconnaissance Inspection Report

**Facility:** City of Centreville, Illinois

**Date of Inspection:** April 1, 2021

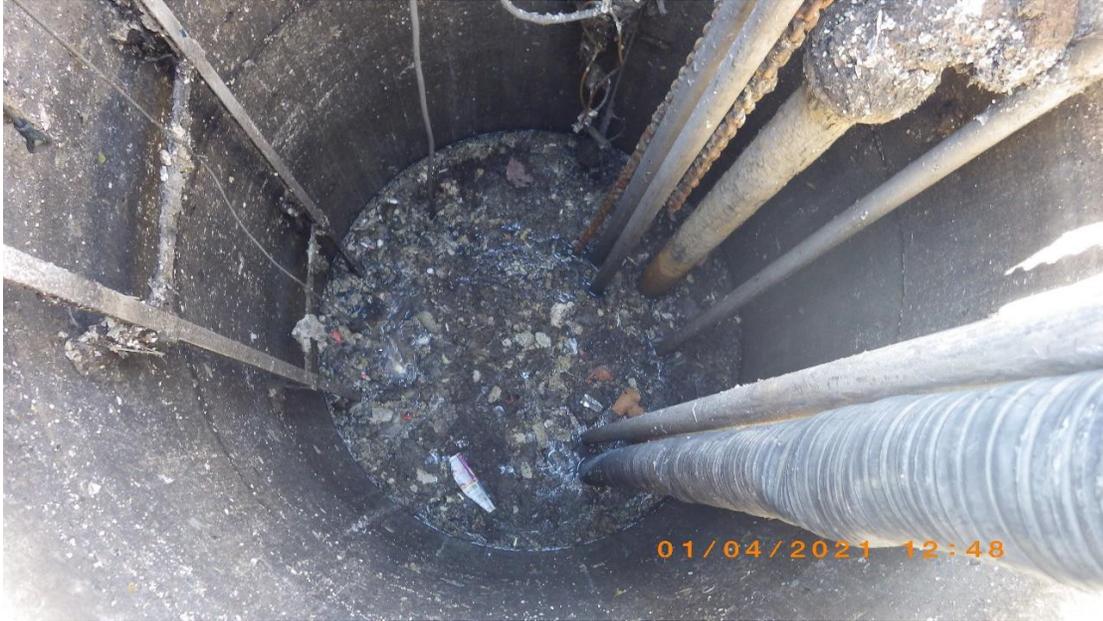
4: RIMG0056

The inspection team next drove to lift station #3, located at 400 Jackson Street, arriving at 1:46 P.M. Mr. Allen stated that this lift station has one pump that is inoperable and the power to the equipment is currently turned off. The station must be manually bypassed using a rented tow-behind pump that the City stores at their Public Works maintenance yard. This pump has a hose diameter of 4 inches and it takes approximately 90 minutes to pump down the wet well.

Description: Lift Station #3 – Wet well.

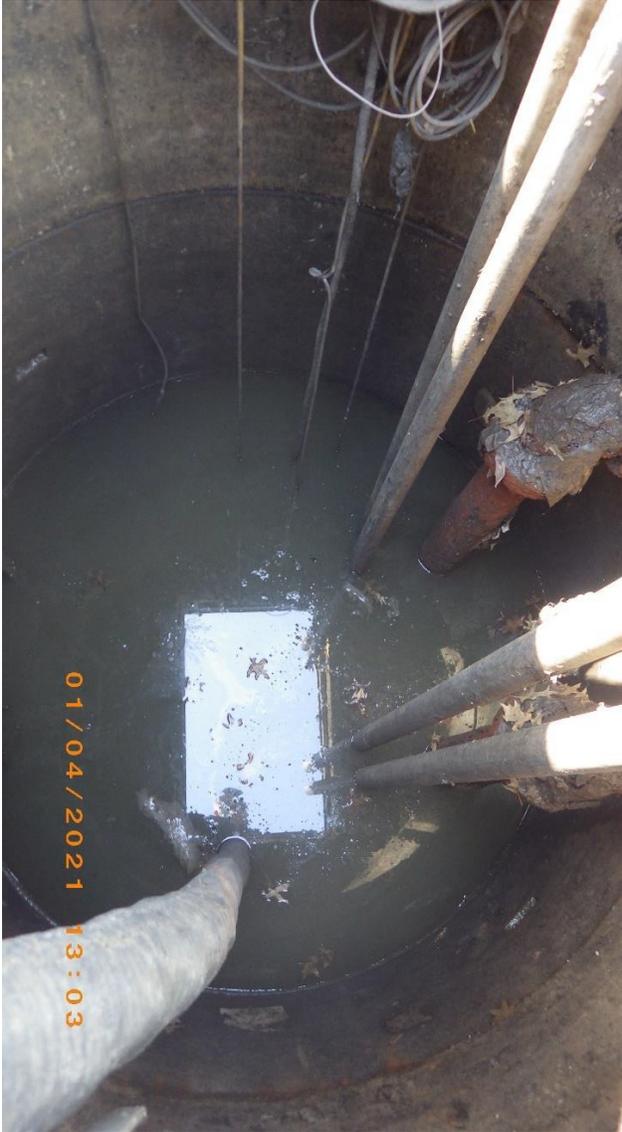
7: RIMG0059

This lift station was recently outfitted with a new control panel, although the wet well contains one inoperable pump. The lift station is scheduled to have two new pumps installed when funds are available, but no timeline was provided. Mr. Allen stated that this lift station does not have a history of overflows even during wet weather events.

Description: Lift Station #2 – Wet Well.

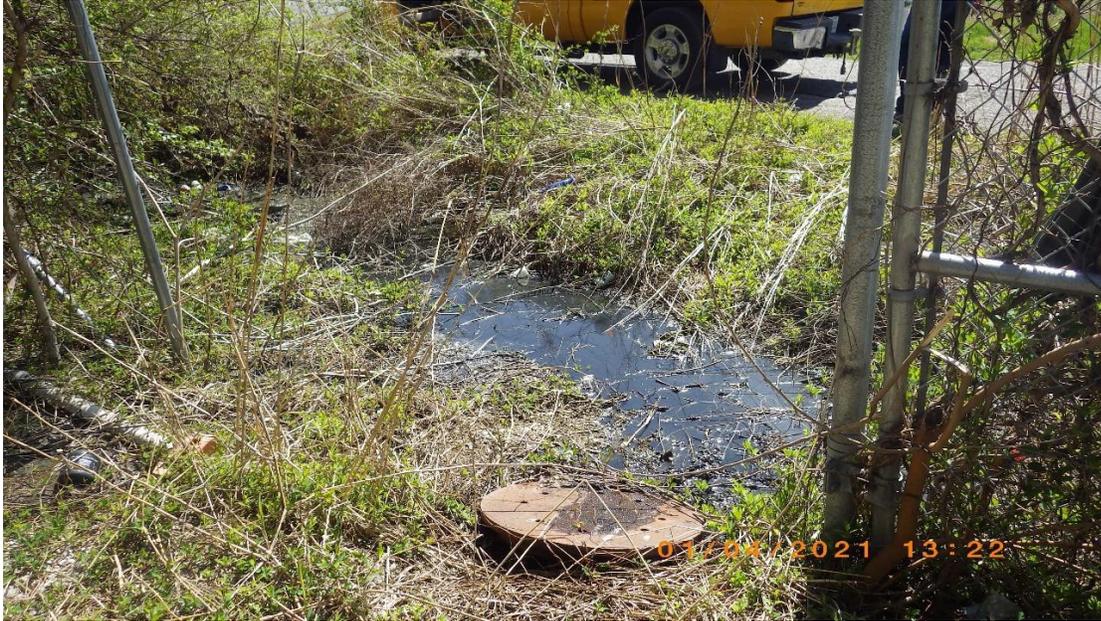
10: RIMG0063

At 2:17 P.M., the inspection team arrived at lift station #5, located at 4200 Missouri Ave. At this time, Dean Maraldo, EPA inspector, joined the team. As the team approached the lift station, there was a sewage odor in the air, a large quantity of sewage-related debris on the ground, and standing water on the ground in the immediate vicinity (picture RIMG0065). After approaching, Mr. Allen lifted a manhole cover revealing an approximately 2 inch diameter PVC pipe immediately southwest of the wet well. After lifting the cover, dark sewage began flowing from the pipe onto the ground and a strong sewage odor was noted (picture RIMG0073). It had not rained in this area since March 25 and this was a dry weather sanitary sewer overflow (SSO). I recorded a video of the sewage flowing from the PVC pipe (RIMG0062.MOV).

Description: Lift Station #5 – Standing sewage adjacent to lift station.

Mr. Stitley told Mr. Allen that the lift station needed to be serviced immediately, either through bypass pumping or a vac truck. Mr. Allen was unsure if there was a suitable bypass location in the vicinity, so he called a contractor to have a vac truck brought to the site the morning of April 2, 2021. This was the earliest he could get a truck out to the lift station. Mr. Stitley also instructed Mr. Allen to maintain records of how much sewage is pumped from the lift station for this initial servicing, and to document future pumping events. Mr. Allen stated that this lift station receives waste from the two motels to the immediately southwest, and he did not know where the waste was pumped to.

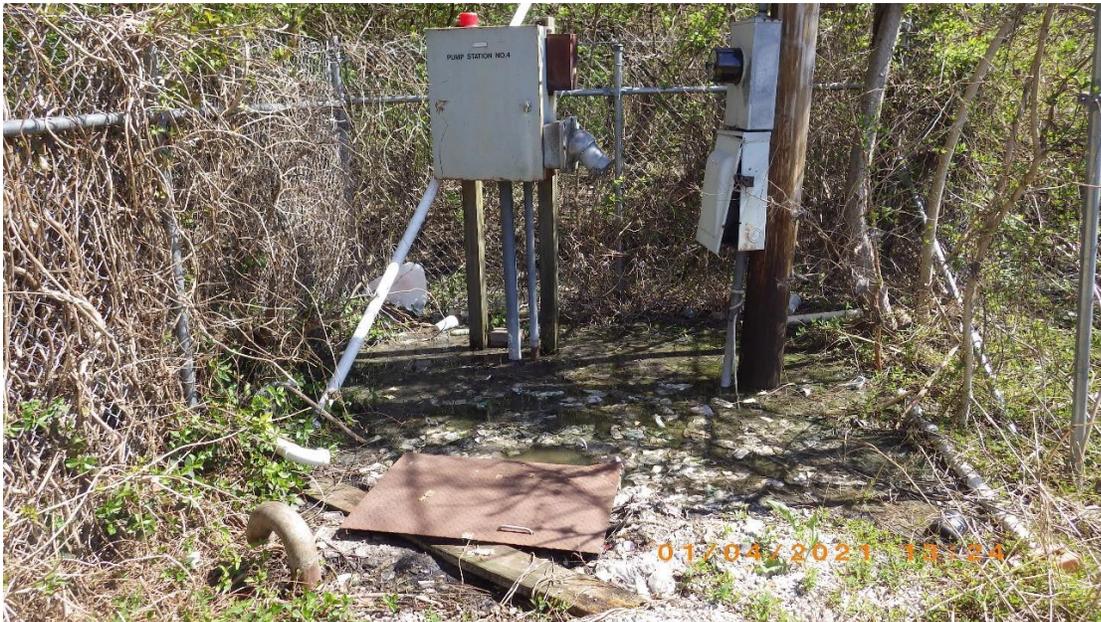
11: RIMG0064

Description: Lift Station #5 – Overview of lift station, note large quantity of sanitary debris on the ground around the wet well (under brown cover).

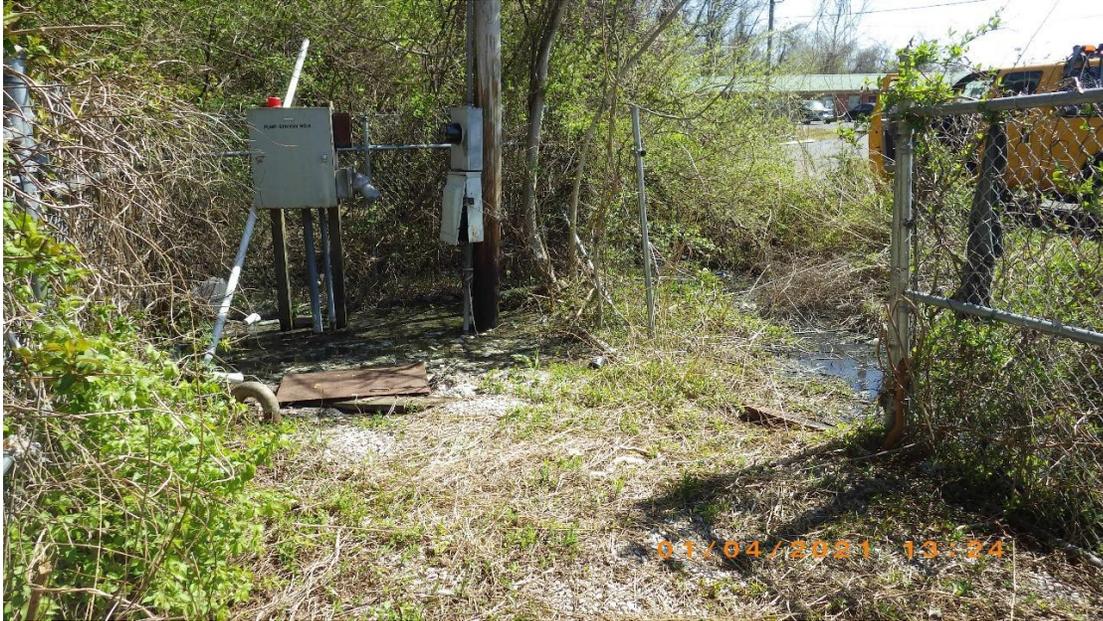
12: RIMG0065

Description: Lift Station #5 – Overview picture. Note standing sewage and sewage-related debris.

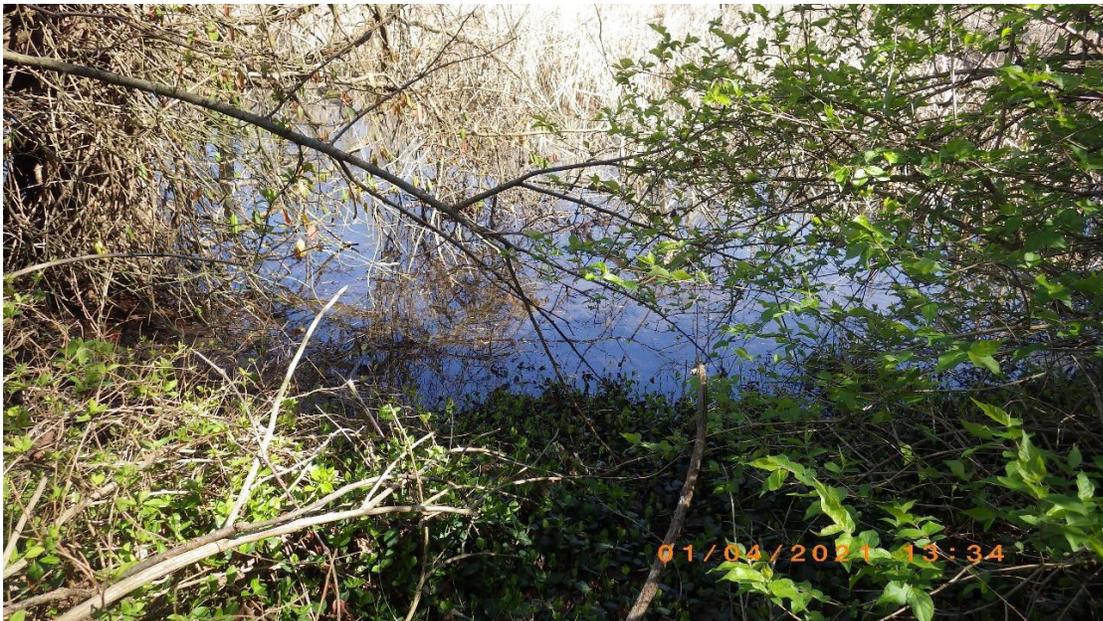
13: RIMG0066

Description: Lift Station #5 - Wetland downhill from the lift station.

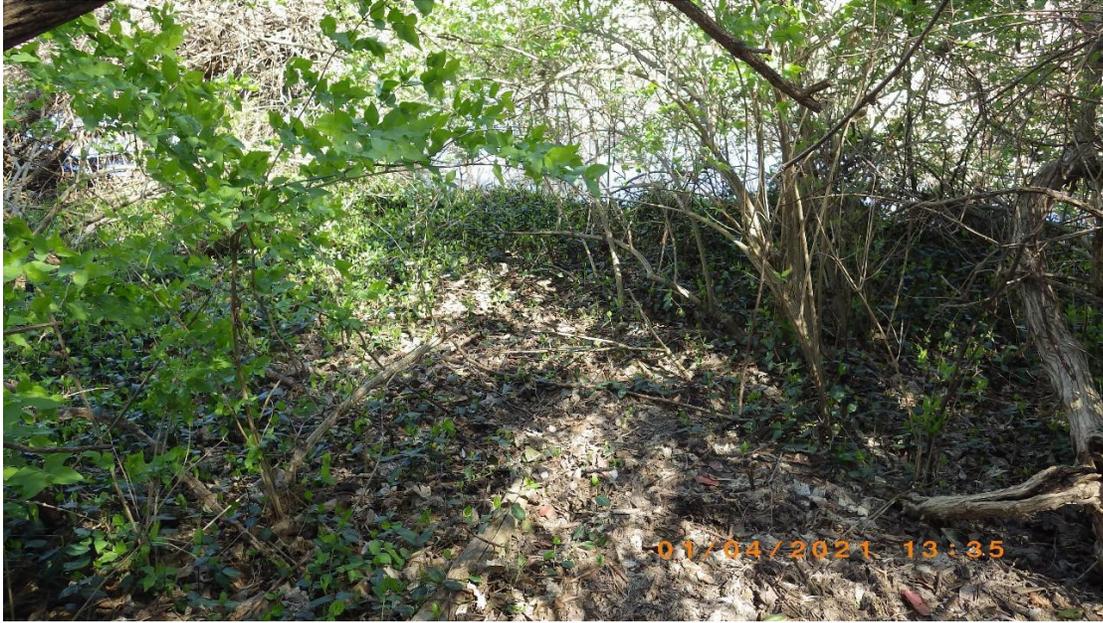
14: RIMG0067

Upon inspecting the surrounding area, there was a dry flow path leading from the lift station to the north/northeast leading down a hill through thick vegetation to a wetland. The area is delineated as wetland on the U.S. Fish and Wildlife Service online wetlands mapper (<https://www.fws.gov/wetlands/data/mapper.html>). This flow path contained large quantities of dried toilet paper and other sewage-related debris.

Description: Lift Station #5 - Dried flow path from lift station leading to standing water in a wetland.

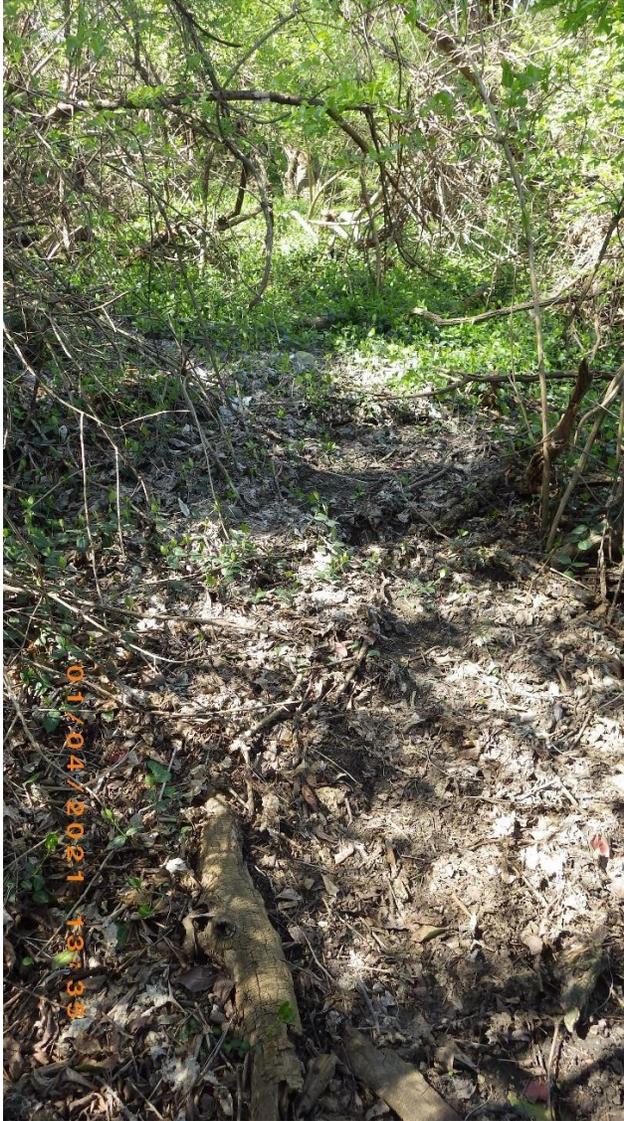
15: RIMG0068

Description: Lift Station #5 - Dried flow path from lift station to standing water, note dried toilet paper in the pathway.

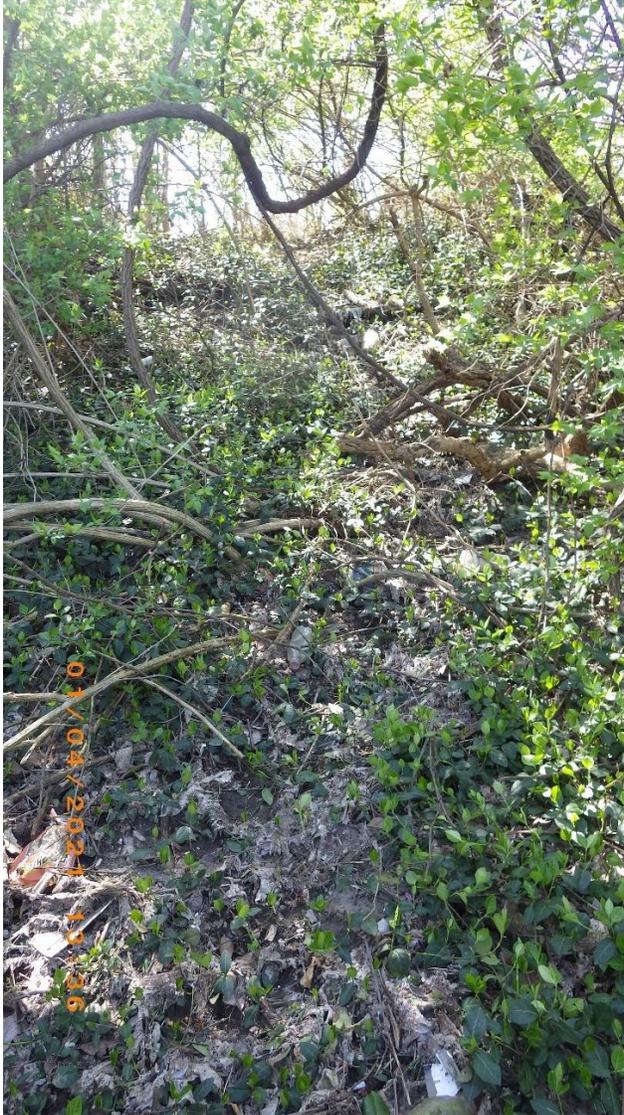
16: RIMG0069

Description: Lift Station #5 - Dried flow path from lift station to standing water, note dried toilet paper in the pathway.

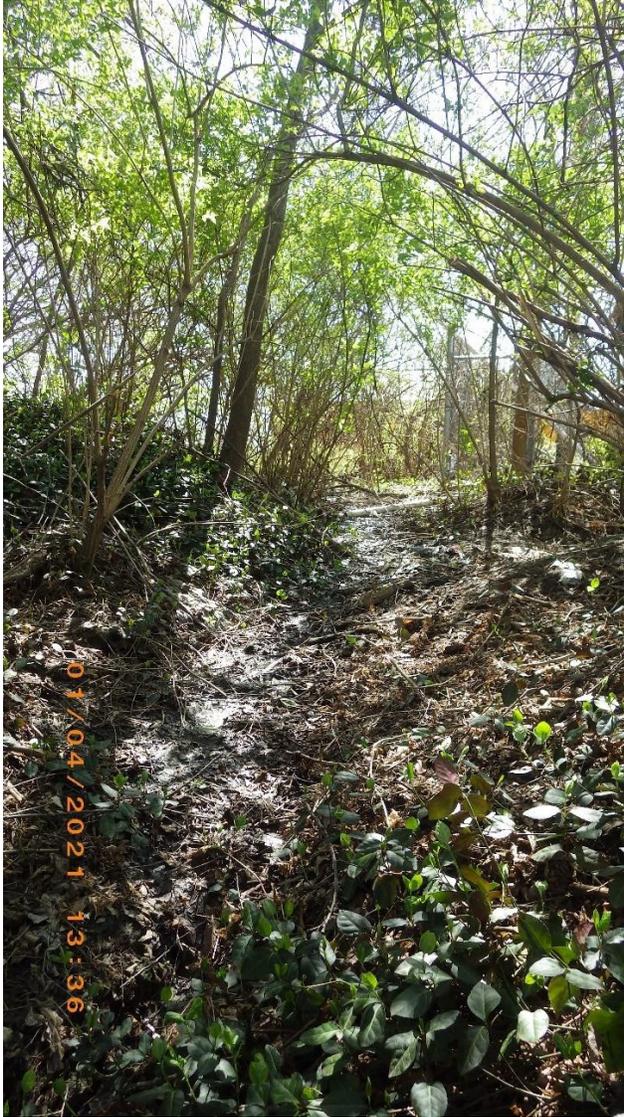
17: RIMG0070

Description: Lift Station #5 - Dried flow path from lift station to standing water, note dried toilet paper in the pathway.

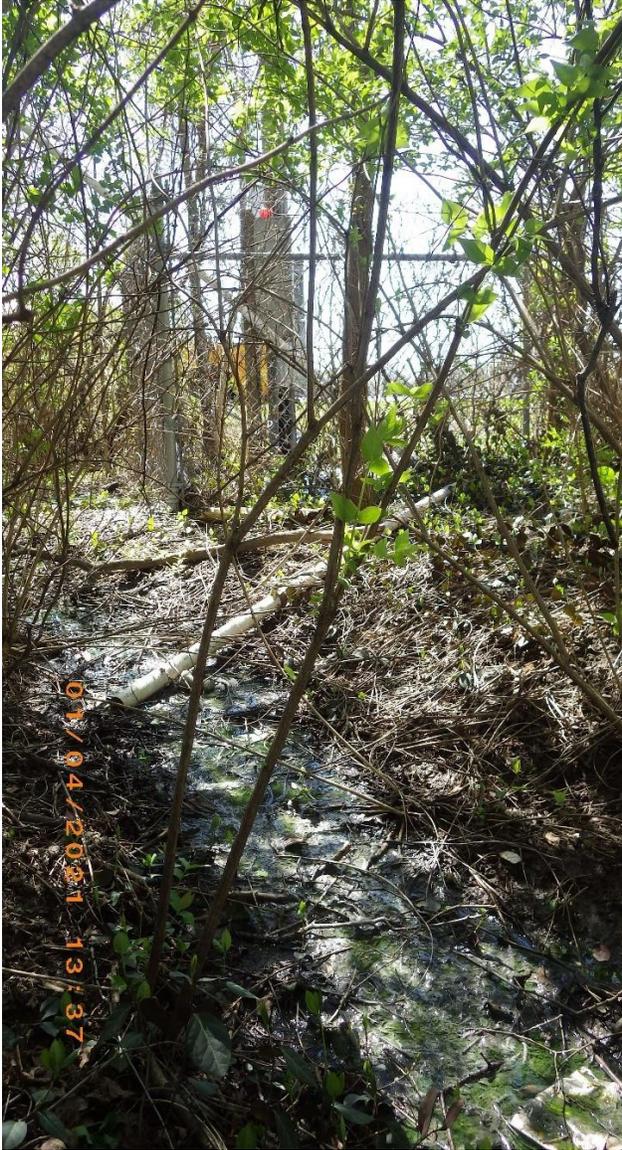
18: RIMG0071

As depicted in pictures RIMG0071 and RIMG0072, there is an approximately 10 foot segment of 2 inch PVC pipe that is laying directly adjacent to the wet well and leads from the wet well to the dried flow path.

Description: Lift Station #5 - Dried flow path leading directly to fence line of lift station. Note 10 foot PVC pipe leading from wet well to flow path.

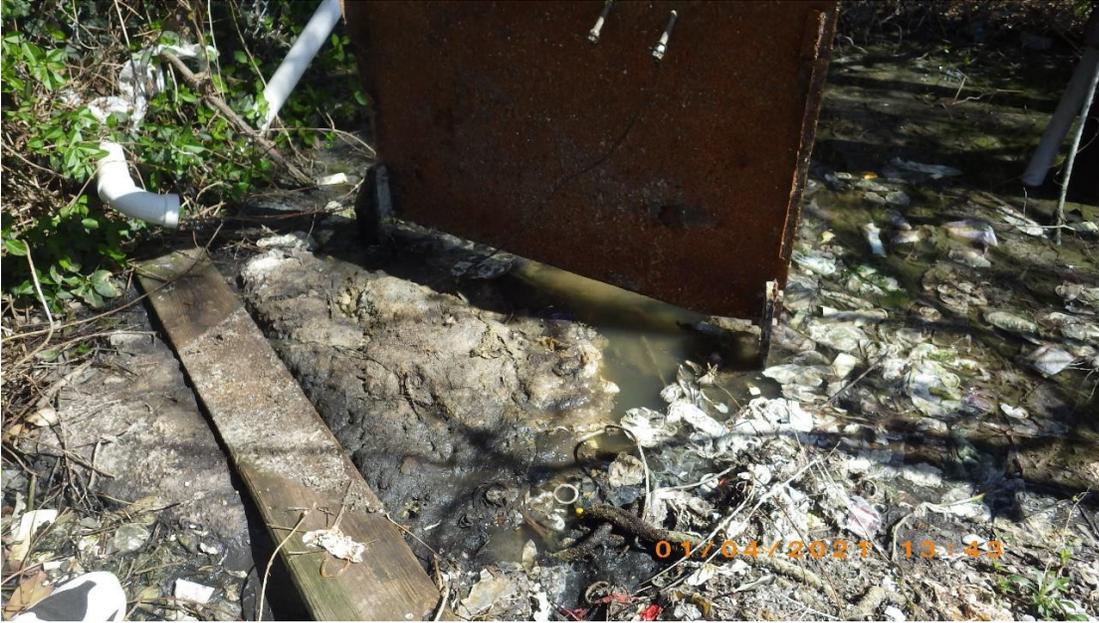
19: RIMG0072

Description: Lift Station #5 – Lifted wet well cover. Wet well was full and the edge of wet well is obscured by debris.

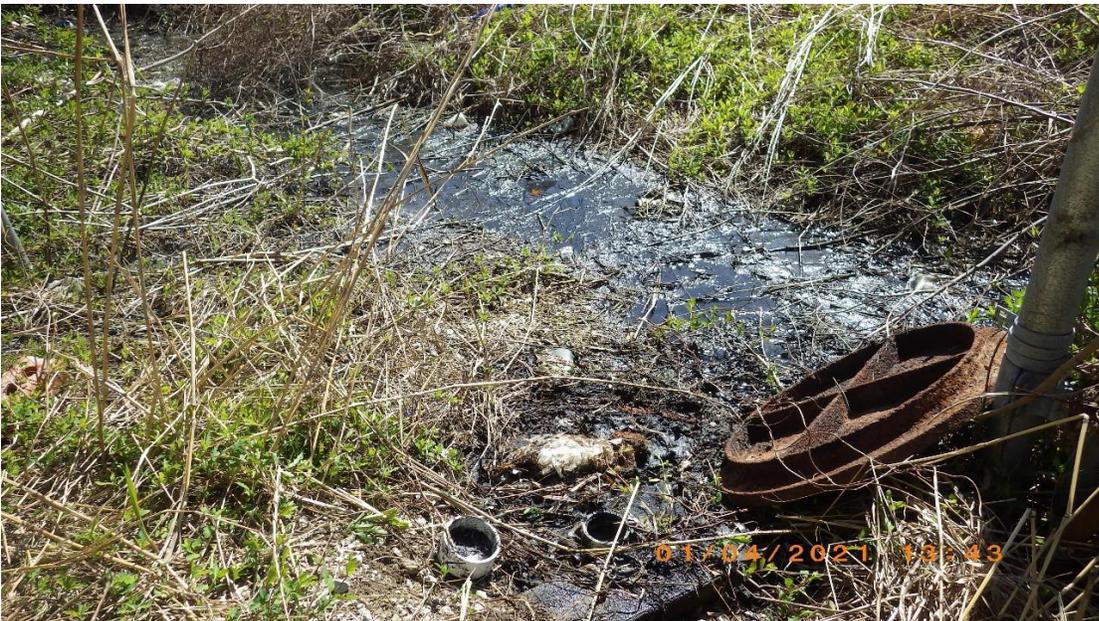
20: RIMG0073

Description: Lift Station #5 – PVC pipe in foreground was the source of the discharge.

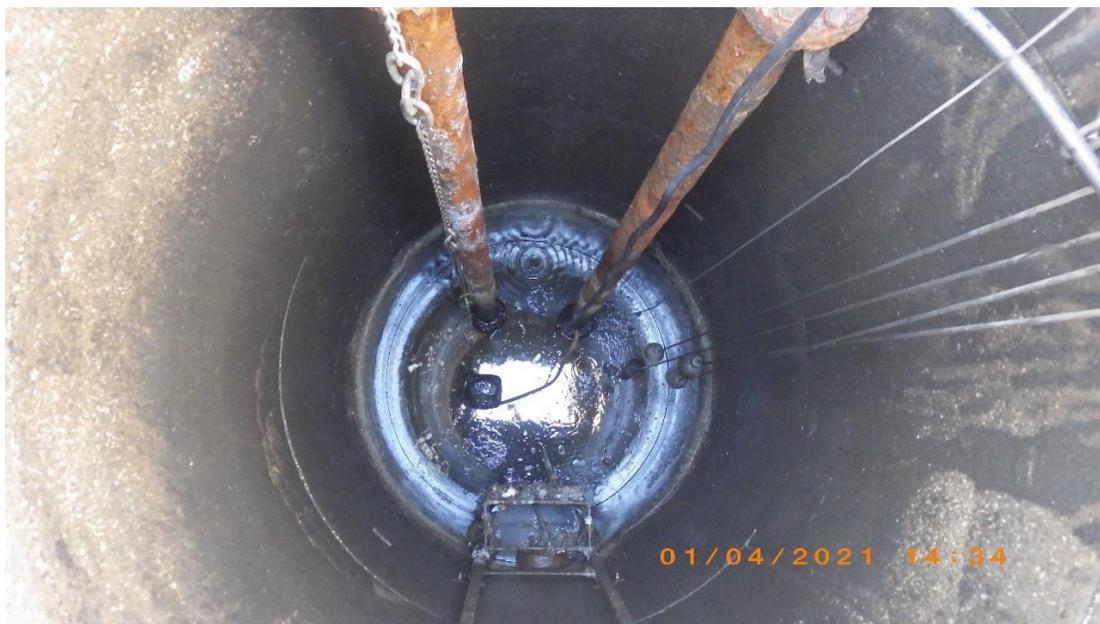
30: RIMG0083

Mr. Allen stated that storm water runs from the surrounding parking lot and pools on top of the lift station. EPA recommended the City address this issue to minimize this run on and reduce potential inflow/infiltration.

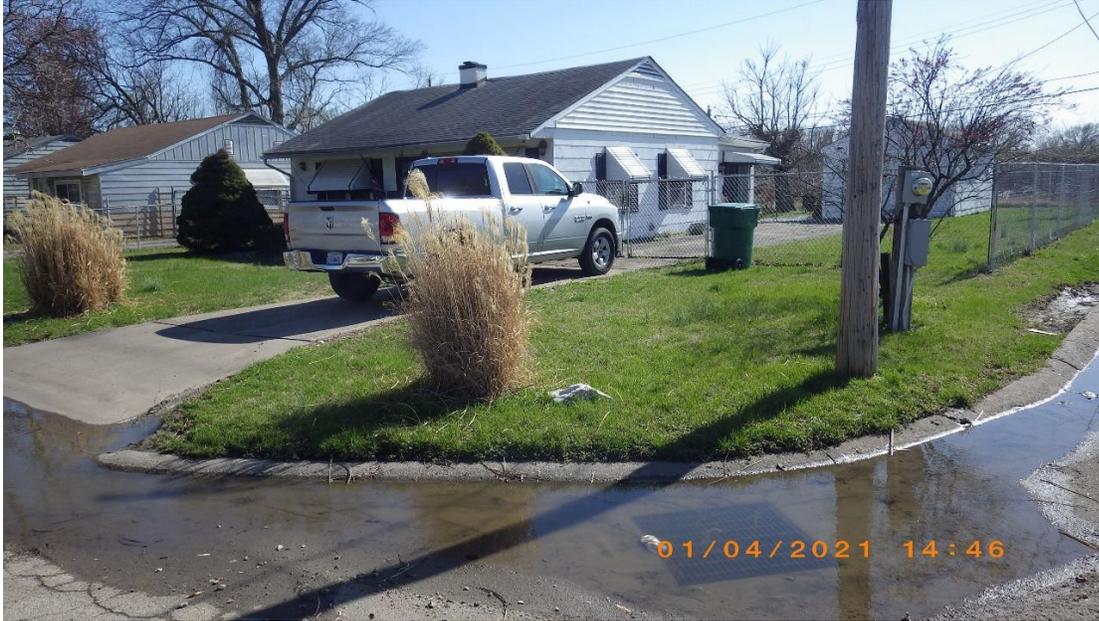
34: RIMG0087

According to Mr. Allen, the lift station is in working order, although the pump on site is undersized and must be operated manually. When a resident calls to have the pooled storm water addressed, City staff will bring a pump to the site and pump the water on the street approximately 50 feet north on Sterling Street and then let it gravity flow in the gutters to the next storm drain. Mr. Allen stated that this is the only location in the City where storm water was addressed this way.

Description: Lift Station #6 – Storm water inlet at east corner of intersection. A pump below grade is undersized and needs to be activated manually. City personnel do not utilize this below grade pump.

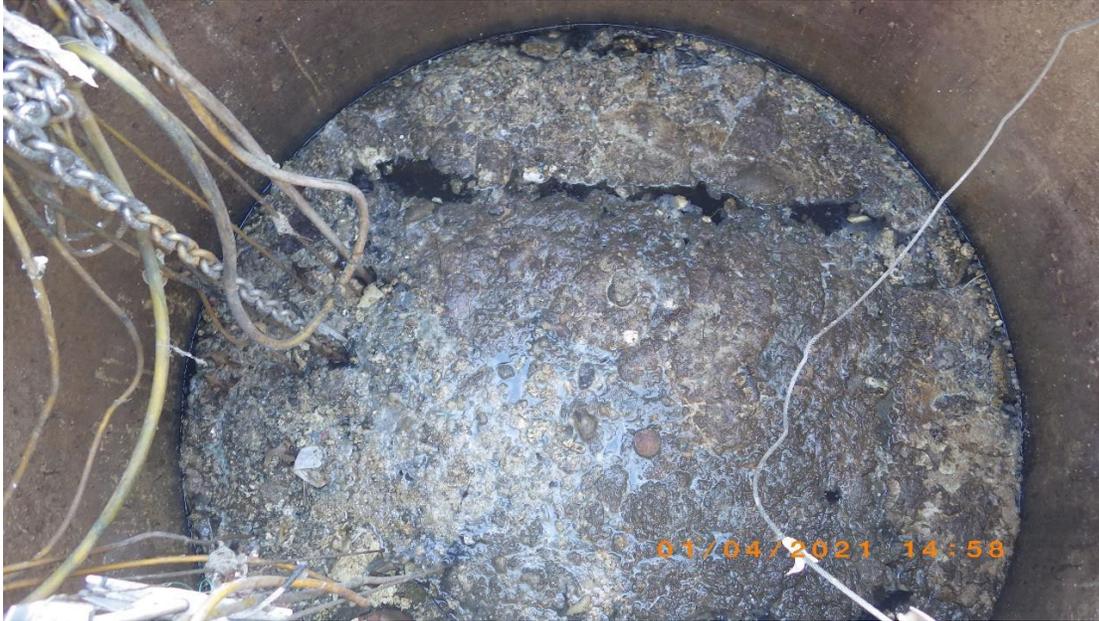
35: RIMG0088

The wet well for this list station was near capacity during the inspection. Mr. Allen stated that this lift station has had difficulty discharging in the past. He asserted that the pump is in good working order and that the problem lies downstream in the Commonfields of Cahokia collection system where this lift station discharges wastewater to. When the lift station cannot discharge its wet well due to downstream capacity issues, a vac truck has to be brought on site.

The lift station is scheduled to receive two new pumps, guide rails, and a control panel when funding is available. No timeline on these replacements was provided.

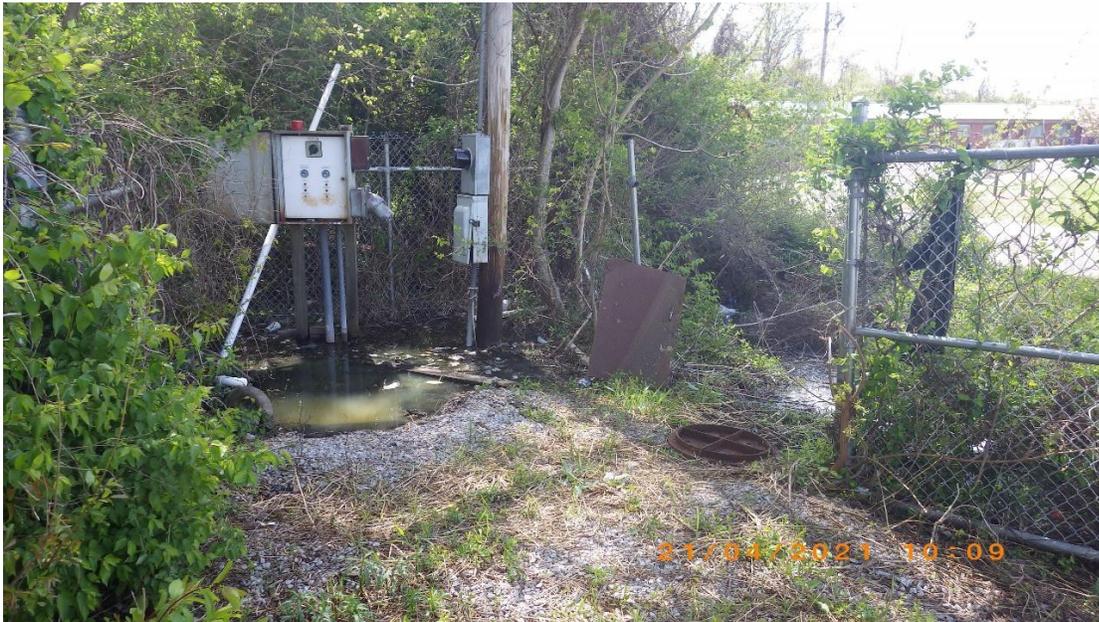
1: RIMG0090

On April 21, 2021, EPA inspector Ted Flatebo returned to lift station #5 in the City of Centreville, located at 4200 Missouri Avenue, arriving at 11:07 A.M. He observed the wet well full of water, standing water in the vicinity of the lift station, and a small but consistent stream of water flowing downhill towards the wetland. A strong sewage odor was also noted.

Description: Lift Station #5 – Full wet well and standing sewage adjacent to lift station. Note wet well cover removed and leaning against fence.

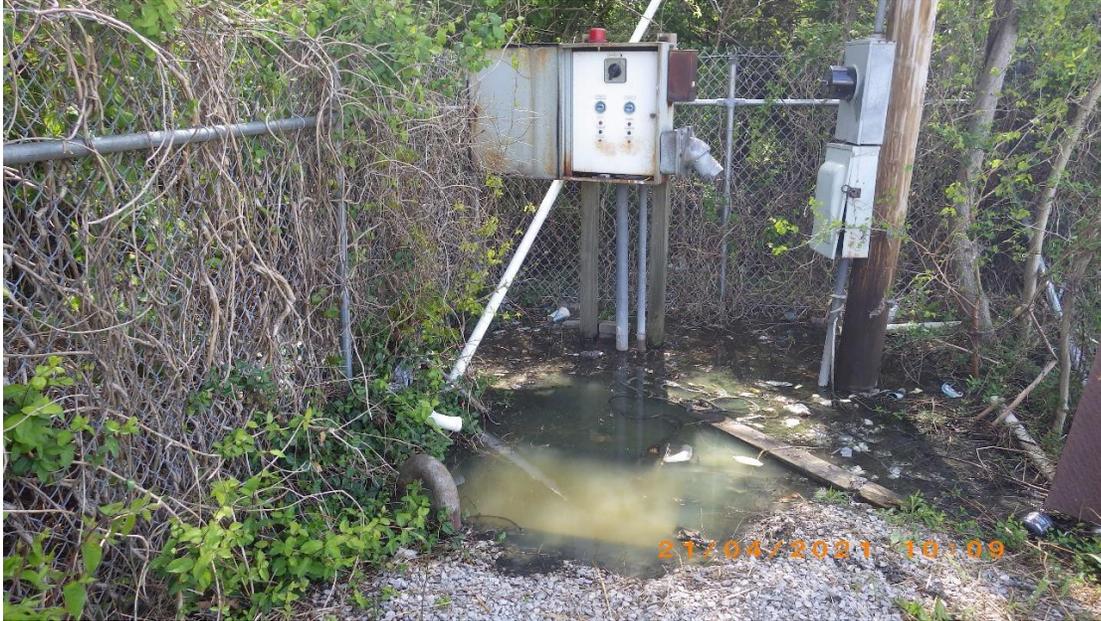
2: RIMG0091

Description: Lift Station #5 – Full wet well

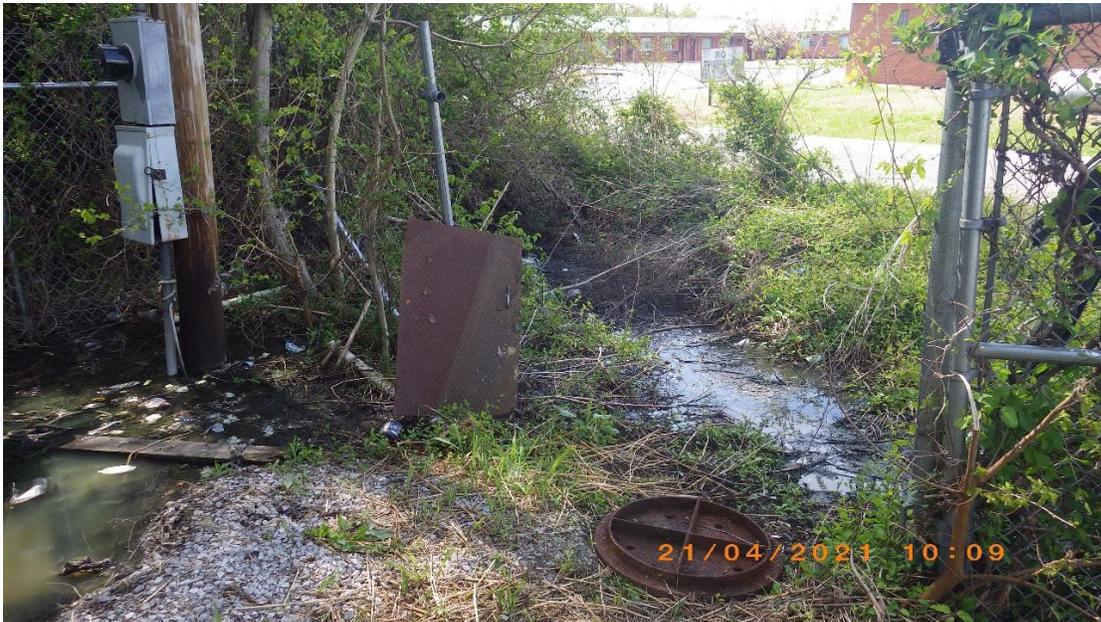
3: RIMG0092

Description: Lift Station #5 – Standing sewage adjacent to lift station. Note wet well cover leaning against fence.

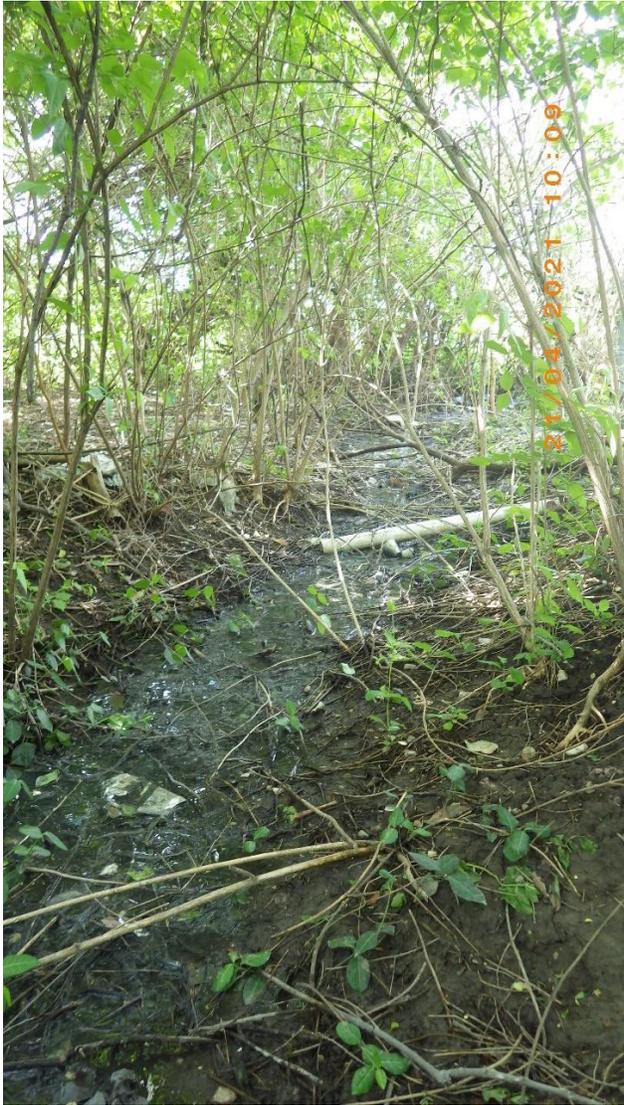
4: RIMG0093

Description: Steady stream of water from lift station flowing downhill.

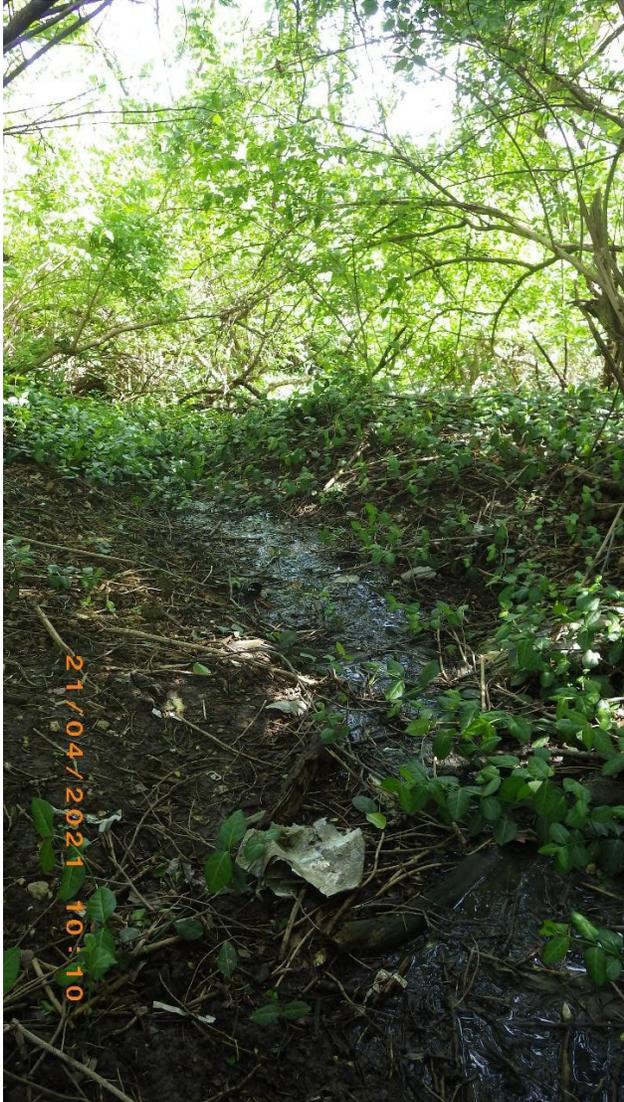
5: RIMG0094

Description: Steady stream of water from lift station flowing downhill.

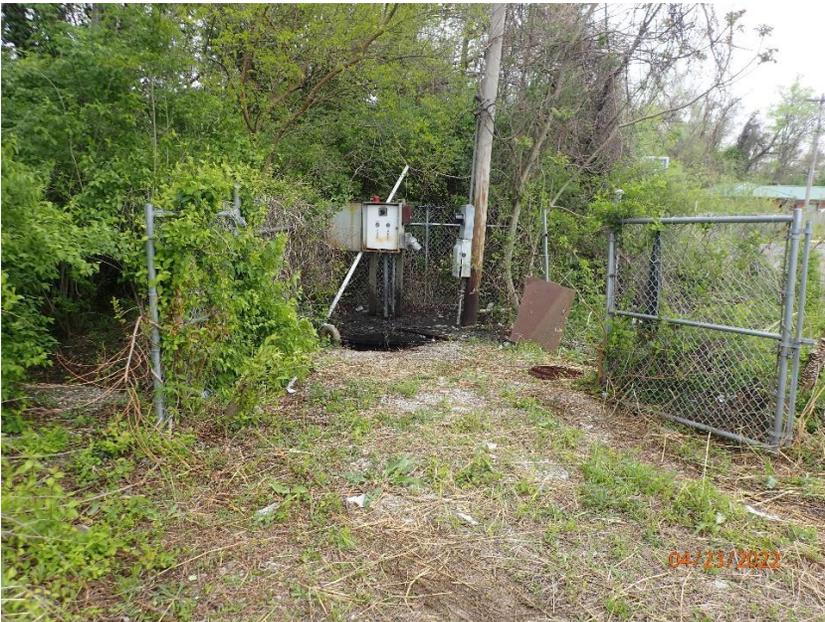
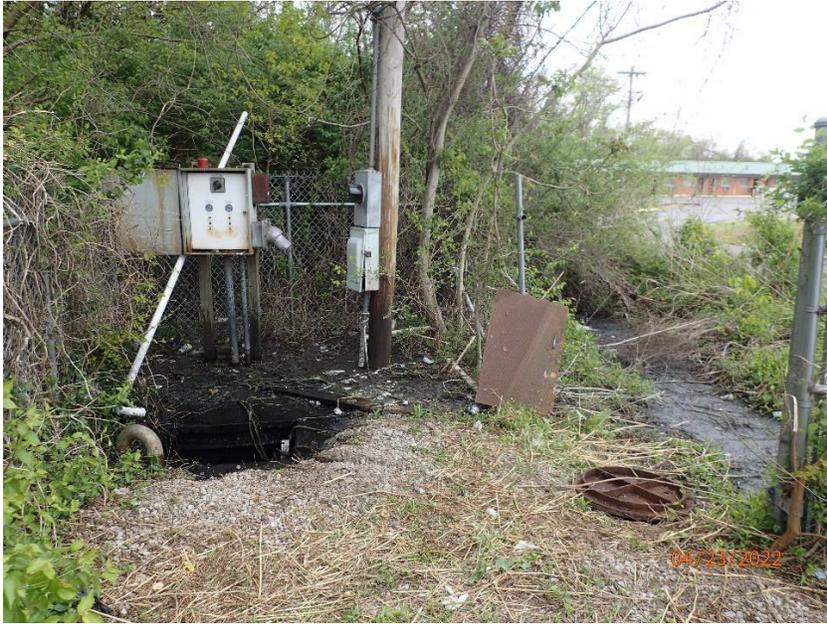
At 11:27 A.M., the inspection team returned to lift station #5 and observed a vac truck emptying the wet well. After the vac truck left the site, the inspection team observed a steady flow of water into the wet well through influent pipes. The pictures included below are all after the vac truck left the site. The inspection team departed the site at 11:44 A.M.

Description: Lift Station #5 – Immediately after being serviced by a vac truck. Note wet well cover removed and leaning against fence.
