**Region 5 Enforcement and Compliance Assurance Division
SDWA DRINKING WATER INSPECTION REPORT**

Inspection Dates: August 11-12, 2021

Systems Inspected: Cahokia Heights, 2525 Mousette Lane, Cahokia, IL 62206
Operating Commonfields of Cahokia - PWSID IL1635030
Operating Village of Cahokia - PWSID IL1630200

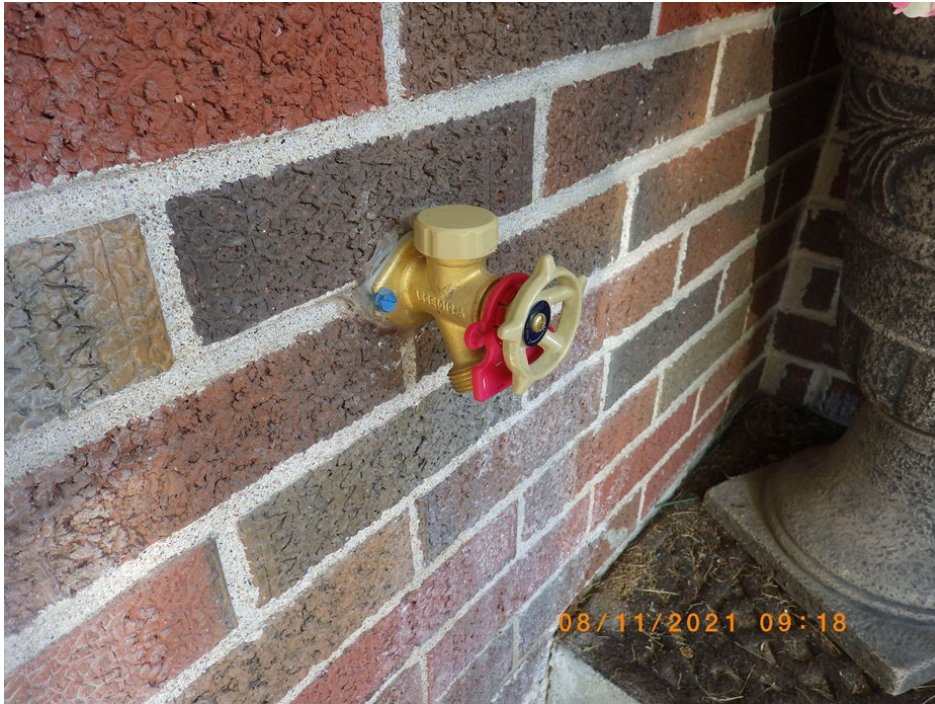
RIMG1463 Hose bib at site 1-01, 253 N 62nd St. 8/11/21

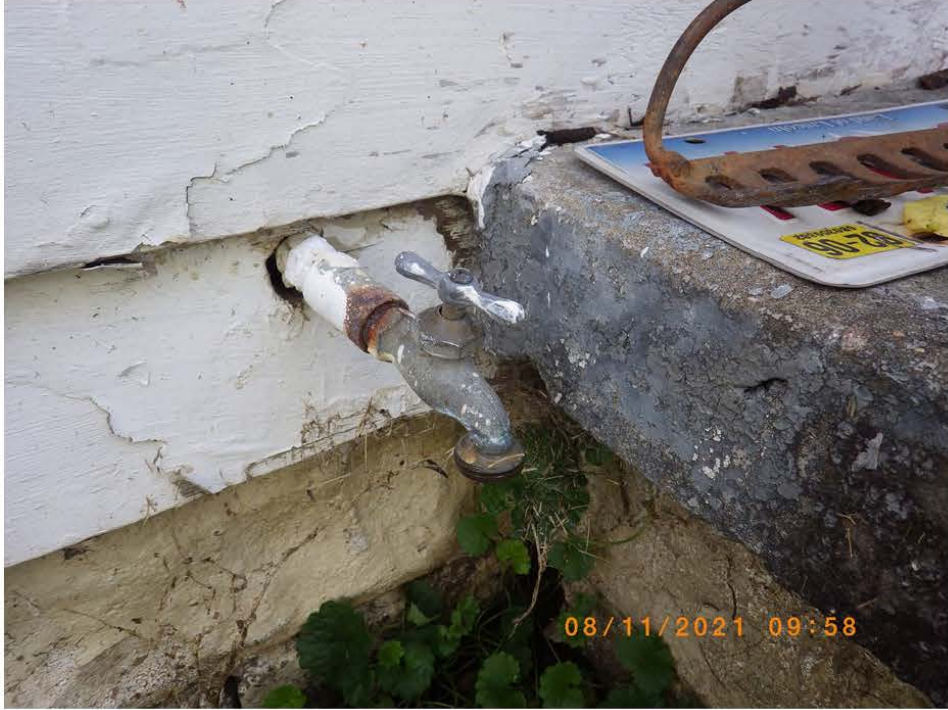
RIMG1464 Hose bib at site 1-03, 305 N 62nd St. 8/11/21

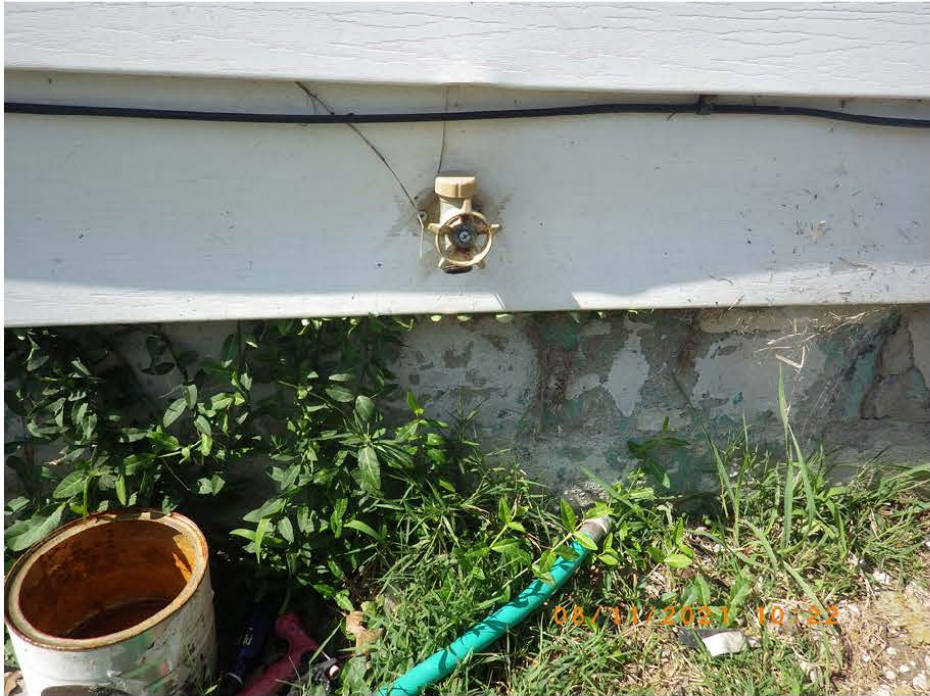
RIMG1465 Hose bib at site 1-04, 307 N 62nd St. 8/11/21

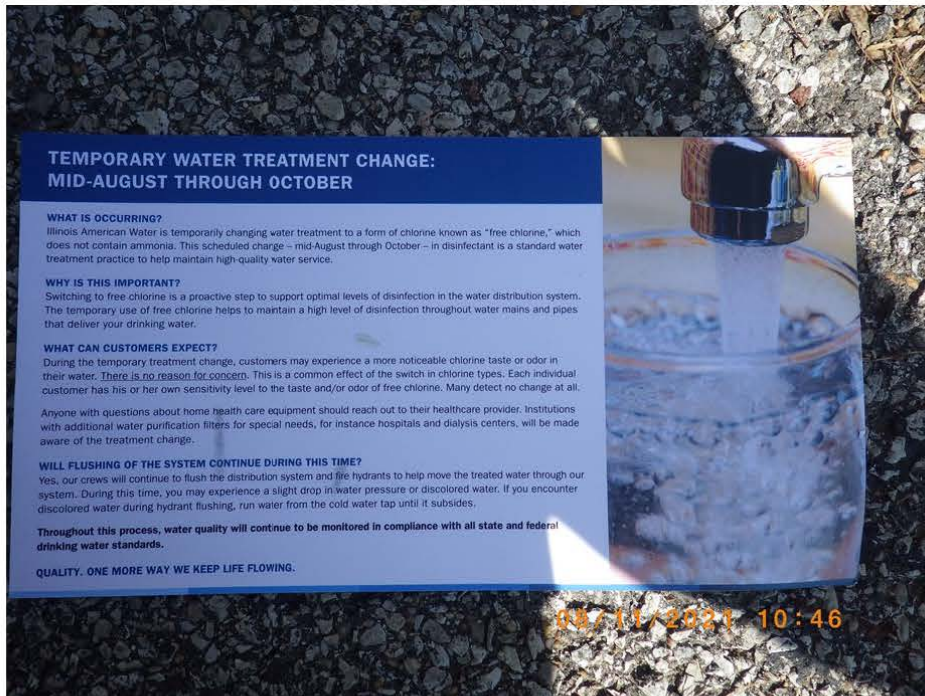
RIMG1466 Customer alert issued by IAW to notify residents of treatment change and flushing

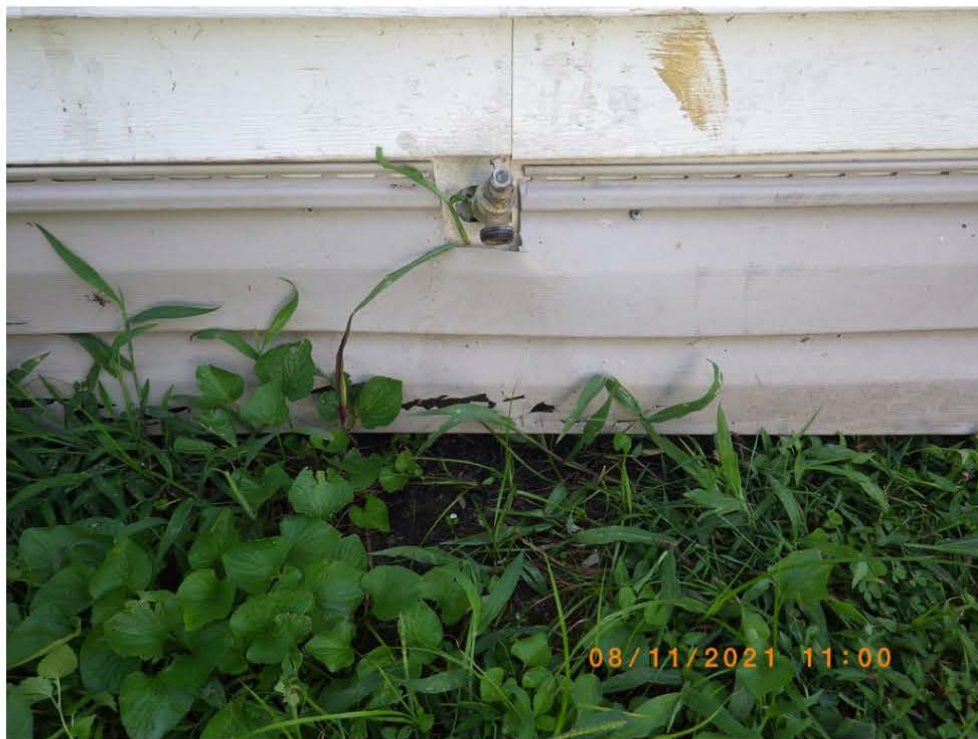
RIMG1467 Hose bib at site 1-05, 5949 Piat Pl, 8/11/21

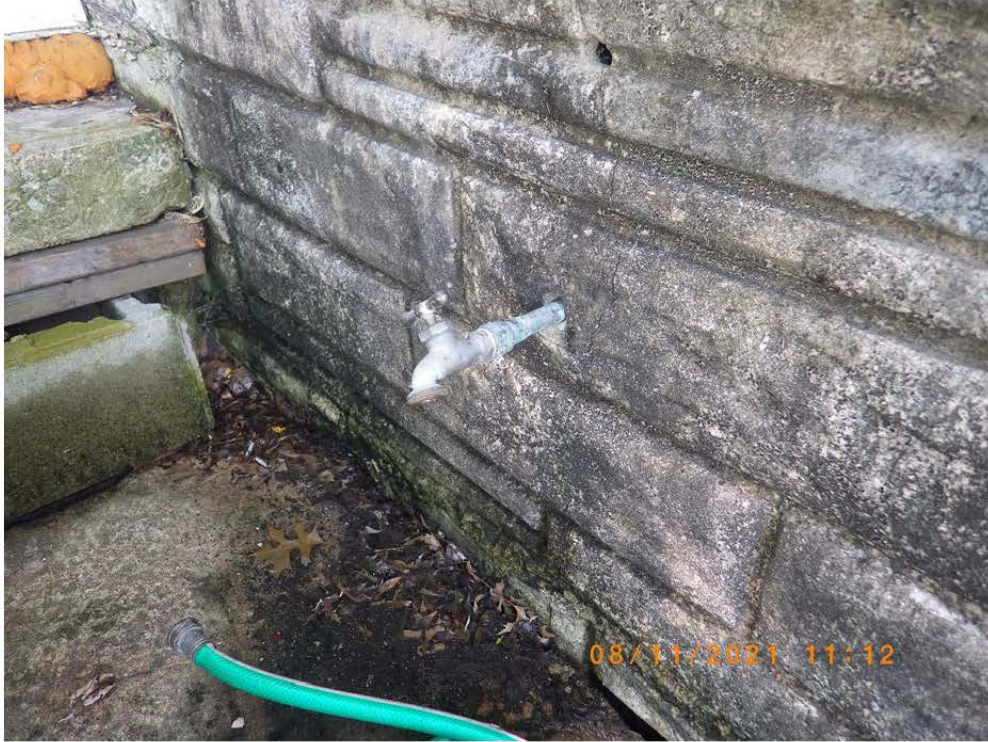
RIMG1468 Hose bib at site 1-06, 5951 Piat Pl, 8/11/21

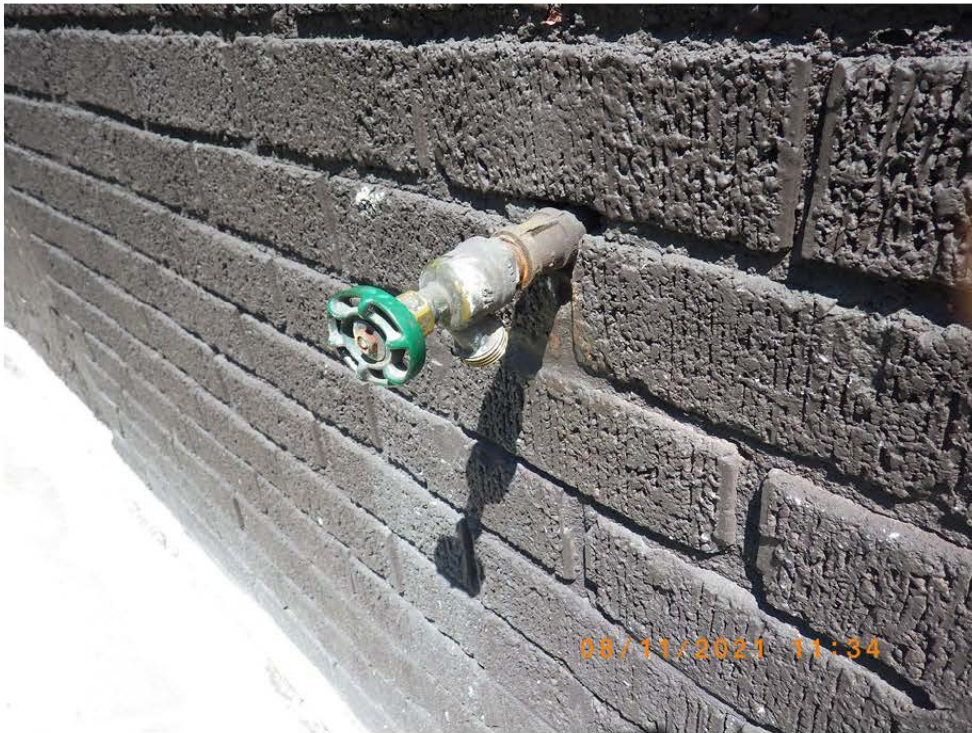
RIMG1469 Hose bib at site 1-07, 401 N 59th St, 8/11/21

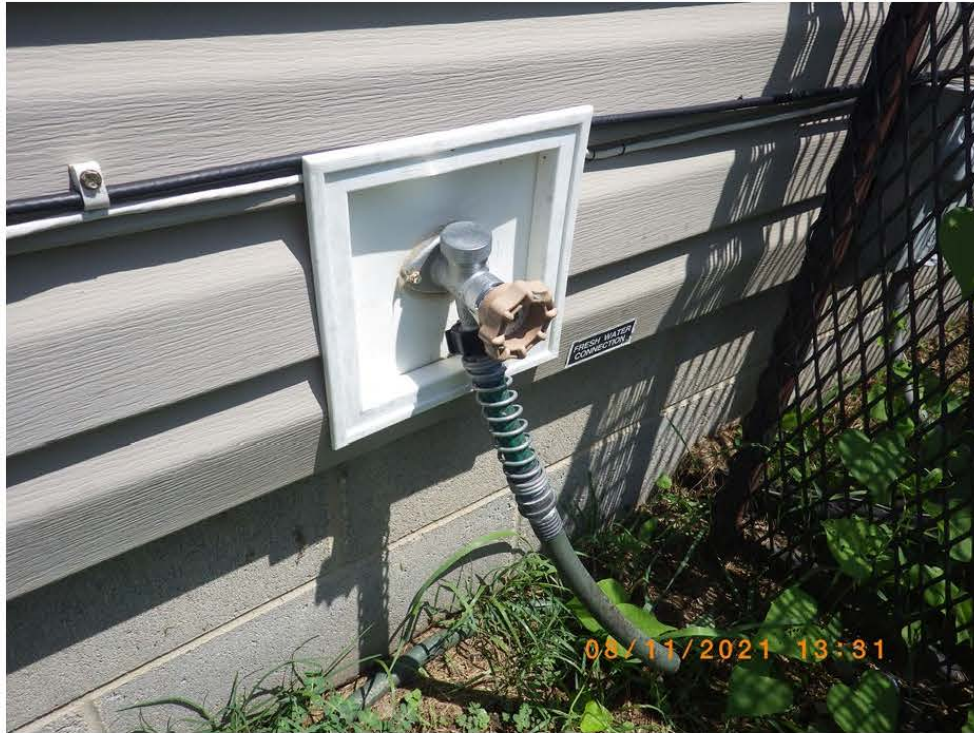
RIMG1470 Hose bib at site 1-08, 5620 Russell Ave, 8/11/21

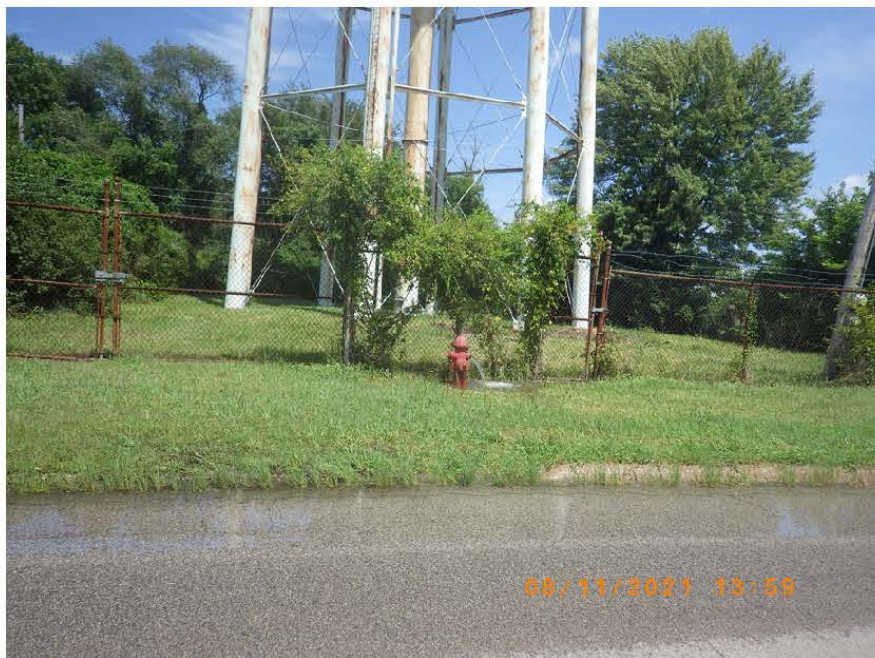
3. The frequency and duration of hydrant flushing may be contributing to surface flooding in low lying areas. EPA observed an open hydrant near a water tower that was open to flushing and had been left unattended (see photo RIMG1471).

RIMG1471 Ongoing flushing in Cahokia Heights near the water tower near Church St. and S 57th, 8/11/21

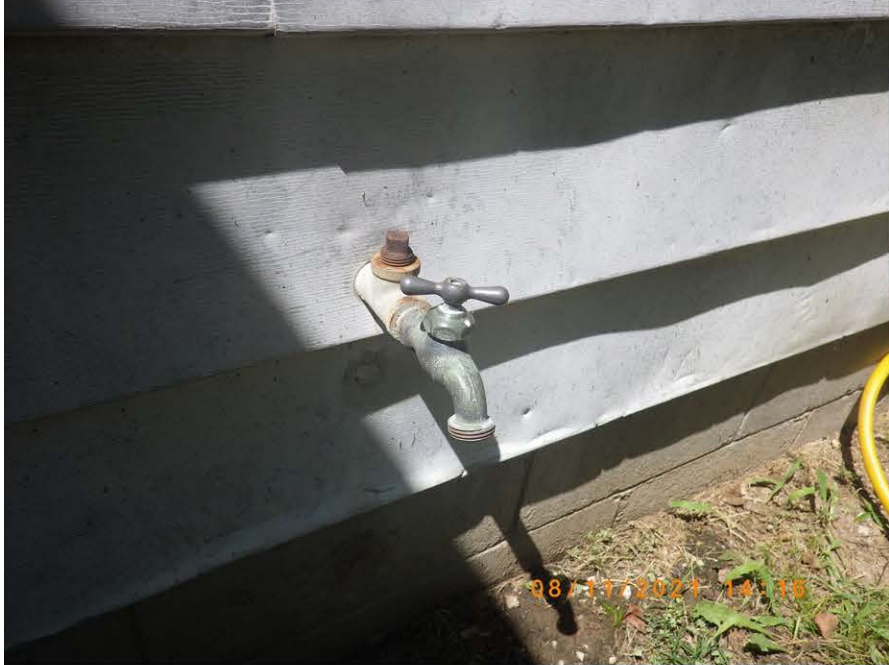
RIMG1472 Hose bib at site 1-09, 5603 Old missouri Ave,
8/11/21

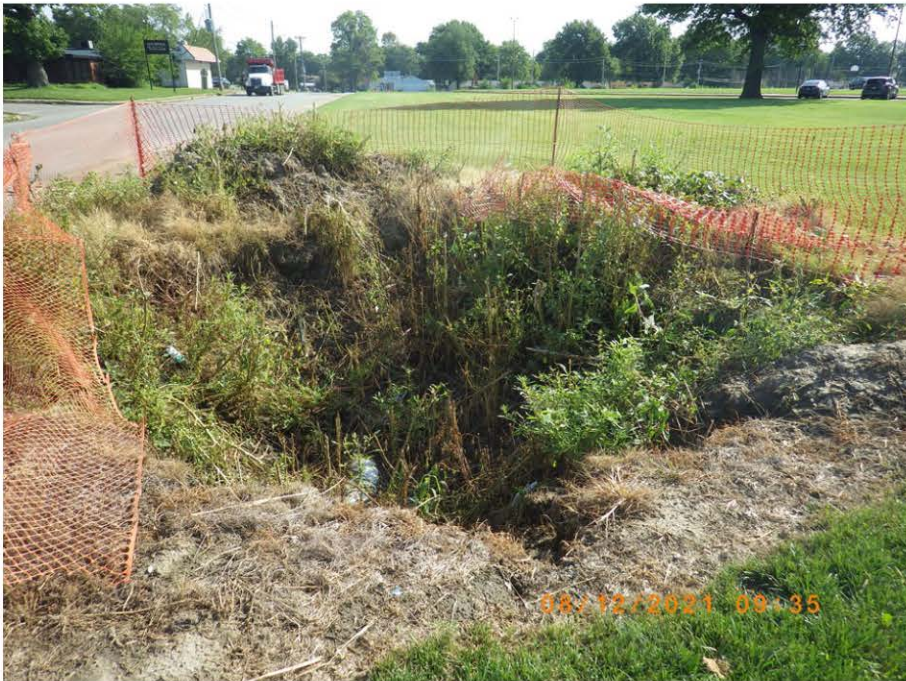
RIMG1473 Open pit in front of Cahokia High School, 800
Range Ln
