Re: EPA Inspection of the City of Benton Harbor public water system (PWS ID# MI0000600) in Berrien County, Michigan

**Region 5 Enforcement and Compliance Assurance Division
SDWA DRINKING WATER INSPECTION REPORT**

City of Benton Harbor
Berrien County, Michigan

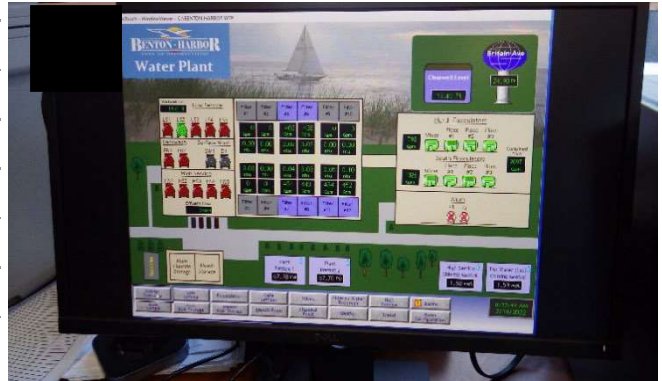
Photo 1

Description: Main Drinking Water Plant display through SCADA.

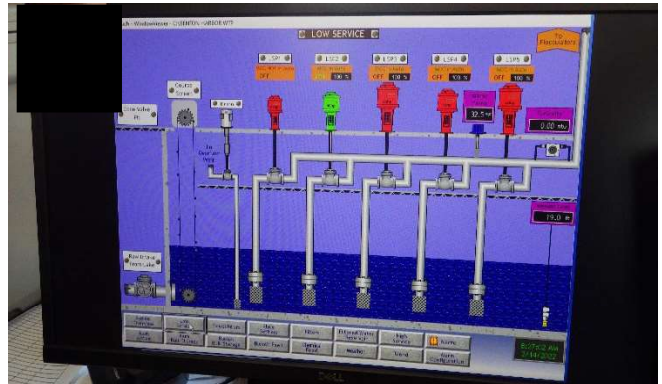
Photo 2

Description: Low service pumps display through SCADA.

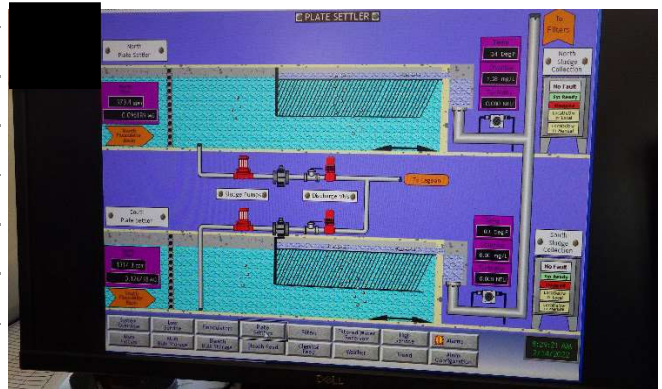
Photo 3

3. The settled water turbidimeters on the North and South Plate Settlers do not seem to be reporting to SCADA.
4. During the inspection EPA observed an increase of approximately 1 mg/L in the chlorine residual from the start of the inspection around 8:30 AM to around 10:00 AM. At the time of the inspection, it was EPA's understanding that the chlorine feed was occurring upstream of the reservoirs. Based on where chlorine is being applied to the water upstream of the reservoirs, the amount of chlorine being injected, and the location of the finished water chlorine analyzer taking measurements from the suction well it is highly unlikely that the chlorine dosing was occurring at a location upstream of the reservoirs. In follow up conversation after the inspection, it has been determined that chlorine is being injected into the suction well and not upstream of the filters as previously stated and therefore the chlorine residual spike was being observed during the day operations of the plant. The chlorine dosing directly into the suction well means that the existing continuous chlorine analyzers are not an accurate representation of the residual disinfectant levels throughout the treatment process.

Description: North and South Plate Settlers display through SCADA.

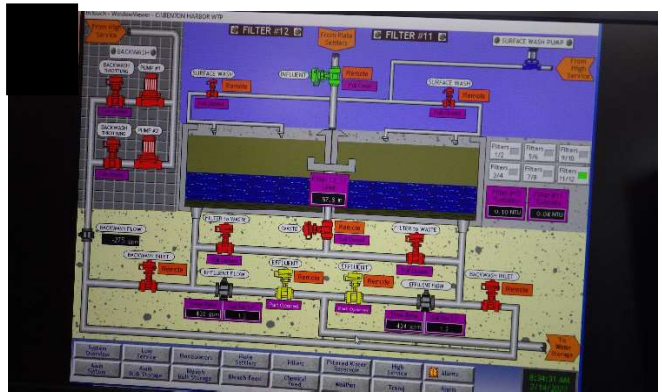
Photo 6

1. The SCADA alarms for Filter 12 turbidity and the Reservoir levels were disabled when observing the SCADA system at the beginning of the inspection. When EPA checked the SCADA system at the end of the inspection the System had enabled the alarms.

Description: Filters 11 and 12 through SCADA.

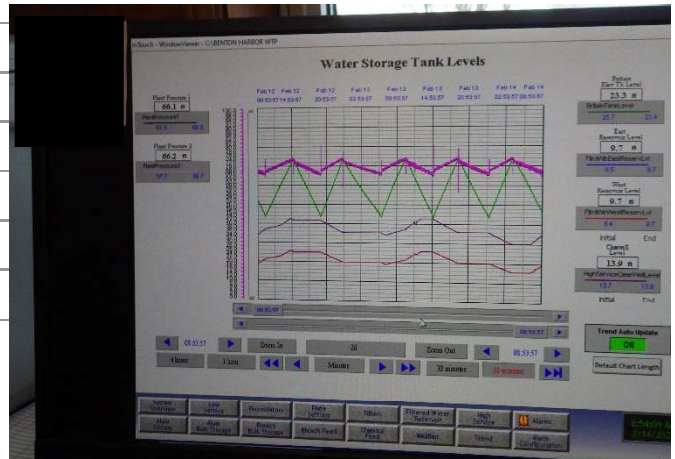
Photo 13

Description: Water reservoirs displayed through SCADA.

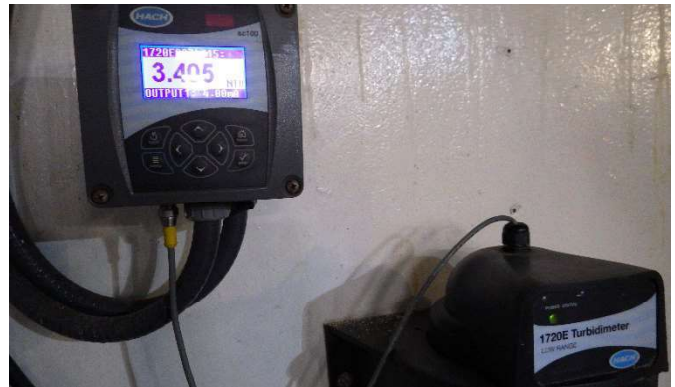
Photo 14

Description: Raw water turbidimeter.

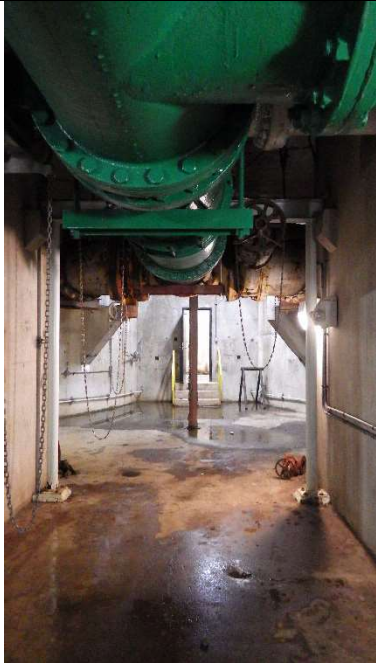
<p>Photo 15</p> <p>File Name: RIMG0507</p> <p>Location: Benton Harbor PWS</p> <p>02/14/2022 09:02 AM (ET)</p> <p>Photographer: Sasha Letuchy</p> <p>Camera: RICOH WG-4 GPS</p> <p>Direction of Photo: Inside</p> <p>Description: Drip observed from raw water pipes.</p>

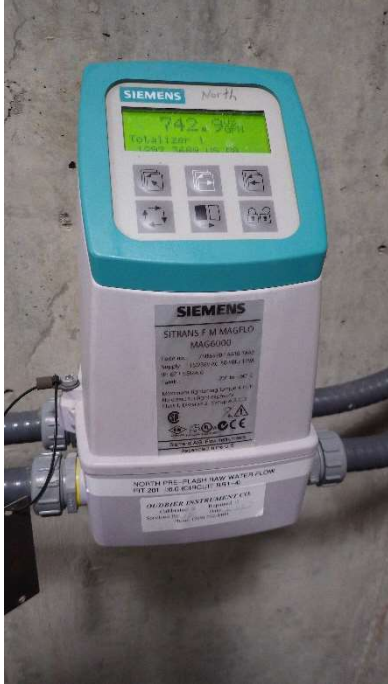
<p>Photo 16</p> <p>File Name: RIMG0508</p> <p>Location: Benton Harbor PWS</p> <p>02/14/2022 09:05 AM (ET)</p> <p>Photographer: Sasha Letuchy</p> <p>Camera: RICOH WG-4 GPS</p> <p>Direction of Photo: Inside</p> <p>Description: Raw water flow meter on the North Plate Settler.</p>

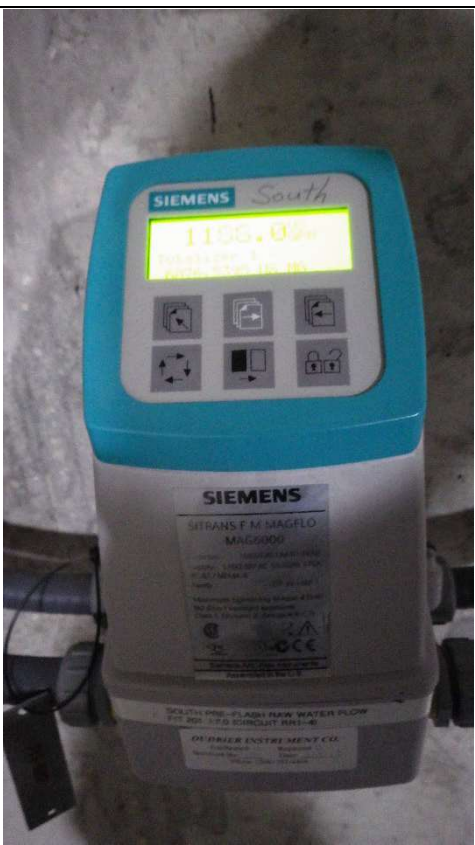
Photo 17

Description: Raw water flow meter for the South Plate Settler.

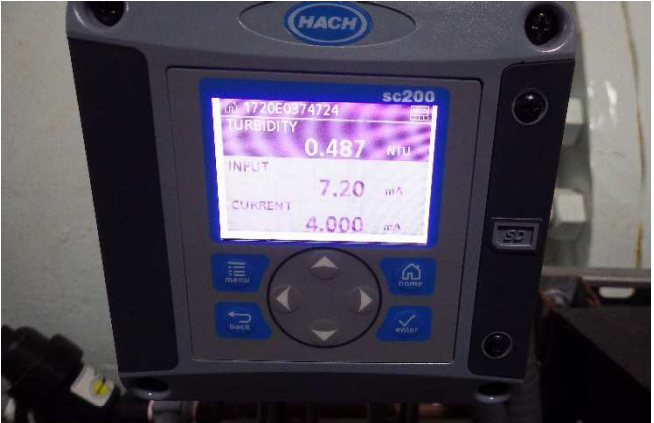
<p>Photo 19</p> <p>File Name: RIMG0511</p> <p>Location: Benton Harbor PWS</p> <p>02/14/2022 09:09 AM (ET)</p> <p>Photographer: Sasha Letuchy</p> <p>Camera: RICOH WG-4 GPS</p> <p>Direction of Photo: Inside</p> <p>Description: South Plate Settler turbidimeter.</p>

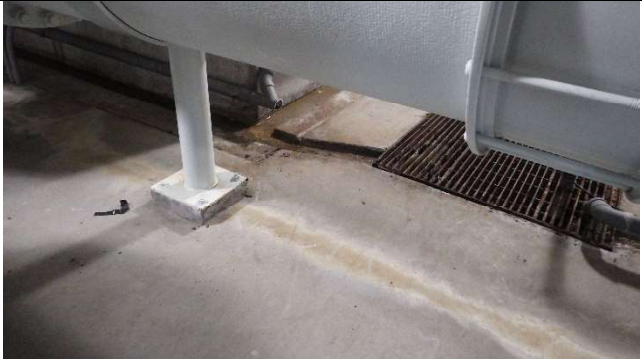
<p>Photo 21</p> <p>File Name: RIMG0513</p> <p>Location: Benton Harbor PWS</p> <p>02/14/2022 09:11 AM (ET)</p> <p>Photographer: Sasha Letuchy</p> <p>Camera: RICOH WG-4 GPS</p> <p>Direction of Photo: Inside</p> <p>Description: Water draining from turbidimeter to draining in ground around the South Plate Settler backwash flow meter.</p>

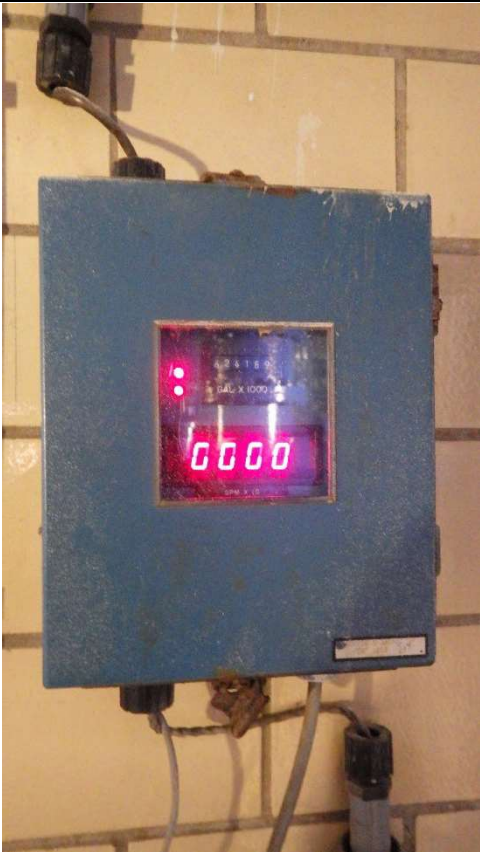
<p>Photo 22</p> <p>File Name: RIMG0514</p> <p>Location: Benton Harbor PWS</p> <p>02/14/2022 09:30 AM (ET)</p> <p>Photographer: Sasha Letuchy</p> <p>Camera: RICOH WG-4 GPS</p> <p>Direction of Photo: Inside</p> <p>Description: Backwash flow meter.</p>

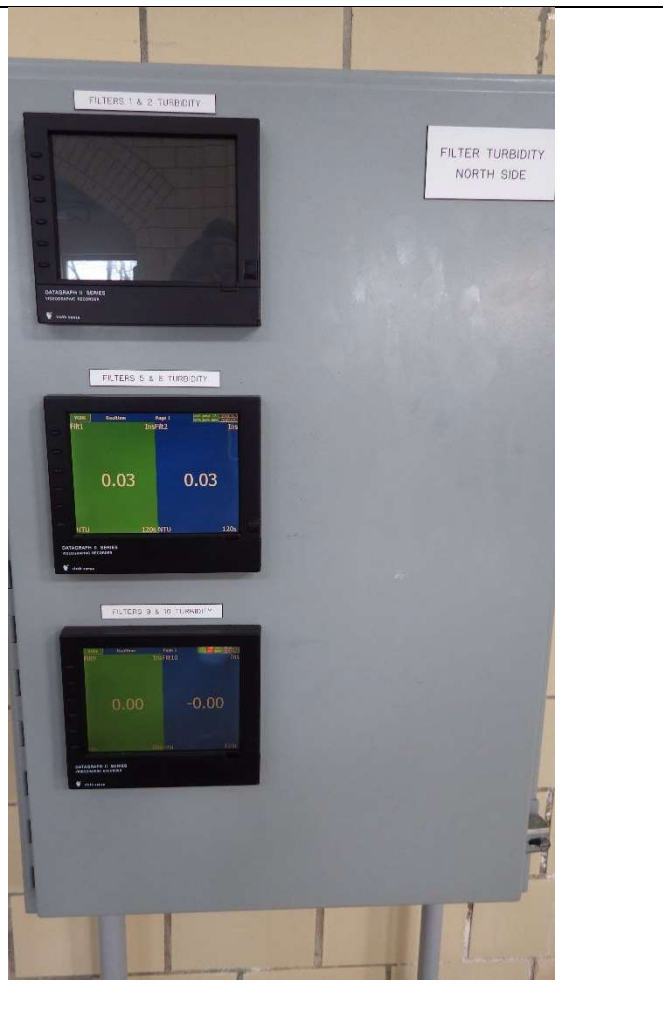
Photo 26

Description: North side filter panel that displays turbidity readings for filters 1, 2, 5, 6, 9, and 10.

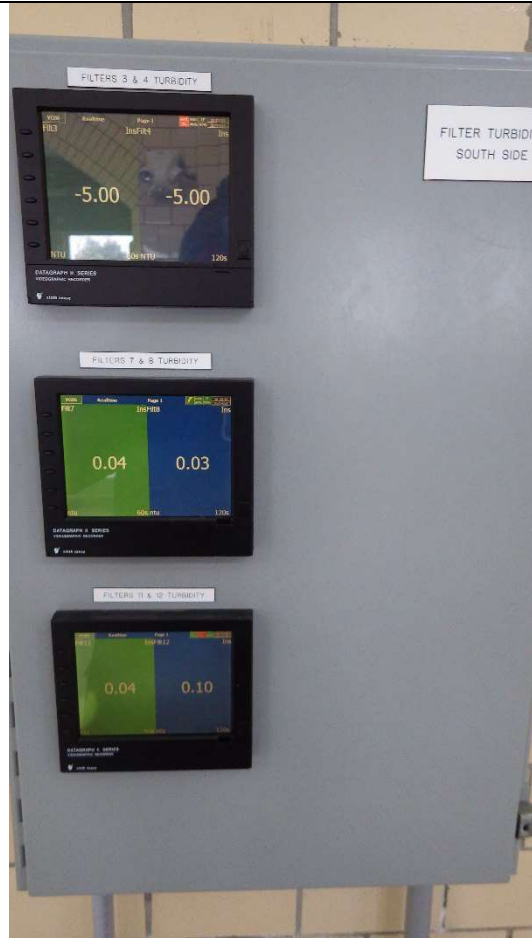
Photo 27

Description: South side filter panel that displays turbidity readings for filters 3, 4, 7, 8, 11 and 12.

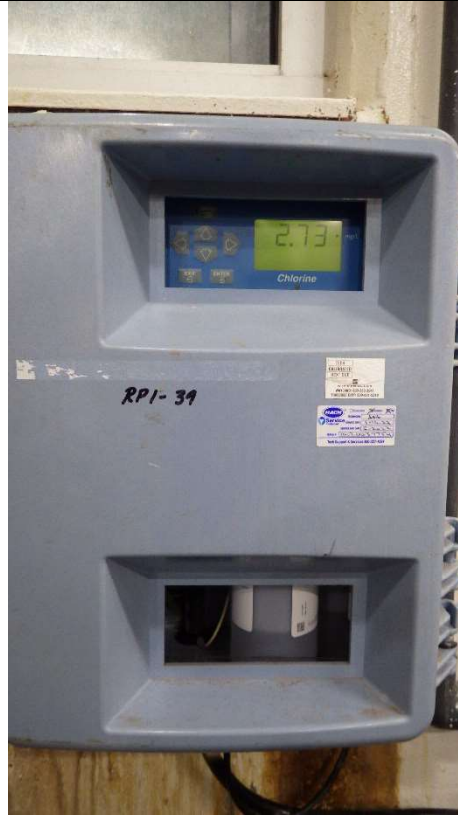
Photo 31

Description: Chlorine analyzer located near the high service pumps. This analyzer is the backup analyzer for reading chlorine residuals on finished water.

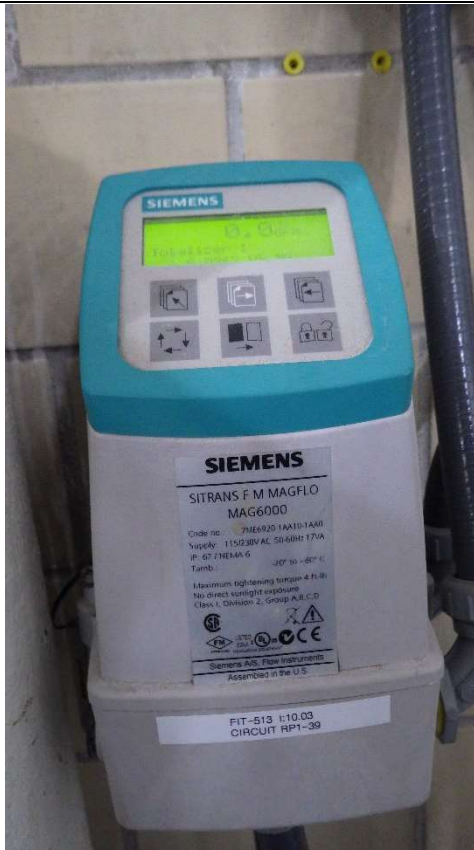
Photo 32

Description: Non-operable flow meter.

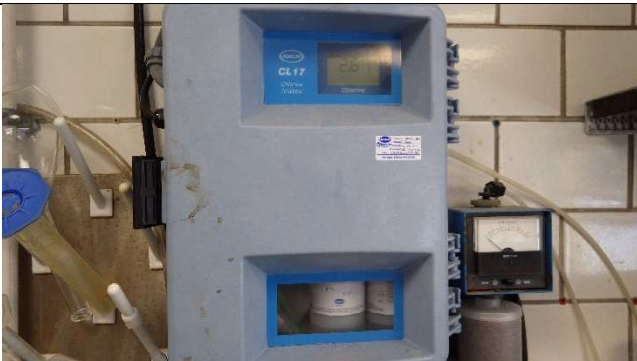
<p>Photo 34</p> <hr/> <p>File Name: RIMG0526</p> <hr/> <p>Location: Benton Harbor PWS</p> <hr/> <p>02/14/2022 10:01 AM (ET)</p> <hr/> <p>Photographer: Sasha Letuchy</p> <hr/> <p>Camera: RICOH WG-4 GPS</p> <hr/> <p>Direction of Photo: Inside</p> <hr/> <p>Description: Finished water chlorine analyzer located in the laboratory at the tap.</p>

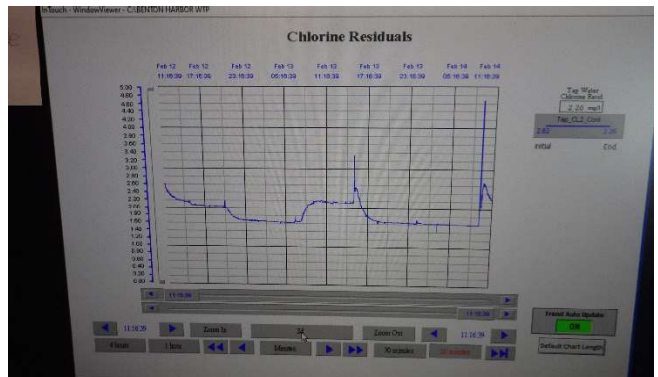
Photo 47

Description: Historical chlorine residual readings for February 14, 2022.
