Subject: May 4-6, 2022 Inspection Trip Report for City of Cahokia Heights

**Purpose:** NPDES SSO Inspection Trip Report

**Facility:** City of Cahokia Heights, Illinois

**Dates of Inspection:** May 4, 2022 – May 6, 2022

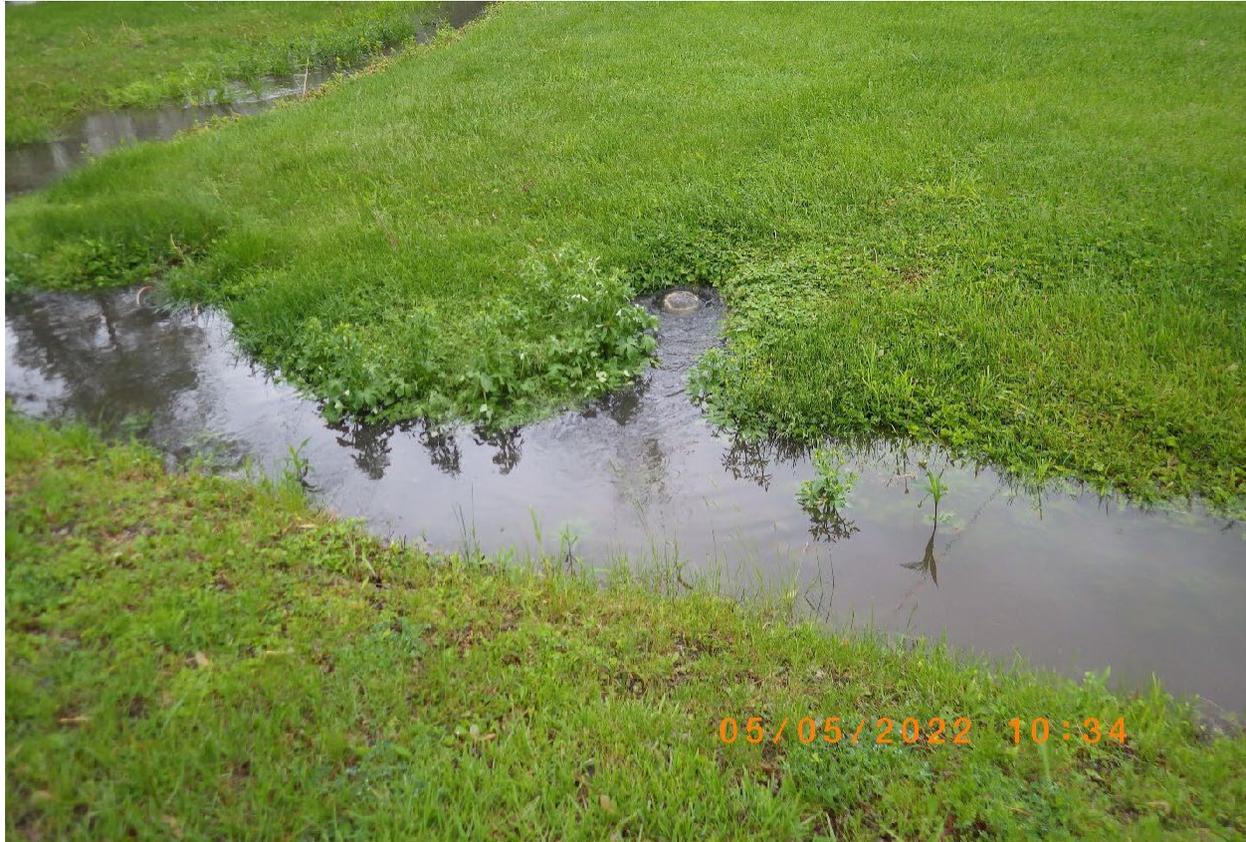
1: BELL0001 (edited to remove Personally Identifiable Information (PII))

Description: SSO from the cleanout on North 82<sup>nd</sup> Street.

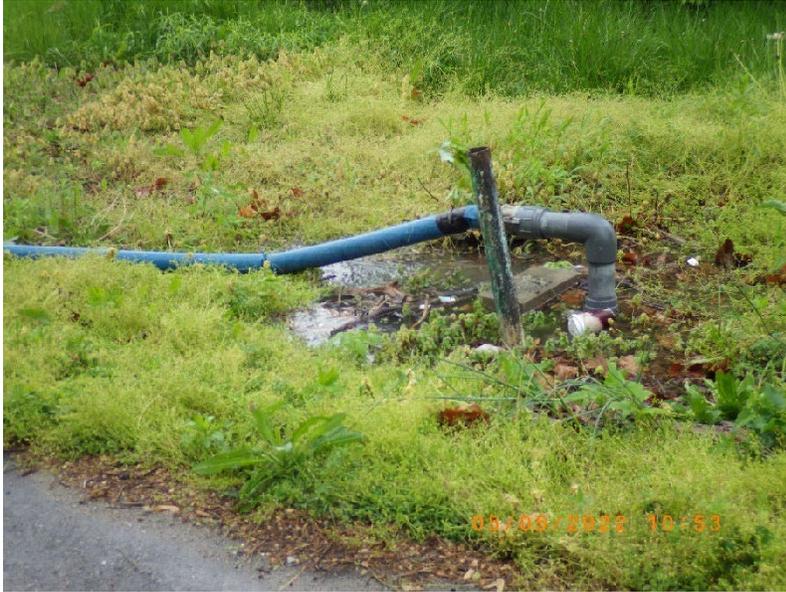
2: BELL0002

<p>Lake Drive Pill Box Lift Station (Lake Drive and 71<sup>st</sup> Street)</p>	<p>9:49 A.M.</p>	<p>The EPA Team observed that there was no warning light installed at this lift station.</p> <p>Two City of Cahokia Heights employees were actively bypassing this lift station at the time of observation. They were using a pump in the back of a pickup truck and a three-inch hose. The employees stated it would take them a few hours to complete the bypass for this lift station and then they would continue to bypass additional inoperable lift stations in the afternoon.</p> <p>The hose the City employees were using to bypass had at least four small holes in it where sanitary waste was leaking out. Some of the sanitary waste was falling into the open manhole where the waste was being pumped out of, and some of the sanitary waste was being released into the roadside ditch. EPA did not observe this wastewater reach a Water of the United States.</p>

Description: The non-functioning lift station at Lake Street and 71<sup>st</sup> Street was being bypassed by the City of Cahokia Heights personnel. The hose used to bypass the lift station leaked sewage. One of the leaks of sewage went into the ditch by the side of the 71<sup>st</sup> Street.

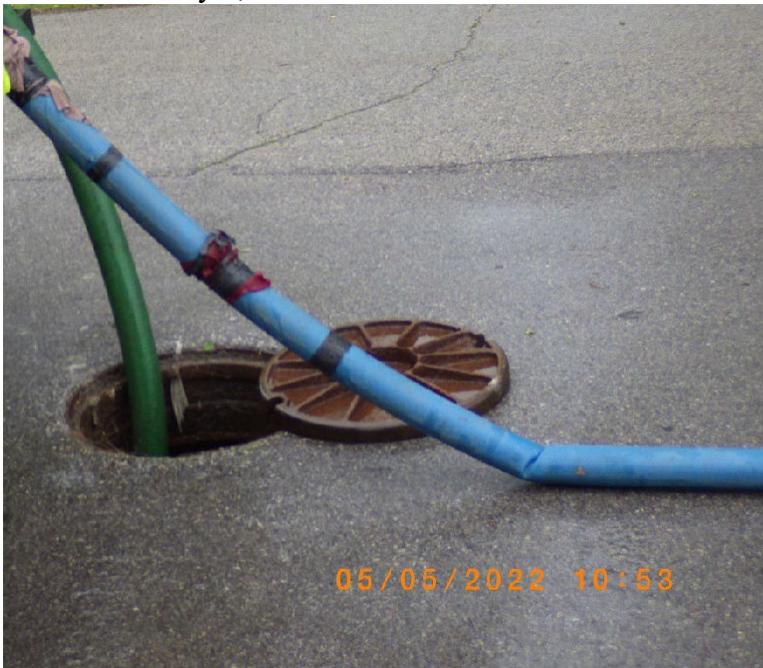
3: BELL0003 (edited to remove PII)

Description: Two other hose leaks from the bypass hose dripped back into the wet well.

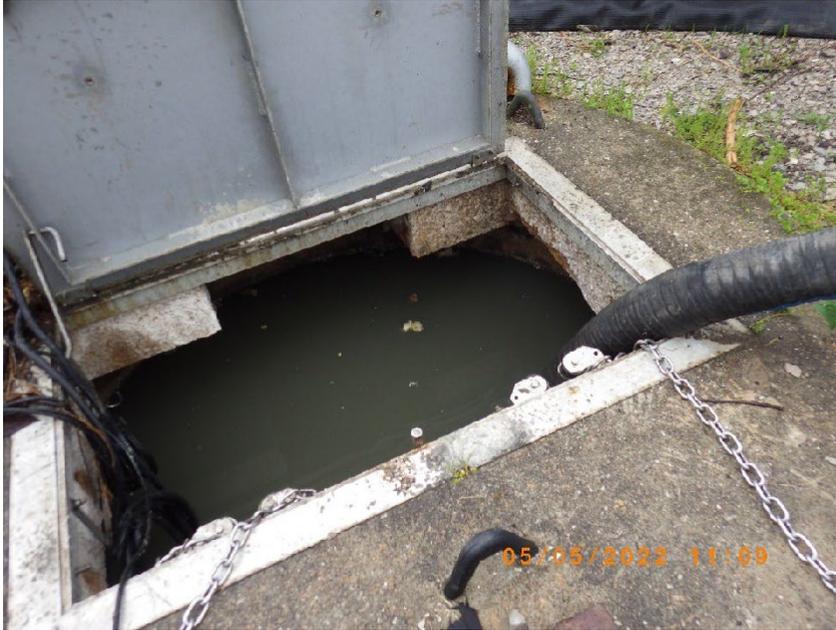
4: BELL0004

<p>600 Golden Road Lift Station (Golden Street and Dorsey Street)</p>	<p>10:09 A.M.</p>	<p>This lift station was recently renovated (October 2020). On the day of observation, the pumps were not functional and there was a tow-behind pump located at the site. The floats in the wet well were pulled out and were lying on the ground near the wet well. The electrical panel and gate were not secured. The red light on top of the control panel was flashing on and off.</p> <p>The wet well was approximately 30% full. City of Cahokia staff stated they would manually bypass this lift station on May 5, 2022, but it appeared they had not yet bypassed it.</p>
<p>4200 Missouri Avenue Lift Station (previously named the Pocket Road Lift Station in EPA reports)</p>	<p>10:14 A.M.</p>	<p>The gate around the lift station was closed and had a chain around the gates, but it was not locked. The EPA Team observed that the pump was continuously running, but water was coming back into the wet well from the location of the force main out of the station. Wet well was high, there was only about 6 inches between the water level and the top of the wet well. The water level in the wet well appeared to be steady at the time of observation.</p>

Description: The wet well at the Golden and Dorsey lift station was almost full.

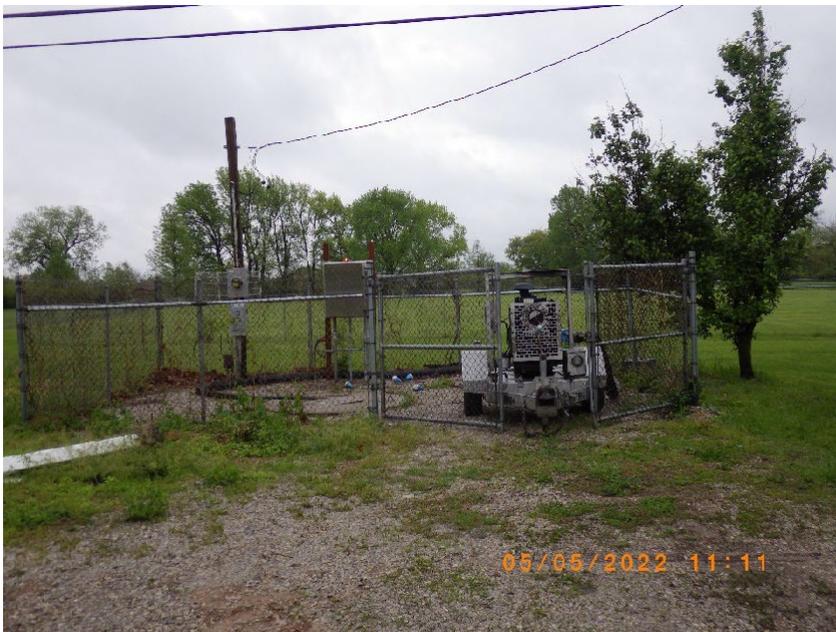
5: BELL0005

Description: A tow behind pump was parked at the Golden and Dorsey lift station. City personnel manually turn it on to dewater the wet well.

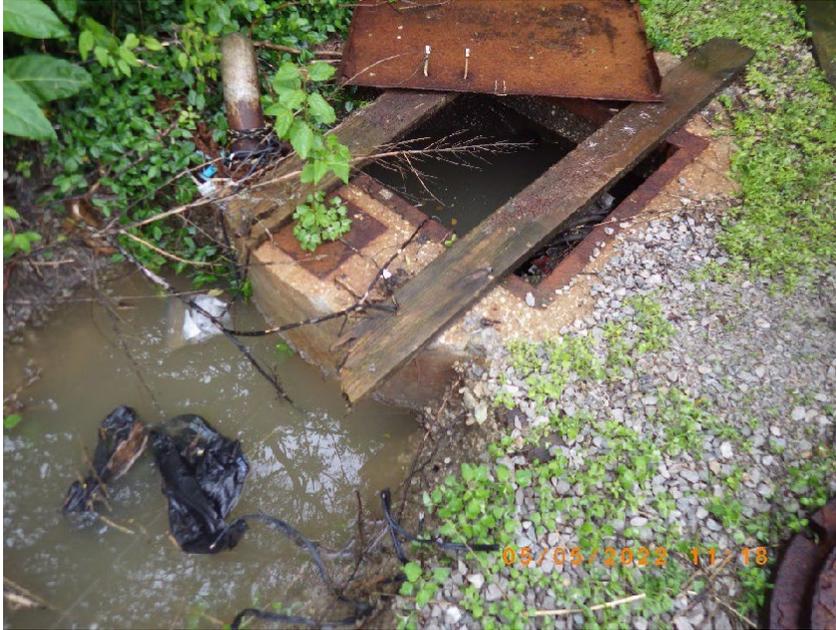
6: BELL0006

Description: The wet well at the Pocket Road lift station was approximately 90% full.

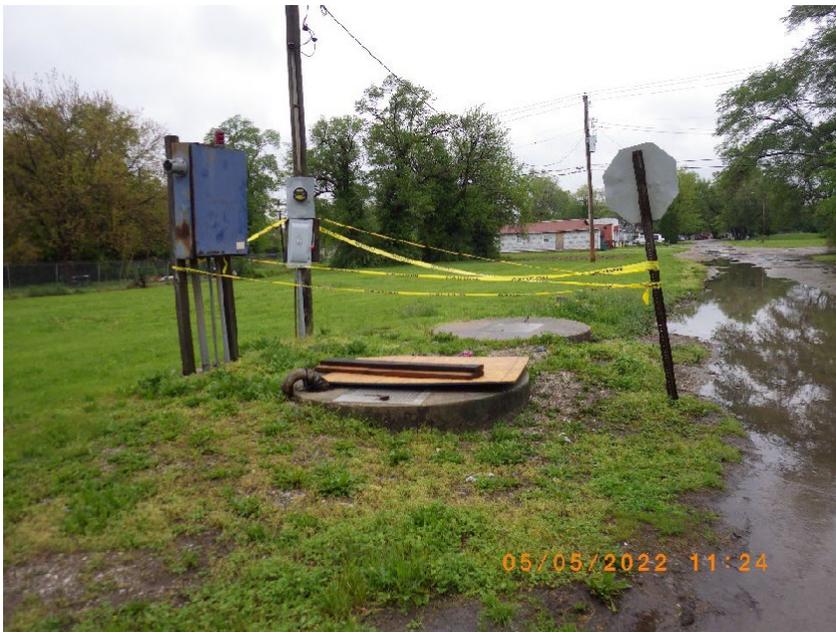
7: BELL0007

401 Jackson Lift Station (Pocket Road and Jackson Street)	10:24 A.M.	<p>There was a sheet of plywood and small wood pieces on top of the wet well, but it was not secured. Yellow caution tape was strung around the electric pole at the lift station.</p> <p>The wet well was approximately 30% full. City of Cahokia staff stated they would manually bypass this lift station on May 5, 2022, but it appeared they had not yet bypassed it.</p>
323 Pfeiffer Road Lift Station (Pfeiffer Road and Johnson Lane)	10:28 A.M.	<p>The gate around the lift station was closed and had a chain around the gates, but it was not locked. The open wet well was covered by a wooden pallet.</p> <p>The wet well was approximately 30% full. City of Cahokia staff stated they would manually bypass this lift station on May 5, 2022, but it appeared they had not yet bypassed it.</p>
Lady of Snows Lift Station	10:41 A.M.	The lift station was unsecured. The pump was running at the time of observation. Water was actively being discharged via a rigid pipe into the manhole at the top of the hill.

Description: Jackson Street lift station is non-functioning and needs to be manually dewatered by City personnel.

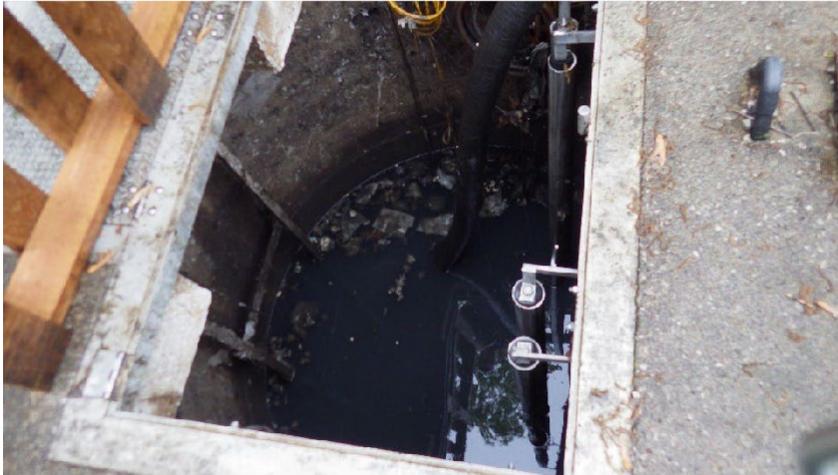
8: BELL0008

Description: The Pfeiffer Street wet well level was low on the day of the inspection.

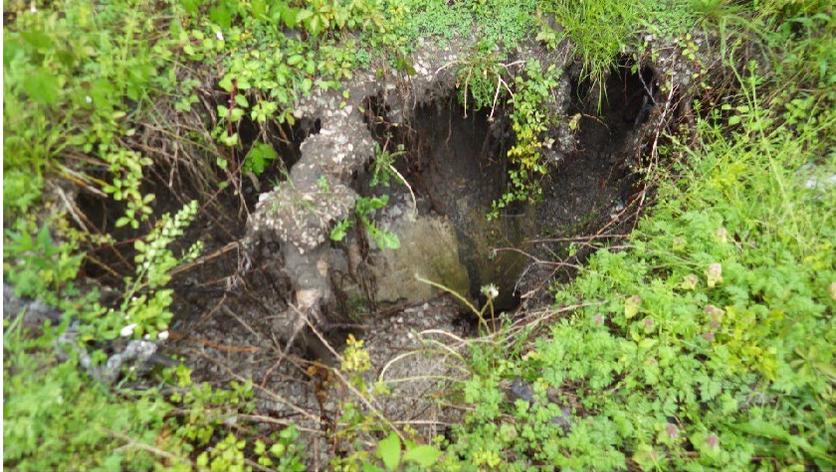
10: BELL0010

Description: Open erosional hole by a storm water pipe near the Diversion Station. There is a crack in the pipe that was first observed by EPA in April, 2022.
