Norfolk Southern Railway Company

Sulphur Run Culvert Sediment Removal Plan

**East Palestine Train Derailment
Columbiana County, Ohio**

Rev Date: November 10, 2023

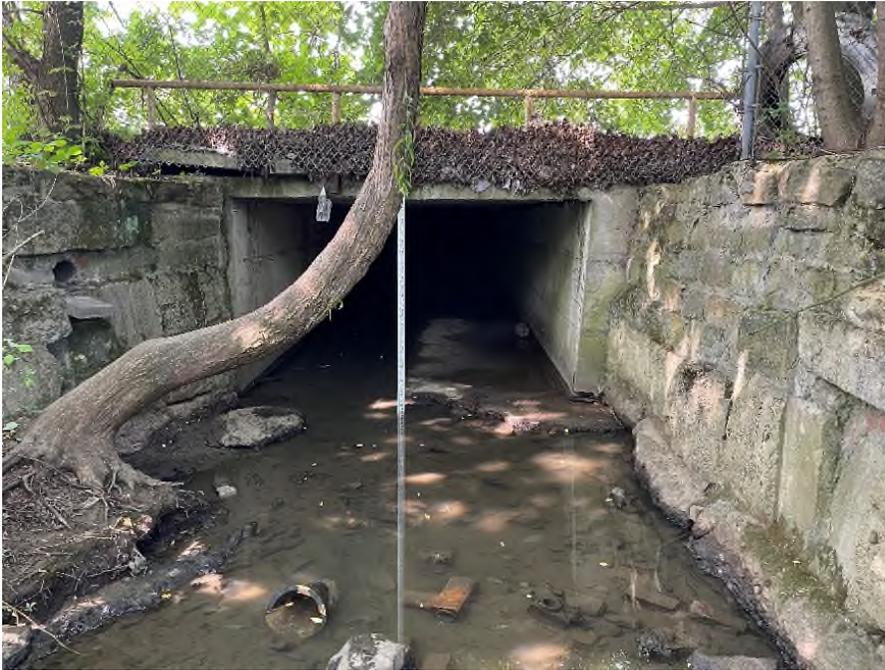
Photograph: 1

Description:
Culvert C1 upstream
end, looking
downstream at
entrance

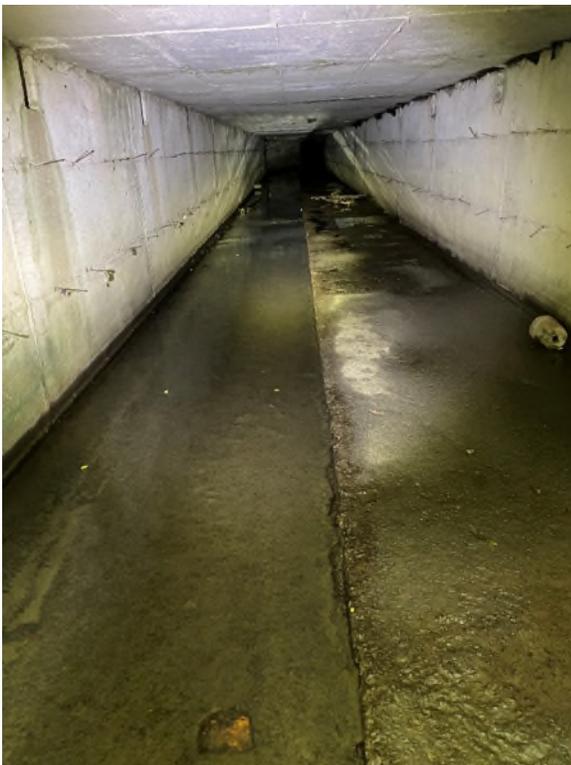
Photograph: 2

Description:
Culvert C1 interior,
looking downstream at
entrance

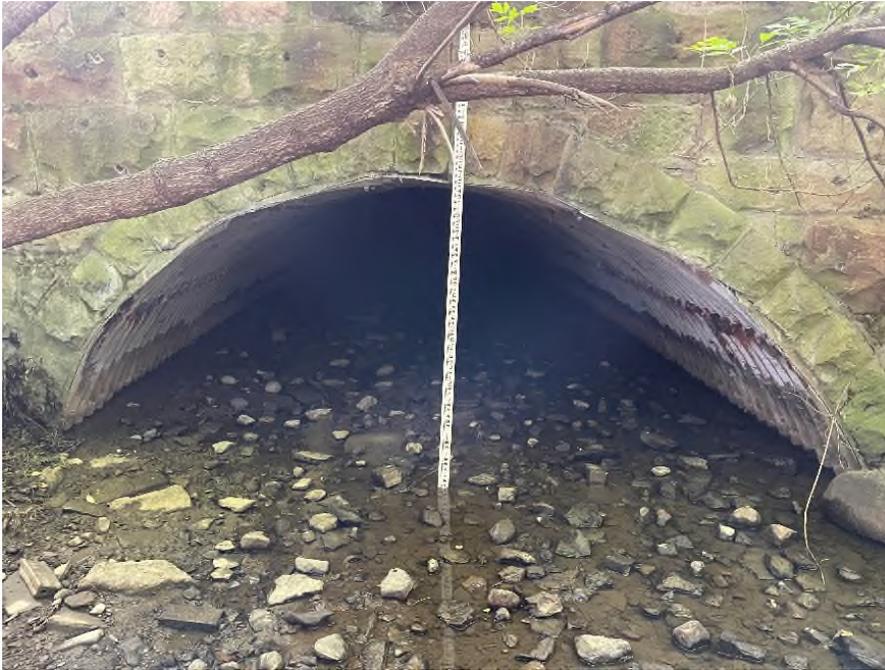
Photograph: 3

Description:
Culvert C1 downstream end, looking upstream at exit

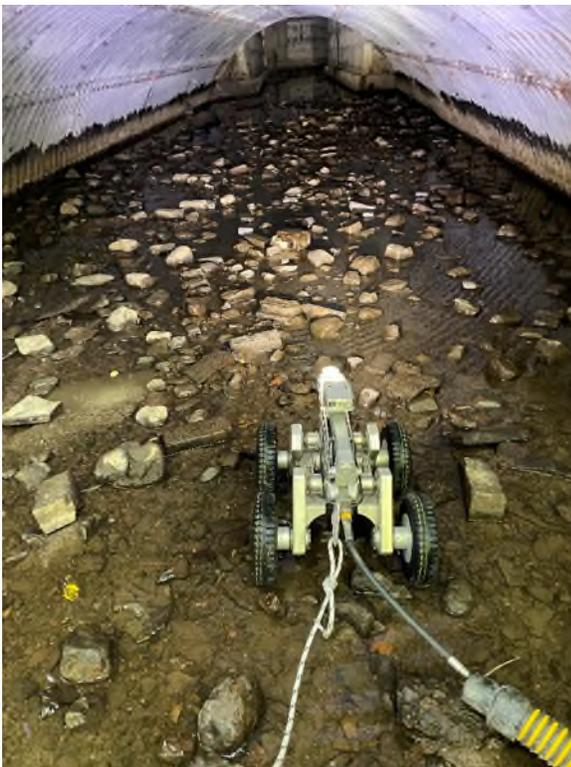
Photograph: 4

- Culvert C1
 - Inspection: Culvert was only accessed from the downstream end by the rover camera system; upstream end not accessible with the system. The rover only advanced approximately 5 feet into the culvert due to accumulated debris obstructing the unit. Therefore, conditions along the culvert length are unknown.

Description:
Culvert C1 interior, looking upstream at exit – rover camera unit in foreground

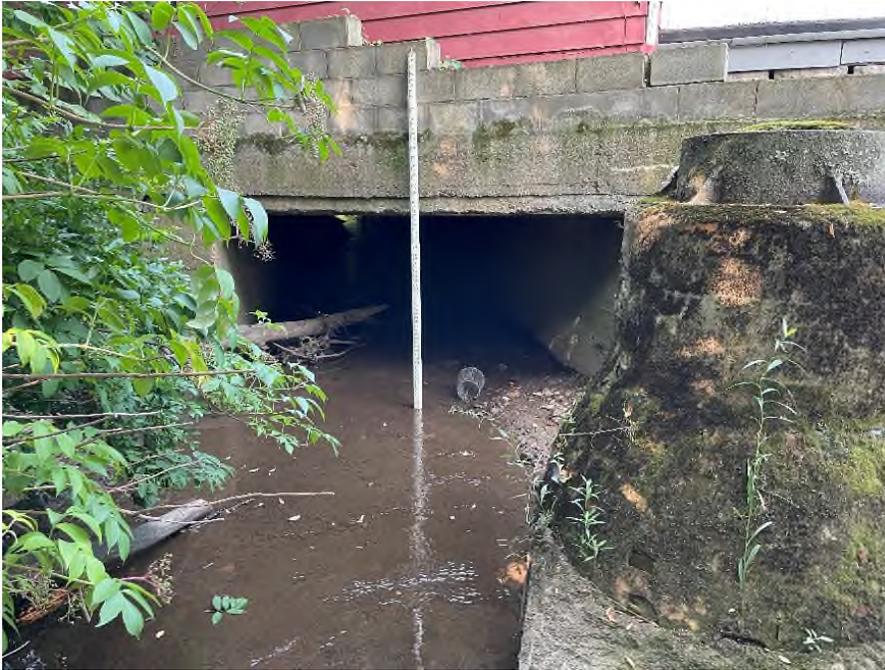
Photograph: 5

Description:
Culvert C2 upstream end, looking downstream at entrance

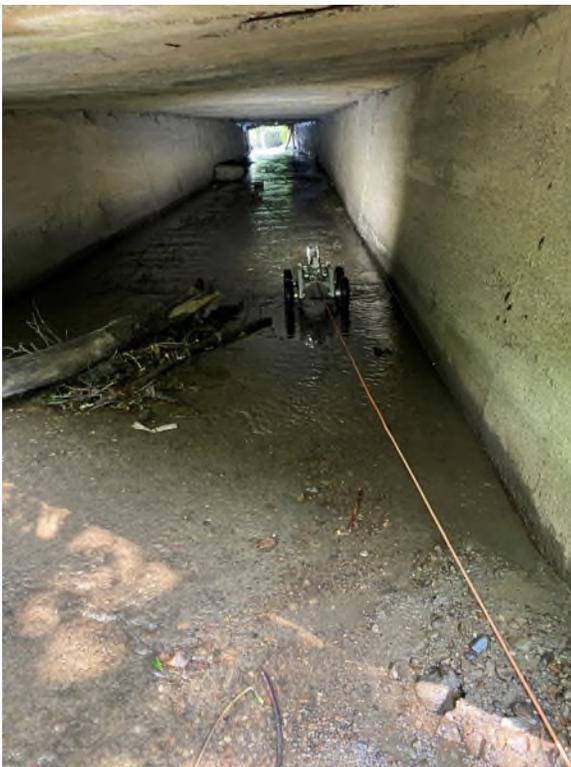
Photograph: 6

Description:
Culvert C2 interior, looking downstream at entrance – rover camera unit in foreground

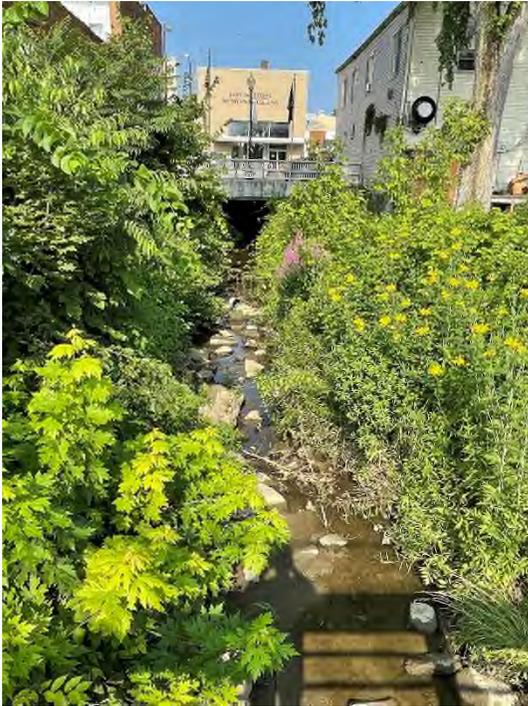
Photograph: 9

Description:
Culvert C3 upstream end, looking downstream at entrance

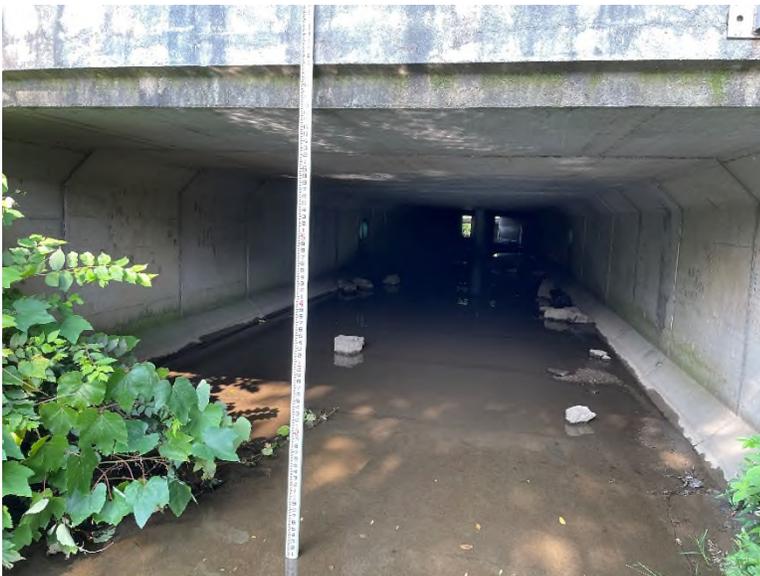
Photograph: 10

Description:
Culvert C3 upstream end and interior, looking downstream at entrance

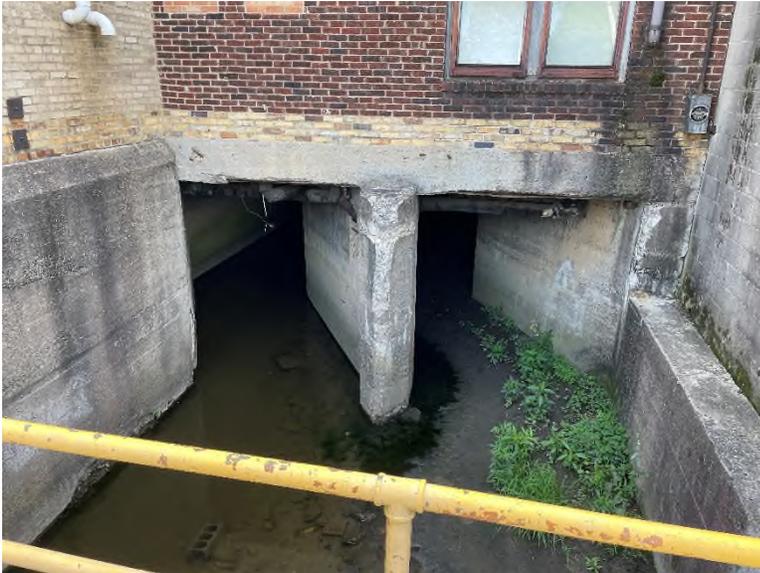
Photograph: 11

Description:
Culvert C3 downstream
end, looking upstream
at exit

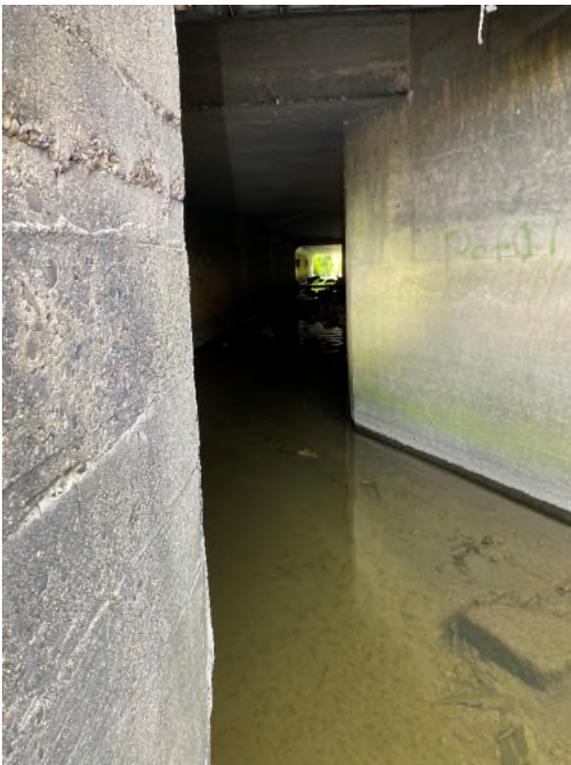
Photograph: 12

Description:
Culvert C3 interior,
looking upstream from
exit – left side/channel

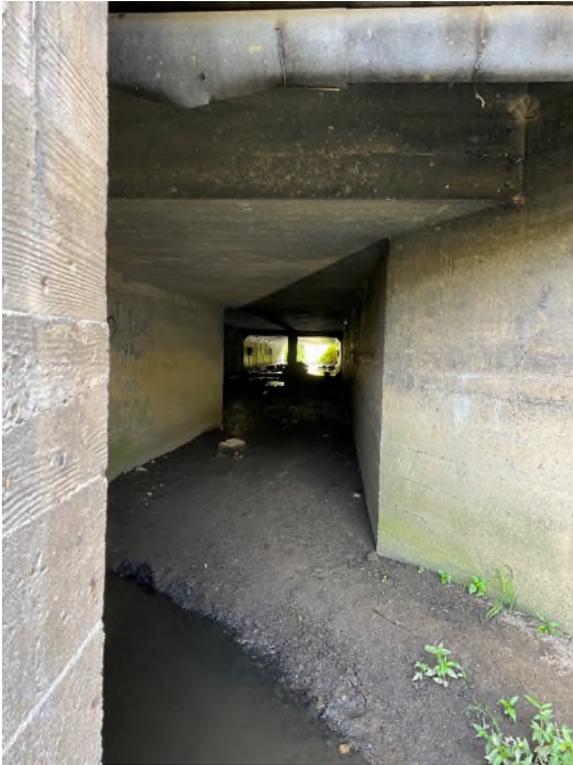
Photograph: 13

Description: Culvert
C3 interior, looking
upstream from exit –
right side/channel

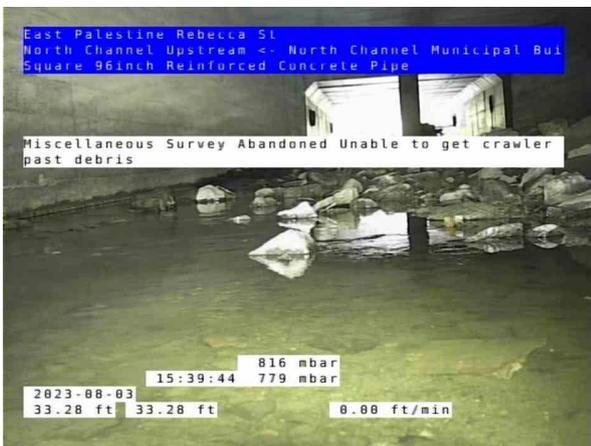
North Channel Upstream-North Channel Municipal Building_94be1f30-7cd0-4415-8a6f-ab66625ffbf_20230803_094417_053.jpg, 00:04:19, 33.28ft
Miscellaneous Survey Abandoned / Unable to get crawler past debris

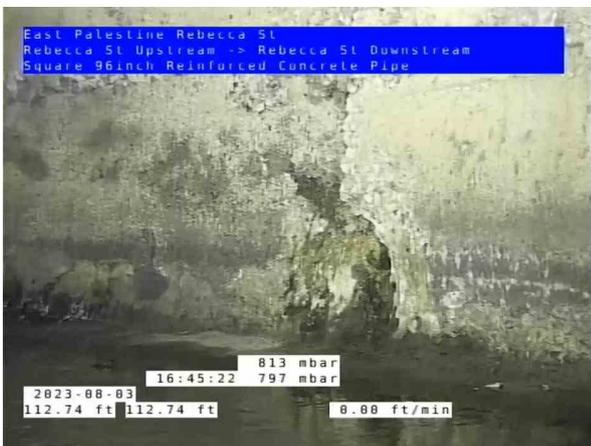
- Culvert C2
 - Inspection: Rover camera system traversed the full length of the culvert with no obstructions encountered. The culvert contains multiple breaks and fractures mostly at the downstream end, and wooden slats were

Rebecca St Upstream-Rebecca St Downstream_00b267ff-80a7-4010-8d32-b657c569c33a_20230806_172205_377.jpg, 00:06:46, 112.73ft
 Fracture Multiple from 1 o'clock to 5 o'clock, Start

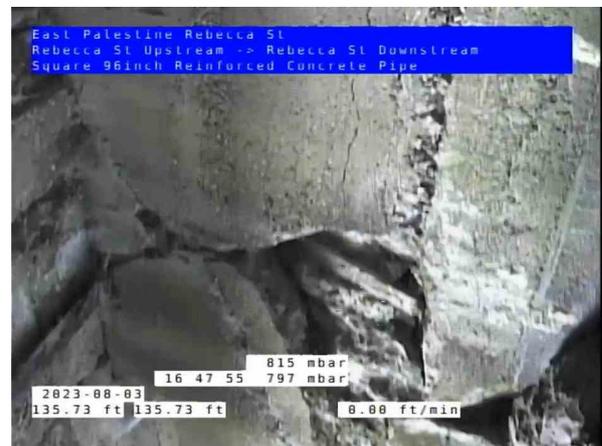
Rebecca St Upstream-Rebecca St Downstream_57db7f96-8f3b-43a5-8bc1-e18a320c72a8_20230806_172244_483.jpg, 00:09:27, 135.69ft
 Broken from 1 o'clock to 4 o'clock
