NONPOINT SOURCE SUCCESS STORY

Improving Stream Aquatic Health by Implementing Best Management Practices in Mountain Run Watershed

EPA 841-F-18-001F
February 2018

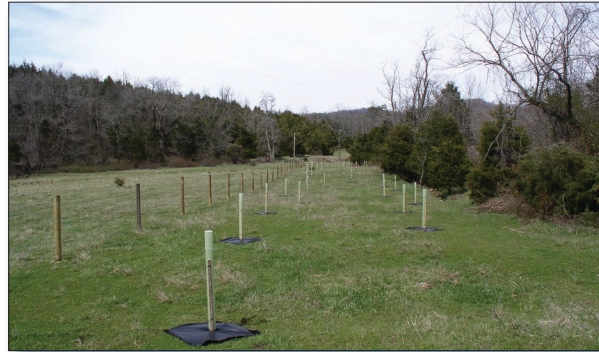
Figure 2. Livestock exclusion stream fencing and riparian buffer in Mountain Run watershed.

The BMPs installed in the watershed from 2002 through 2012 included 155 acres of harvestable cover crop, 71 acres of small grain cover crop, 25 acres of riparian forest buffer, 15 acres of riparian buffer, and 30 acres of legume based cover crop (Figure 2). Also, 23 acres of pasture and hayland forage was improved, and 1,815 feet of streambank protection and two animal control facilities were installed. BMP

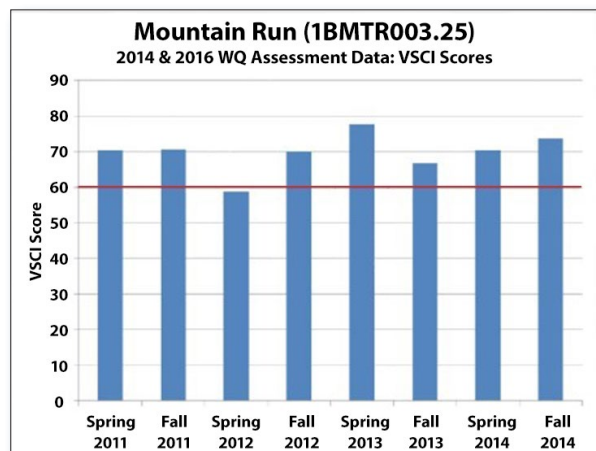
Figure 3. VSCI scores show aquatic life use support at the downstream monitoring station 1BMTR003.25.

DEQ now employs the Virginia Stream Condition Index (VSCI) to evaluate biological conditions of a stream. A stream that achieves a rating of 60 or above is considered to be supporting biological integrity and meeting the stream's aquatic life use.

The BMPs installed in the watershed from 2002 to 2012 helped reduce sediment loadings to the stream. The biological monitoring conducted by DEQ at station 1BMTR003.25 in 2011–2014 indicated an improvement in the benthic macroinvertebrate community, reflected through VSCI scores that met the threshold for full support of aquatic life. Although a single spring 2012 score of 58 fell slightly below the threshold, the overall average scores indicate full support (Figure 3). In addition, water quality data collected at U.S. Forest Service station 4076 (headwaters) indicated full support of aquatic life use beginning in 2007 (Figure 4). Based on these data, both segments (5.69 miles: VAVB47R_MTN01A00, and 0.95 miles: VAVB47R_MTN02A00) were removed from the state’s impaired waters list in 2014.

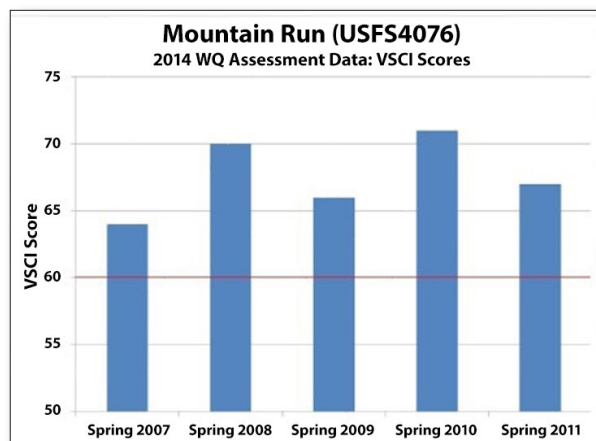
Figure 4. VSCI scores show aquatic life use support at the headwaters monitoring station 4076.

The impaired segments begin in the headwaters and end at their confluence with Smith Creek. The segments were listed on the CWA section 303(d) list for violating the state's water quality general standard for aquatic life during the 2002 assessment period. The impairment at station #4076 was based on bioassessment performed by the U.S. Forest Service using the Macroinvertebrate Aggregated Index for Streams (MAIS), based on the Rapid Bioassessment Protocols methodology. A stream having an index of 12 and above was considered to be in a good condition. Two segments of Mountain Run (5.69 miles and 0.95 miles) received a MAIS score of 11.5, which failed to meet the minimum threshold. As a result, both segments were categorized as moderately impaired and were added to the 2002 CWA section 303(d) list of impaired waters. The Virginia Department of Environmental Quality (DEQ) developed total maximum daily loads in 2004, and created an implementation plan in cooperation with the Virginia Department of Conservation and Recreation (DCR) in 2009 that addressed aquatic life impairments in the Smith Creek watershed, including Mountain Run.
