Subject: March 8-9, 2022 Inspection Trip Report for City of Cahokia Heights

**Purpose:** NPDES SSO Inspection Trip Report

**Facility:** City of Cahokia Heights, Illinois

**Dates of Inspection:** March 8, 2022 – March 9, 2022

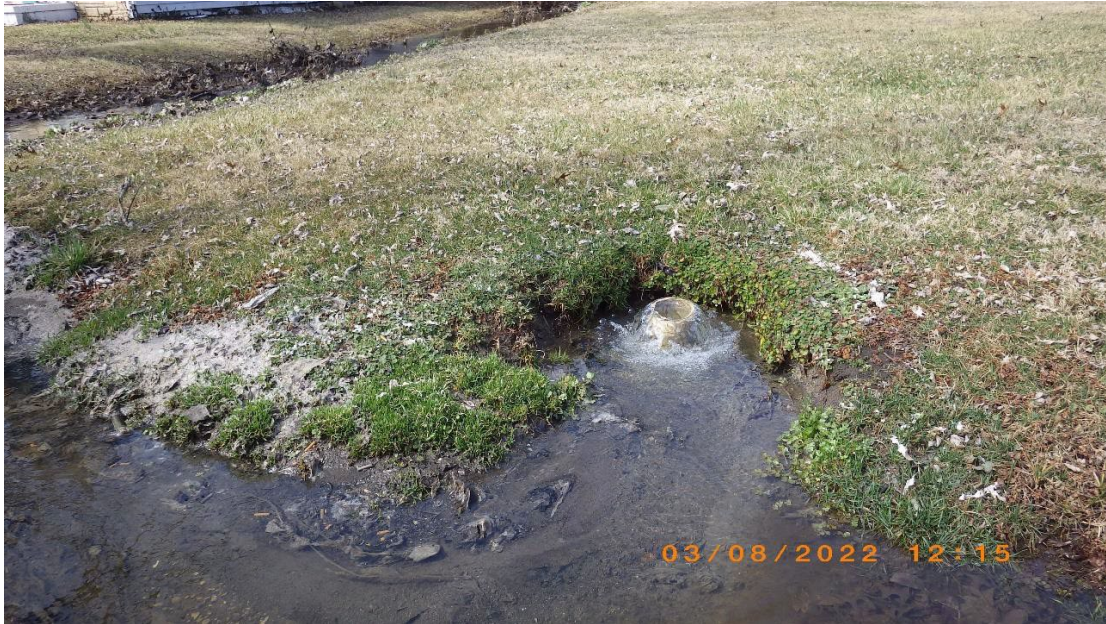
1: RIMG0041

EPA inspectors arrived at the cleanout overflow location on North 82<sup>nd</sup> Street at 12:15PM. The cleanout was discharging at the time of observation. According to City of Cahokia Heights Sewer Department representative Dennis Traiteur, this cleanout had been discharging continuously since February 17, 2022. See Photo 1.

Description: Active discharge of sanitary waste from cleanout.

Location: North 82<sup>nd</sup> Street.

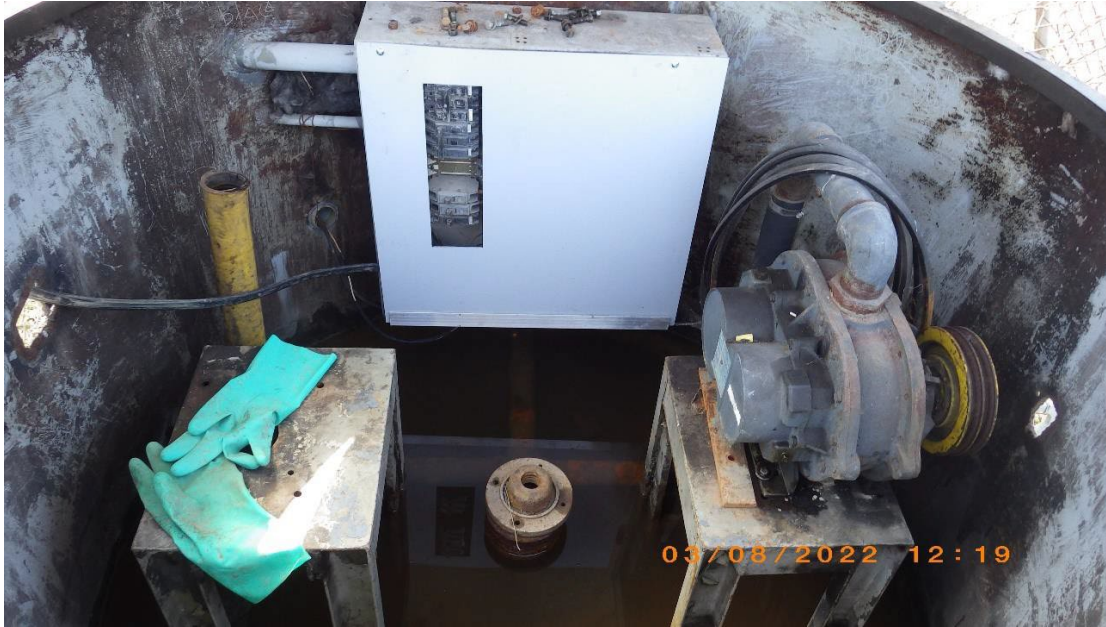
2: RIMG0042

EPA inspectors arrived at the lift station at the intersection of North 82<sup>nd</sup> Street and Bluff Street at 12:20PM. The lift station structure fencing was not secured and the lid to the structure was not locked. The above ground structure was holding water. The pump in this structure did not have belts attached to it, although it is no longer in use due to the installation of submersible pumps. See Photo 2.

Description: Above ground lift station structure. Note belts are off the pump and structure is holding stagnant water.

Location: Intersection of North 82<sup>nd</sup> Street and Bluff Street.

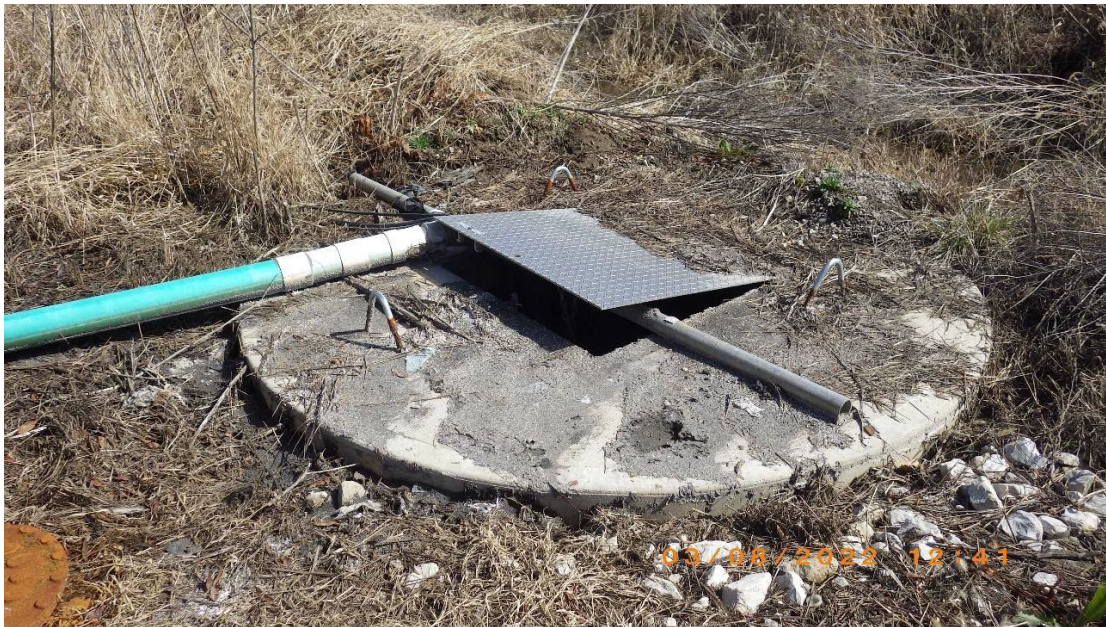
3: RIMG0043

EPA inspectors arrived at the Lady of the Snows lift station located near the intersection of Illinois Route 157 and Missouri Avenue at 12:38PM. The submersible pumps were running at the time of observation and were pumping water through a temporary above ground pipe and discharging it to a manhole adjacent to Missouri Avenue. There was dried material around the top of the wet well. See Photo 3.

Description: Lady of the Snows lift station wet well. Note dried debris on concrete wet well cover and temporary above ground piping.

Location: Near the intersection of Illinois Route 157 and Missouri Avenue.

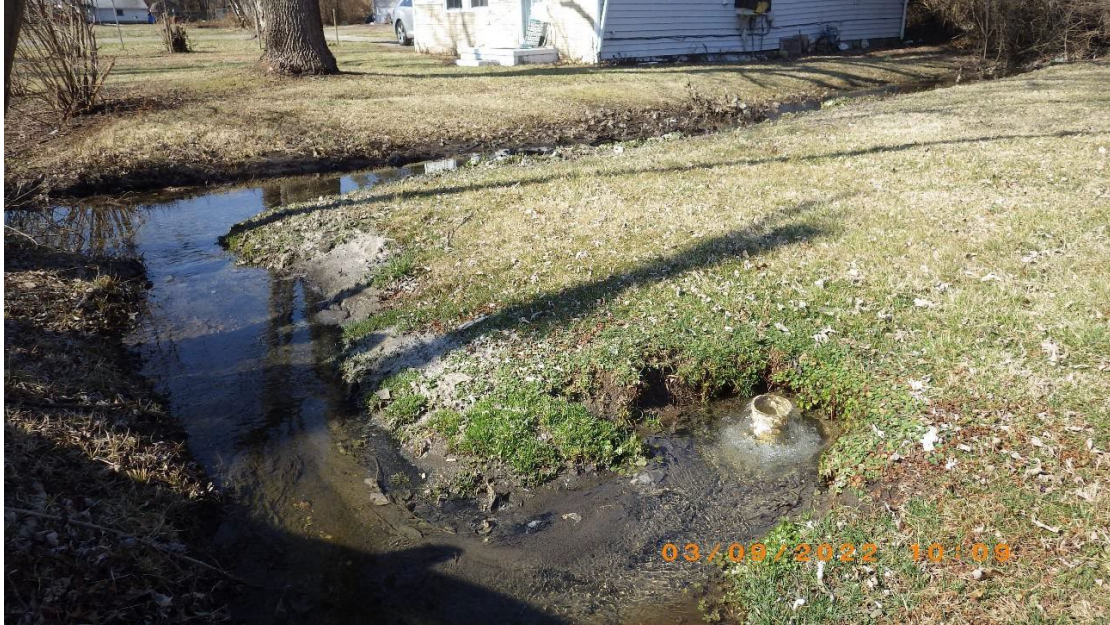
4: RIMG0044

EPA inspectors arrived at the cleanout overflow location on North 82<sup>nd</sup> Street at 10:10AM. The cleanout was discharging at the time of observation. The condition of the cleanout and surrounding area were the same as observed on March 8, 2022. See Photo 4.

Description: Active discharge of sanitary waste from cleanout.

Location: North 82<sup>nd</sup> Street.

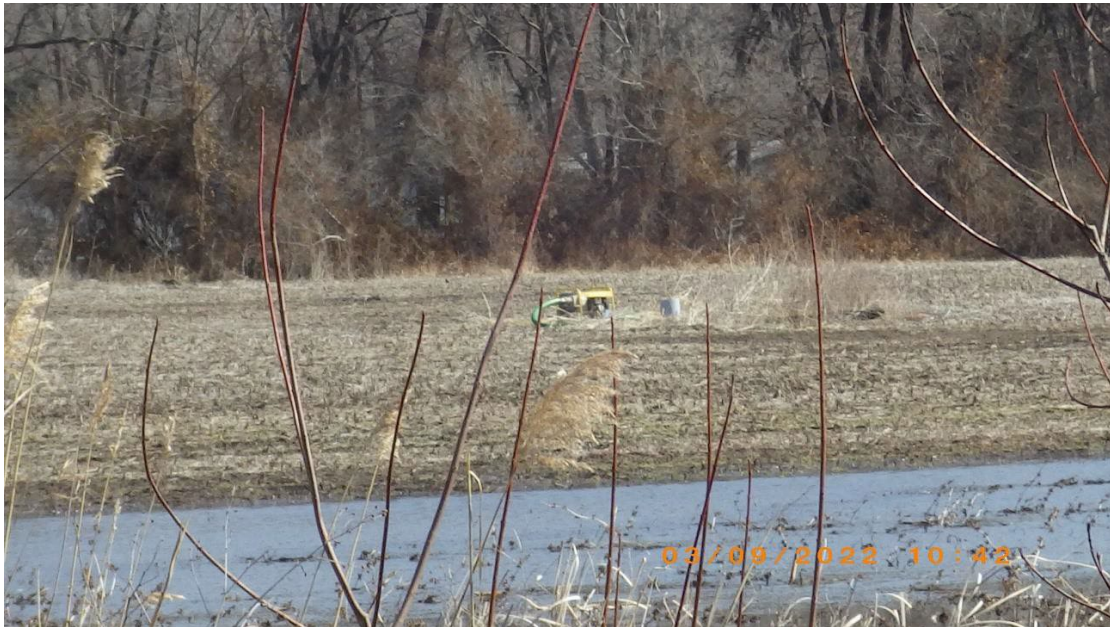
5: RIMG0045

EPA inspectors arrived at the lift station near the intersection of Lauralee Drive and Violet Drive at 10:41AM. The lift station was not overflowing. The lift station was not secured. An abandoned lift station wet well is located next to the current lift station. The top of that wet well was also not secured. Inspectors observed a portable pump located in a field approximately 200 feet northeast of the lift station. Portions of this field were flooded and holding stagnant water at the time of observation. It was unclear if this pump was pumping water into the sanitary sewer system. See Photo 5.

Description: Pump in an agricultural field. Note field is flooded and holding stagnant water.

Location: Approximately 200 feet northeast of the intersection of Lauralee Drive and Violet Drive.

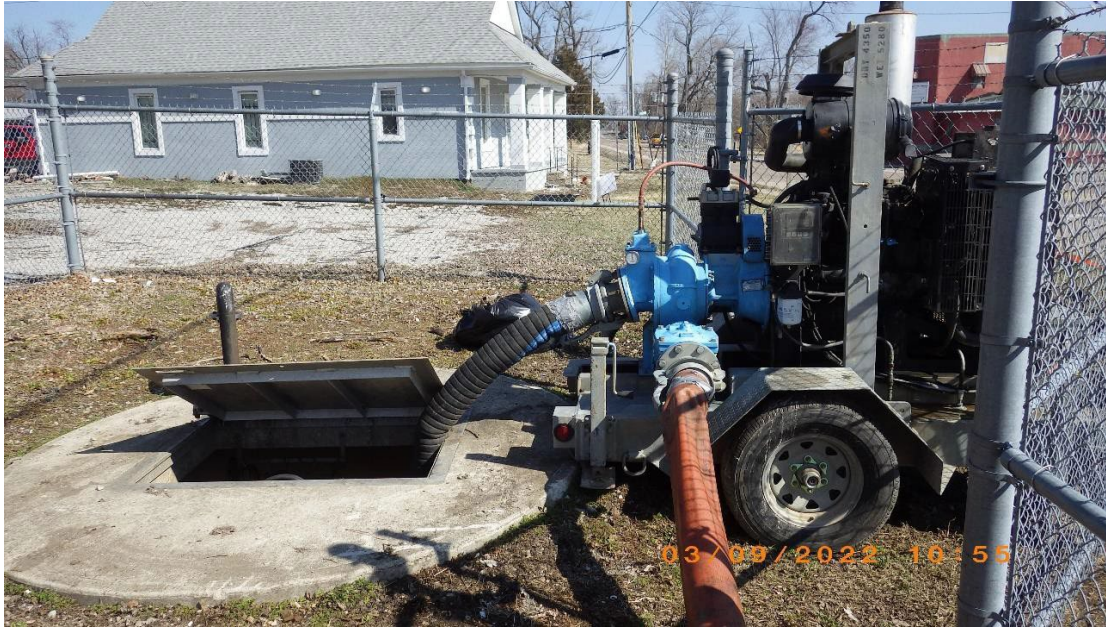
6: RIMG0046

EPA inspectors arrived at the lift station located near the intersection of Illinois Route 157 and Church Road at 10:56AM. This is also called the Railroad lift station by the City of Cahokia Heights. This lift station had a tow-behind pump parked in front of it with hoses going into the

wet well and an adjacent manhole. The pump was not running at the time of observation. See Photos 6 and 7.

Description: Tow-behind pump with hose going into lift station wet well.

Location: Near the intersection of Illinois Route 157 and Church Road.

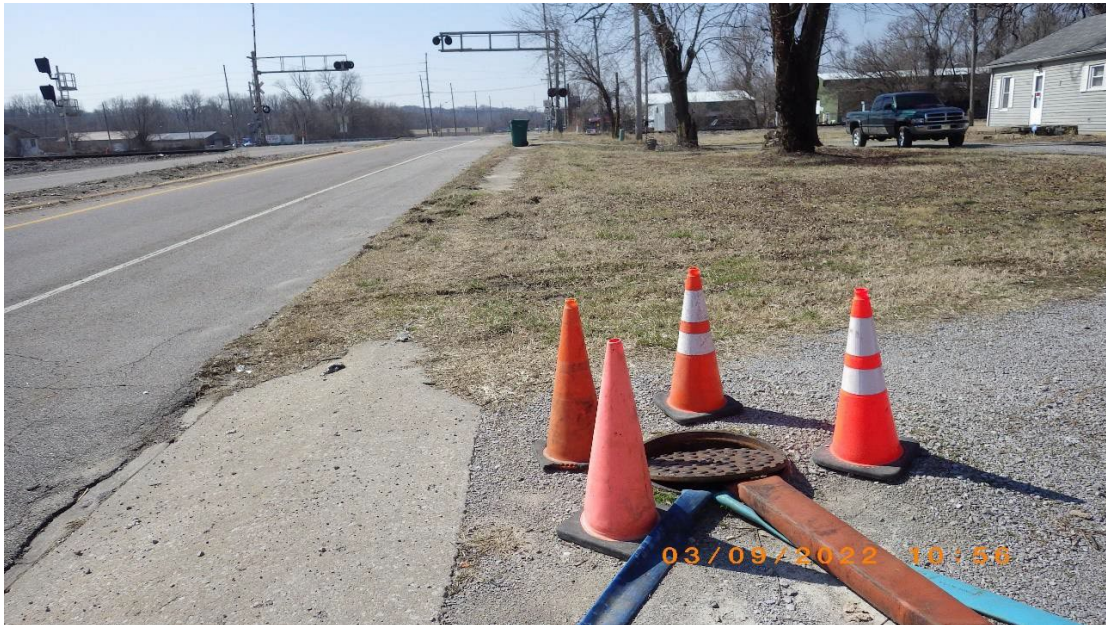
7: RIMG0047

Description: Hose from tow-behind pump going into adjacent manhole.

Location: Near the intersection of Illinois Route 157 and Church Road.

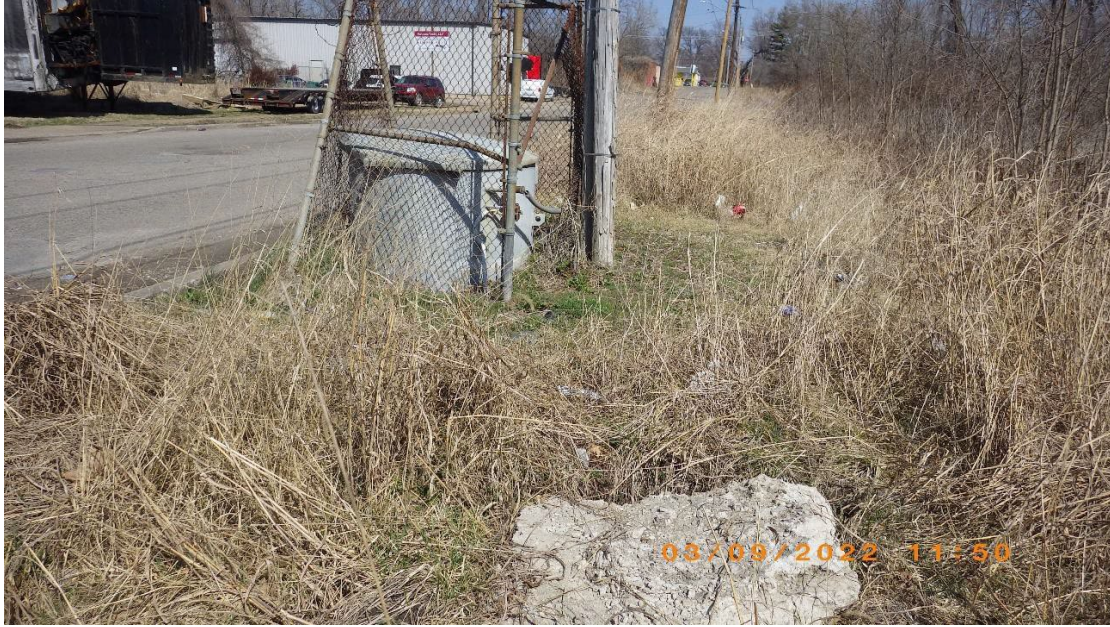
8: RIMG0048

EPA inspectors arrived at a manhole on North 73<sup>rd</sup> Street south of the intersection with State Street at 11:50AM. This manhole is adjacent to a lift station and had been previously identified as a safety concern because it did not have a manhole cover and was holding stagnant water. The city placed a large concrete block on the open manhole. See Photo 8.

Description: Concrete block covering open manhole.

Location: On North 73<sup>rd</sup> Street, just south of the intersection with State Street.
