East Palestine Train Derailment - TAGA Route Map - March 6, 2023

On March 6, 2023, EPA's Trace Atmospheric Gas Analyzer (TAGA) bus performed air monitoring around the East Palestine Derailment Location, monitoring for n-Butyl Acrylate and Vinyl chloride.

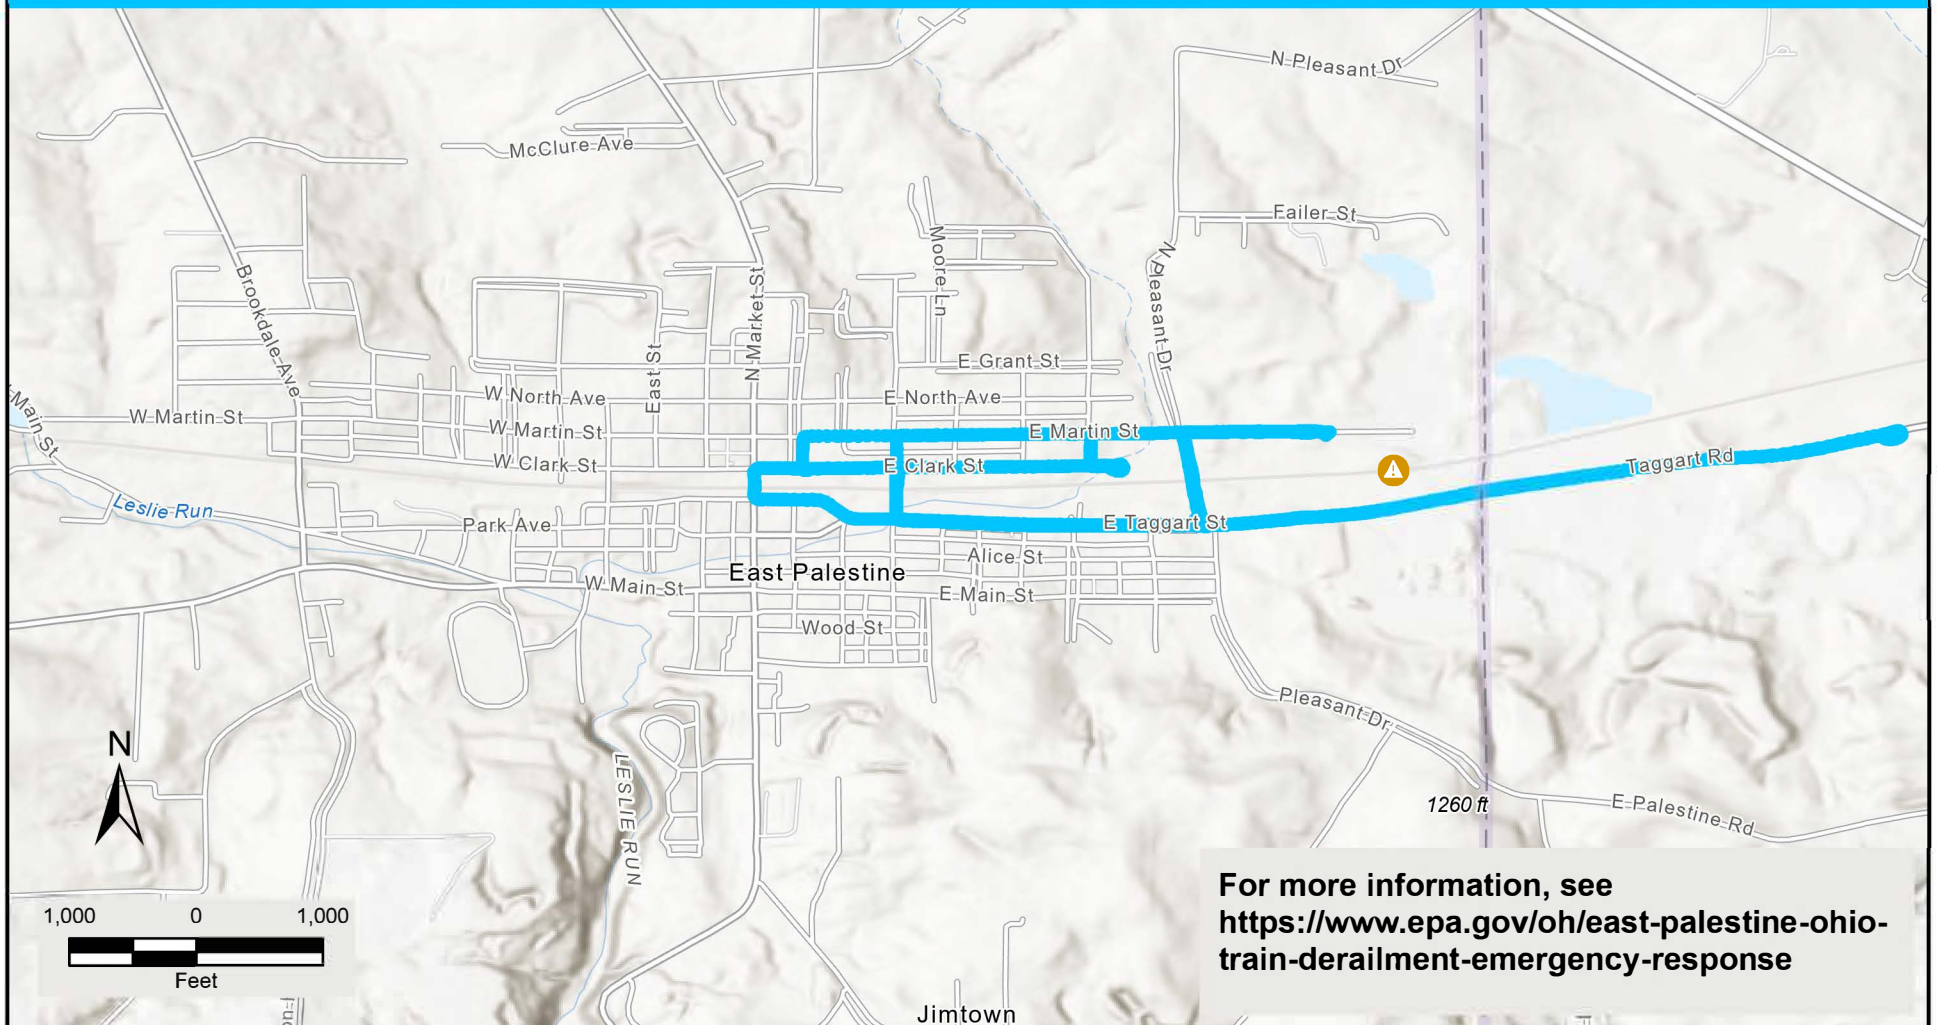
For n-Butyl Acrylate, 99% of the readings were **below** site-specific mobile thresholds. For Vinyl chloride, 100% of the readings were **below** site-specific mobile thresholds.
