**Region 5 Enforcement and Compliance Assurance Division
SDWA DRINKING WATER INSPECTION REPORT**

Inspection Dates: August 11-12, 2021

Systems Inspected: Cahokia Heights, 2525 Mousette Lane, Cahokia, IL 62206
Operating Commonfields of Cahokia - PWSID IL1635030
Operating Village of Cahokia - PWSID IL1630200

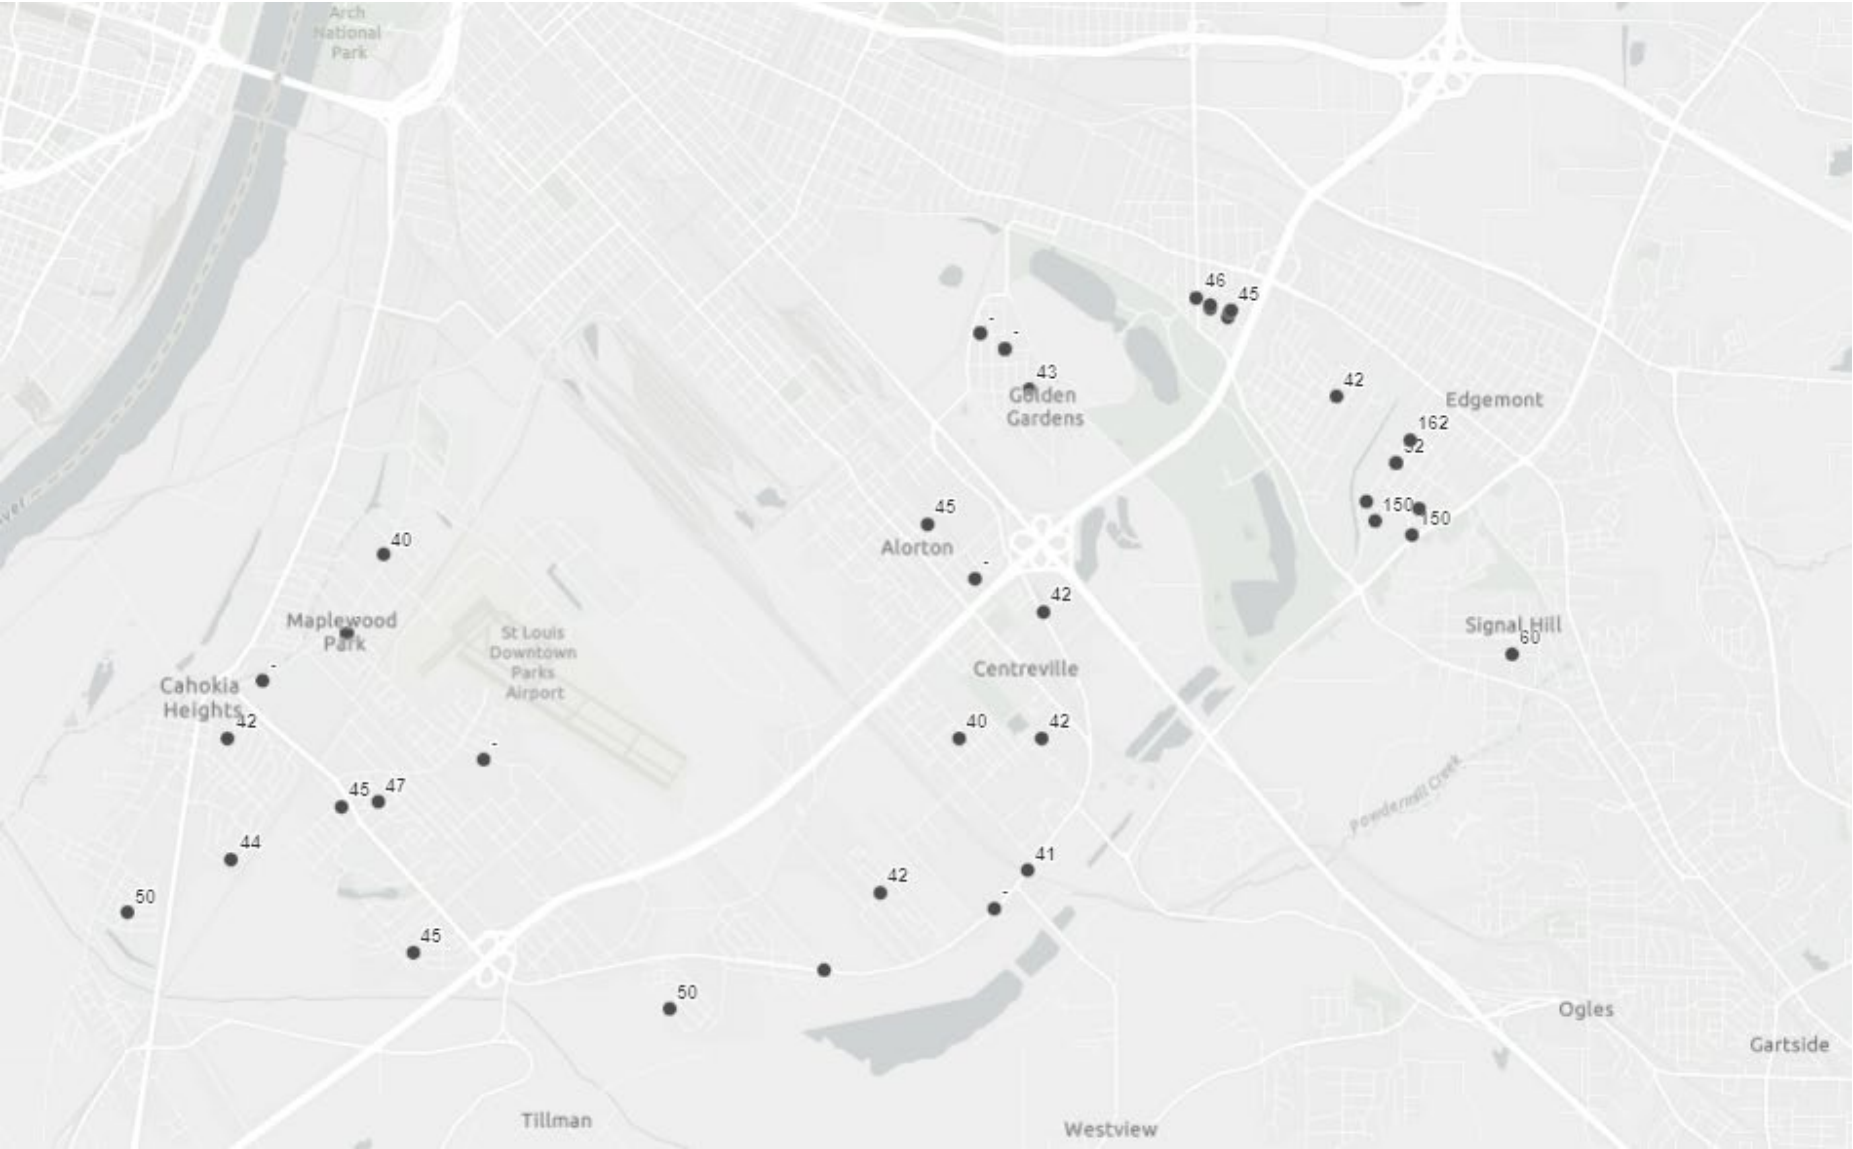
Map of Pressure Readings in Pounds per Square Inch (PSI)

1. Industry standards for pressure management recommend that the pressure in the distribution system be less than 100 psi. The area near the Edgemont booster station, located east of 80th Street, had pressures greater than 150 psi. Residents in this area have complained of frequent line breaks and damage to their residential plumbing systems.
