Norfolk Southern Railway Company

Sulphur Run Culvert Sediment Removal Plan

**East Palestine Train Derailment
Columbiana County, Ohio**

Rev Date: November 10, 2023

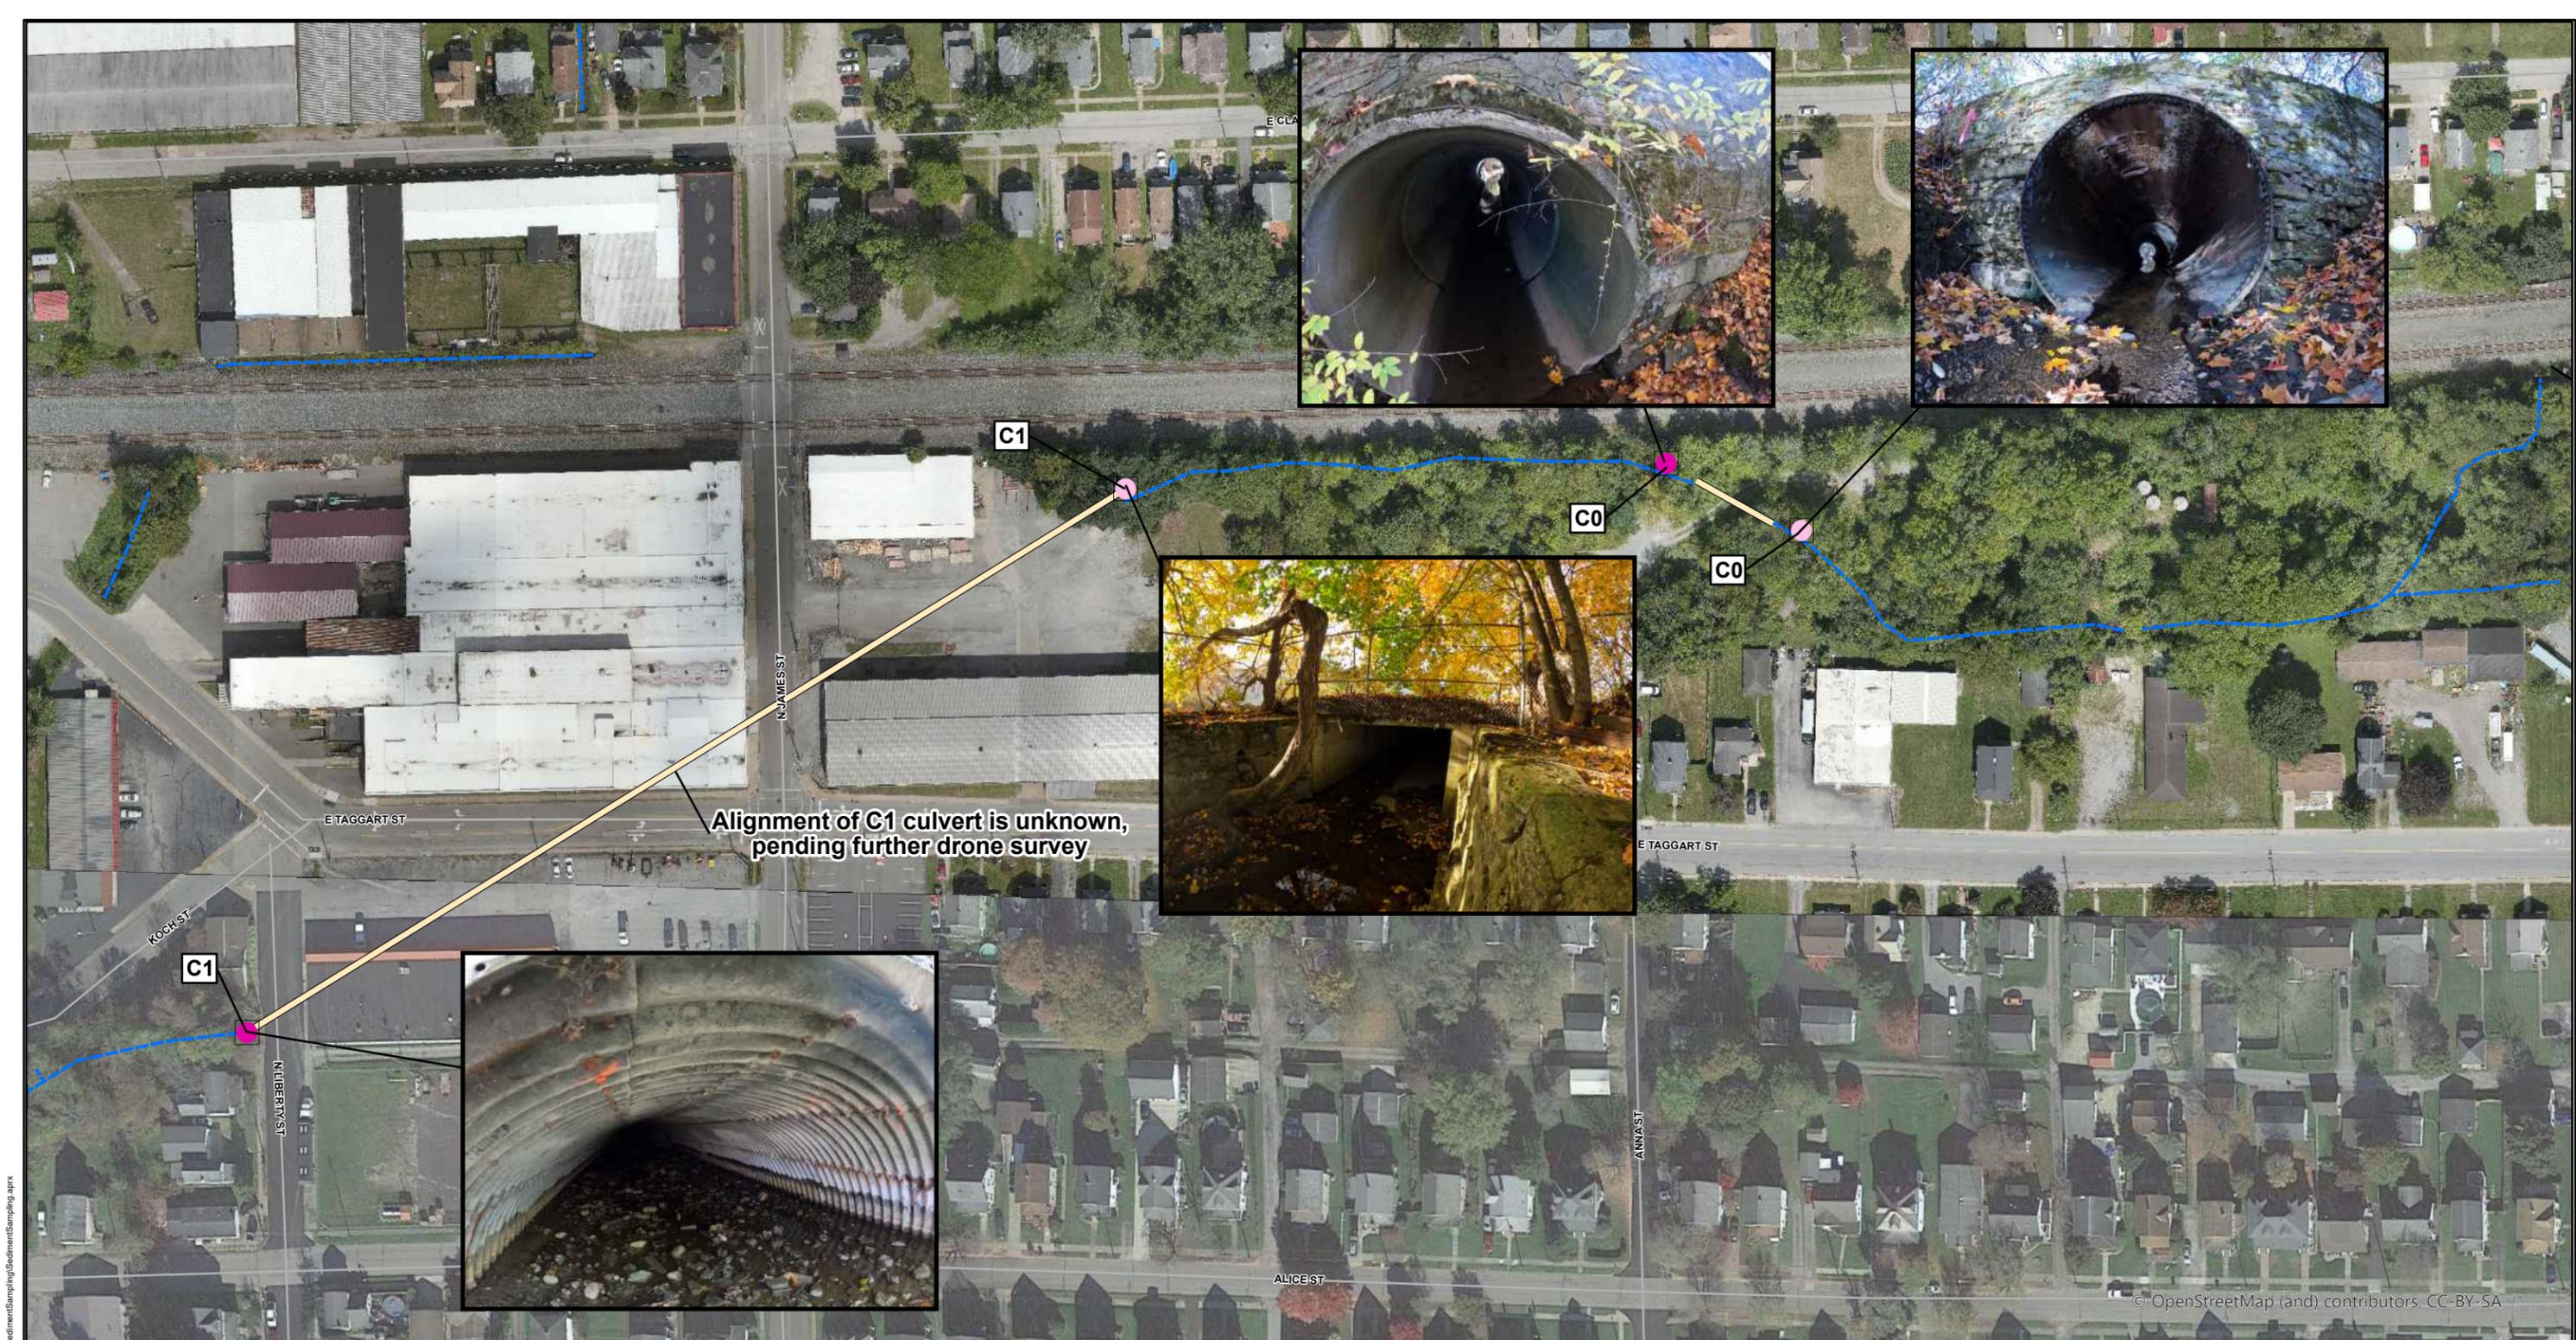
FIGURE
2-1

Additional visual inspections were conducted on October 25 and 26, 2023 in order to confirm culvert construction type and presence of an engineered hard bottom at C0 and C4, and to evaluate potential staging areas for all culverts included in this Plan. Based on visual inspections near the inlets and outlets, materials within the culverts appear to include a mixture of typical stream sediments, larger stone, concrete, and other debris. Photographs of the inlets and outlets were taken as presented on Figures 2-1 and 2-2.

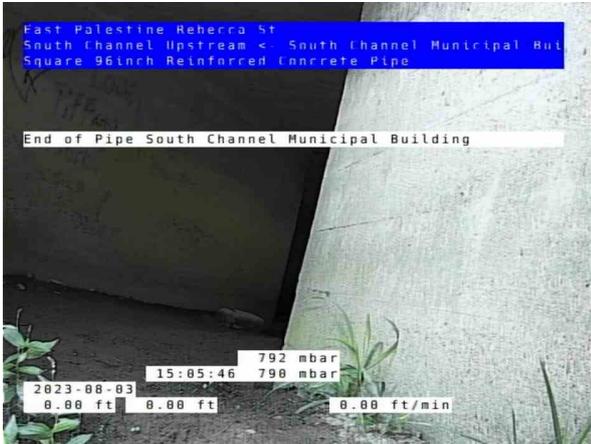
City	Street	Date	Lateral Segment Reference	Section No.
East Palestine	Rebecca St	8/3/2023	South Channel	1

South Channel Upstream-South Channel Municipal Building_cdfaf857-a329-47c7-8921-1e19a3b8e907_20230803_091018_508.jpg, 00:00:00, 0.00ft
 End of Pipe / South Channel Municipal Building

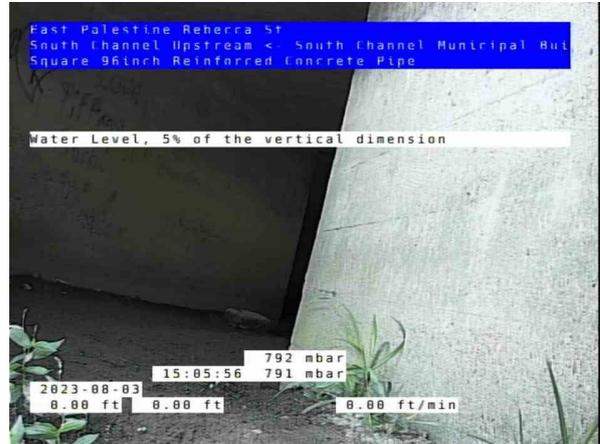
South Channel Upstream-South Channel Municipal Building_67eea4d9-8af3-49ea-a6f2-951e00de471f_20230803_091028_646.jpg, 00:00:05, 0.00ft
 Water Level, 5% of the vertical dimension

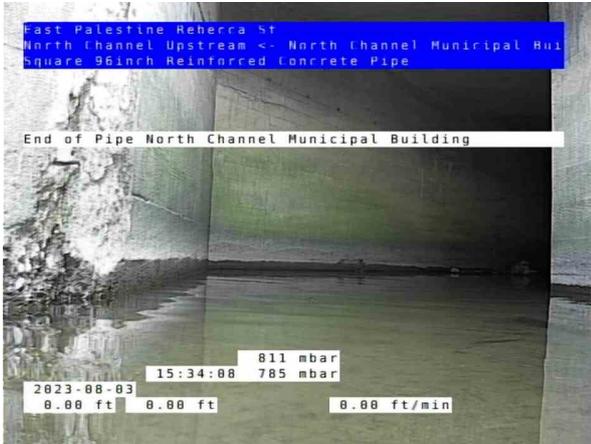
City	Street	Date	Lateral Segment Reference	Section No.
East Palestine	Rebecca St	8/3/2023	North Channel	2

North Channel Upstream-North Channel Municipal Building_6d5ae010-2633-4ac1-b9e7-a352cd0bdb35_20230803_093840_652.jpg, 00:00:00, 0.00ft
End of Pipe / North Channel Municipal Building

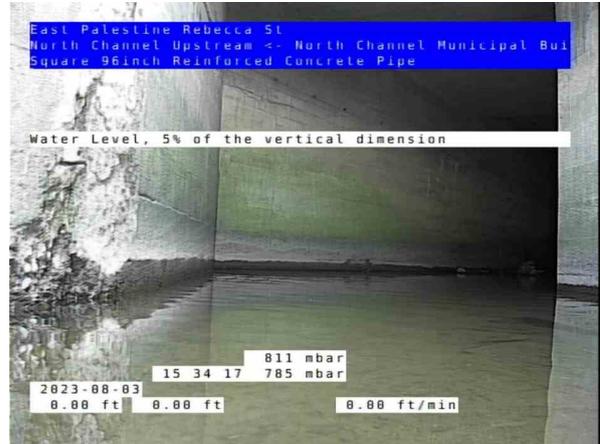
North Channel Upstream-North Channel Municipal Building_00be1484-3263-49f4-a62b-1a6f4d65f819_20230803_093850_296.jpg, 00:00:06, 0.00ft
Water Level, 5% of the vertical dimension

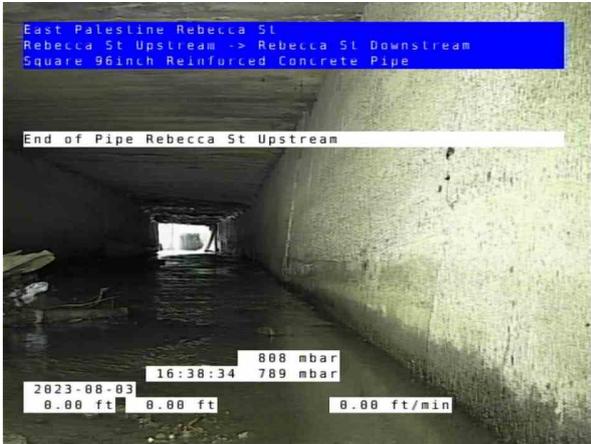
City	Street	Date	Lateral Segment Reference	Section No.
East Palestine	Rebecca St	8/3/2023	Rebecca St	3

Rebecca St Upstream-Rebecca St Downstream_37994f9f-ed2a-4bba-bd1d-869a936dda98_20230803_104307_060.jpg, 00:00:00, 0.00ft
 End of Pipe / Rebecca St Upstream

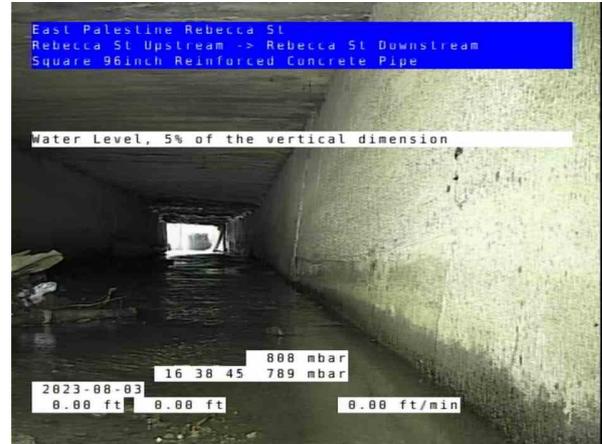
Rebecca St Upstream-Rebecca St Downstream_34a2e015-2605-4393-96a2-5e02a841f91b_20230803_104318_874.jpg, 00:00:04, 0.00ft
 Water Level, 5% of the vertical dimension

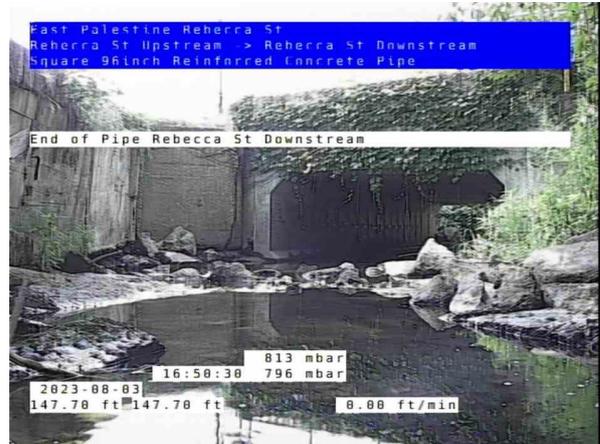
Rebecca St Upstream-Rebecca St
 Downstream_54fc9765-48cc-41bc-9157-3bb70cf7c0eb_202308
 03_105503_851.jpg, 00:11:26, 147.70ft
 End of Pipe / Rebecca St Downstream

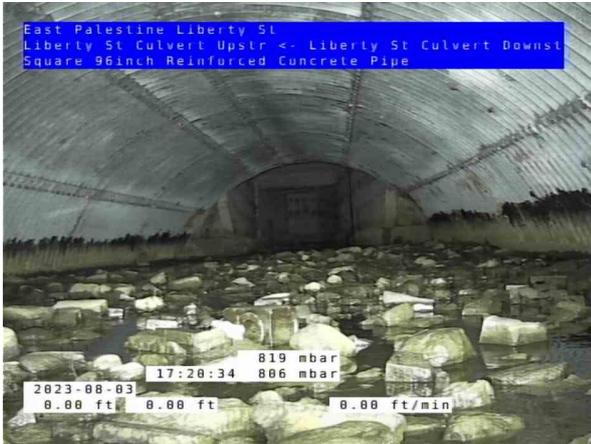
City	Street	Date	Lateral Segment Reference	Section No.
East Palestine	Liberty St	8/3/2023	Liberty St Culvert	4

Liberty St Culvert Upstream-Liberty St Culvert
 Downstream_c3af6d16-33b3-4788-88b3-1f991373a502_20230
 803_112507_951.jpg,00:00:00,0.00ft
 End of Pipe / Liberty St Downstream

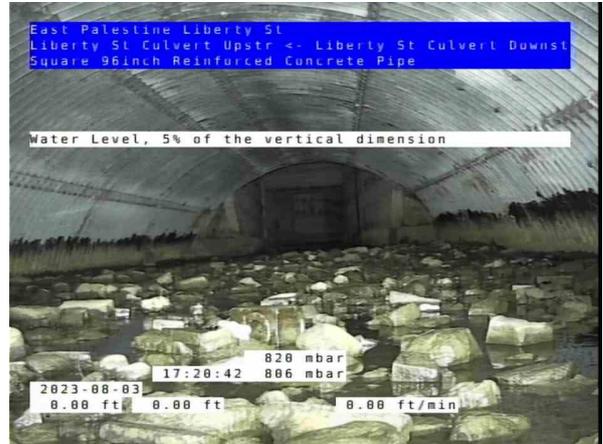
Liberty St Culvert Upstream-Liberty St Culvert
 Downstream_ecc8eb4e-9d71-492d-a08c-606706c95575_20230
 803_112515_388.jpg,00:00:18,0.00ft
 Water Level, 5% of the vertical dimension
