Subject: March 31, 2021 to April 2, 2021 SSO Reconnaissance Inspection Report

Purpose: Commonfields of Cahokia – SSO Reconnaissance Inspection Report

Facility: Commonfields of Cahokia Sewer District

Dates of Inspection: March 31, 2021 through April 2, 2021

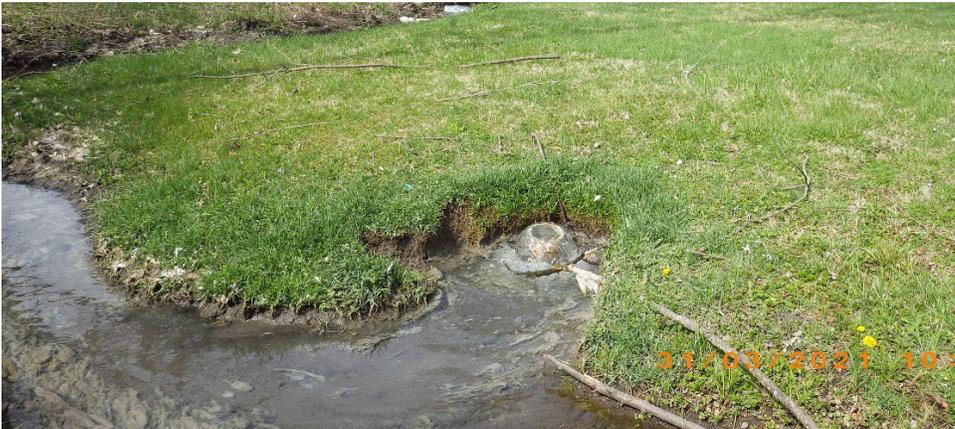
1: RIMG0051 (Photo cropped to remove Personal Identifiable Information)
Description: Cleanout was discharging sanitary waste during dry weather.
Location: East of North 80th Street.
Camera Direction: Northwest
Date/Time: March 31, 2021 / 11:21 A.M.

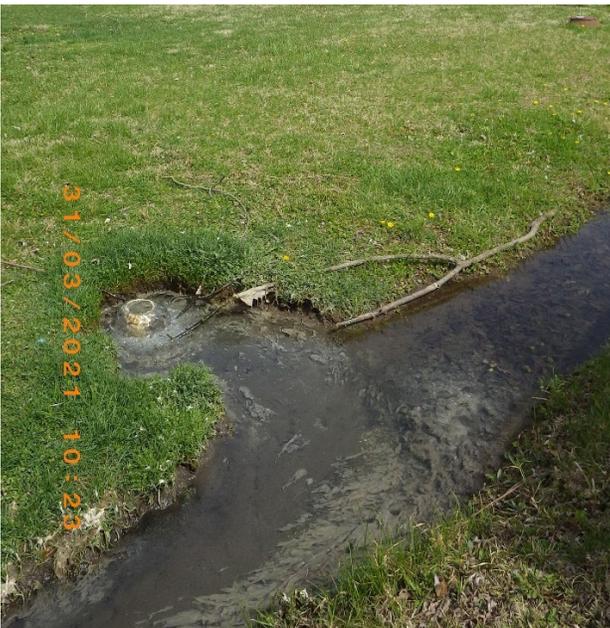
2: RIMG0052 (Photo cropped to remove Personal Identifiable Information)
Description: Cleanout was discharging sanitary waste during dry weather.
Location: East of North 80th Street.
Camera Direction: North
Date/Time: March 31, 2021 / 11:23 A.M.

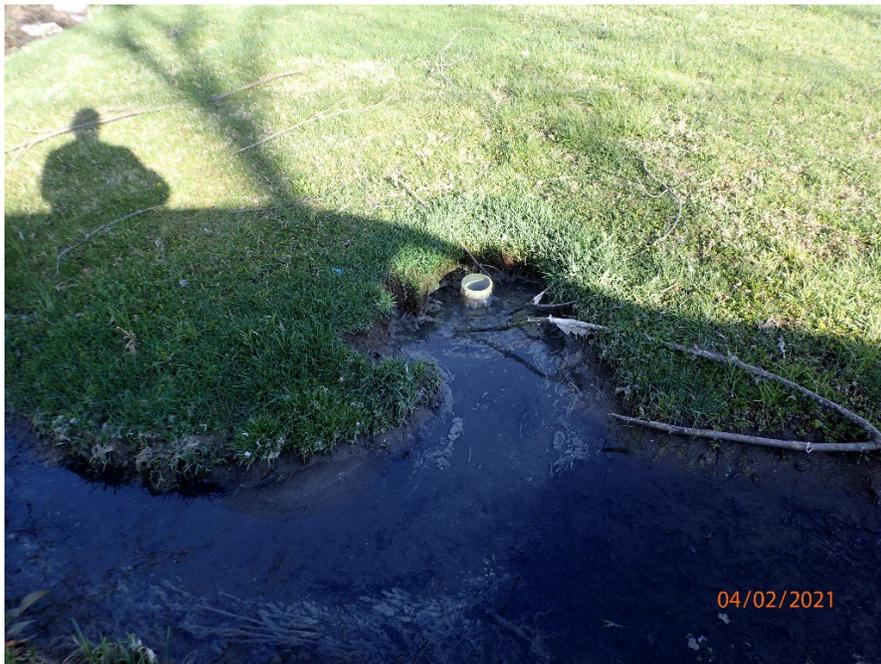
P4020025

Description: Cleanout was discharging sanitary waste during dry weather.

Location: East of North 80th Street.

Camera Direction: Northwest
